91 Audi connect user management option greyed out or SOS and Roadside with no function, DTCs P169A00, U13EB00

91 23 69 2052299/6 February 6, 2023. Supersedes Technical Service Bulletin Group 90 number 22-73 dated June 29, 2022, for reasons listed below.

Model(s)	Year	VIN Range	Vehicle-Specific Equipment
All Audi Vehicles	2019 – 2022	All	Not Applicable

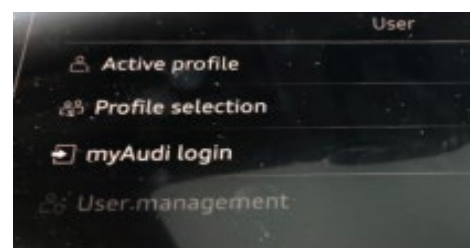
- The Audi connect “User management” screen is greyed out and the customer cannot complete the key user pairing (Figure 1).

Figure 1. User management.

- **DTC P169A00** (Transport mode active) is stored in the engine control module (ECM), J623 (address word 0001).
- **DTC U13EB00** (Emergency call module and communication unit Flight mode activated) is stored in the emergency call module and communication unit, J949 (address word 0075).

1. Change the adaptation for fight mode in diagnostic address 0075 at, *Self-diagnosis >> Go to address 0075 >> Adaptation values "Basis connect function" >> Flight mode >> Deactivate.*
2. Hit "Apply".
3. Cycle the ignition off and then back on.
4. Within Self-diagnosis go to DTC readout for diagnostic address 00175 and clear the DTC.
5. Cycle the ignition off and then back on again.
6. Verify that the SOS light is green and/or the Audi connect User management option is now selectable.
7. If the issue persists disconnect the tester, roll the windows up, close all doors, and lock the vehicle for 2-3 minutes to allow the car to go through a sleep cycle, then retry steps 4-6 if necessary.

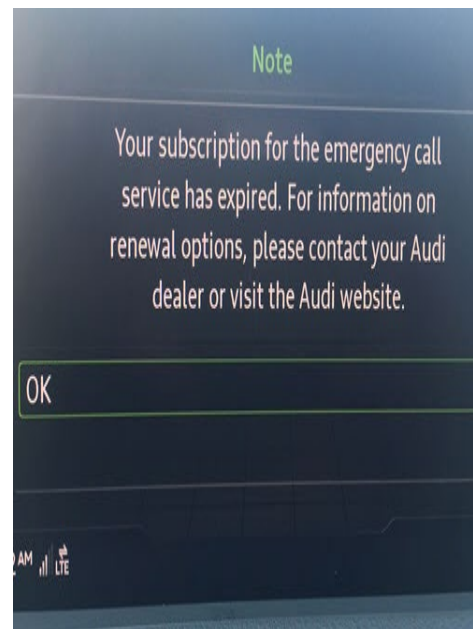
- The SOS emergency button is red or flashing red. When the customer presses the button, the message “Your subscription for the emergency call service has expired. For information on renewal options, please contact your Audi dealer or visit the Audi website” (Figure 2) is displayed.

Figure 2. Error message in MMI.
