Technical Service Bulletin: TSB220251

Bosch® Aftertreatment Diesel Exhaust Fluid (DEF) Dosing Unit Replacement for Fault Code 3559 Active/Inactive

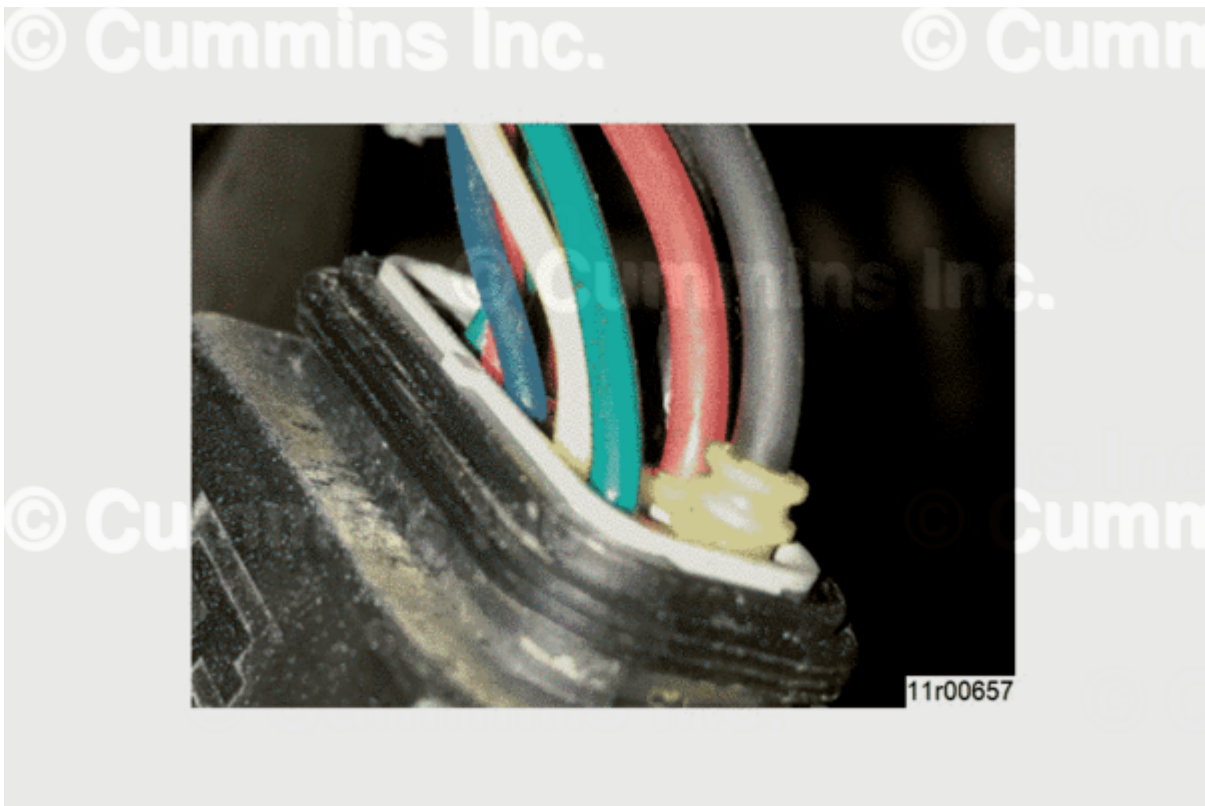
- OEM wiring connector to the aftertreatment DEF dosing unit is loose at the back of the connector at the weather pack seal (see Figures).

Figure 1, Loose Wire at Back of OEM Wiring Connector to Aftertreatment DEF Dosing Unit.

See equipment manufacturer service information to repair or replace the aftertreatment DEF dosing unit connector.

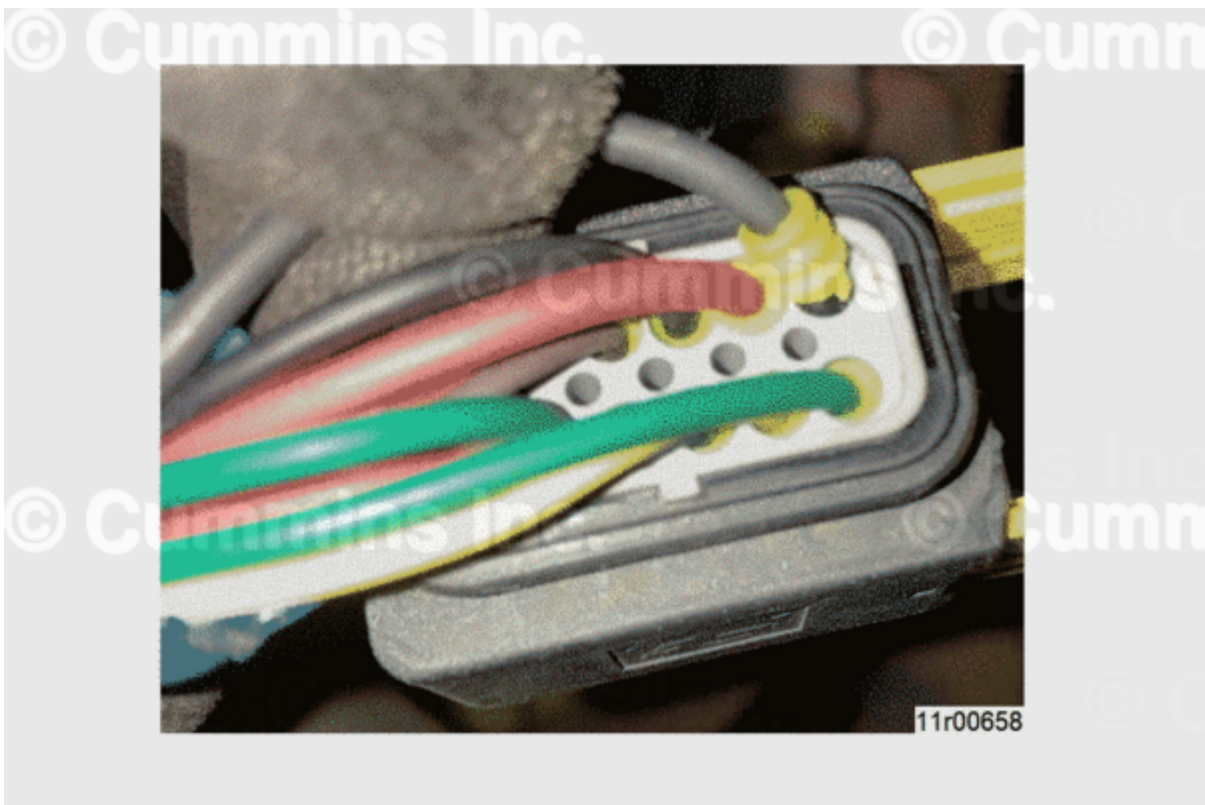
Figure 2, Loose Wire at Back of OEM Wiring Connector to Aftertreatment DEF Dosing Unit.

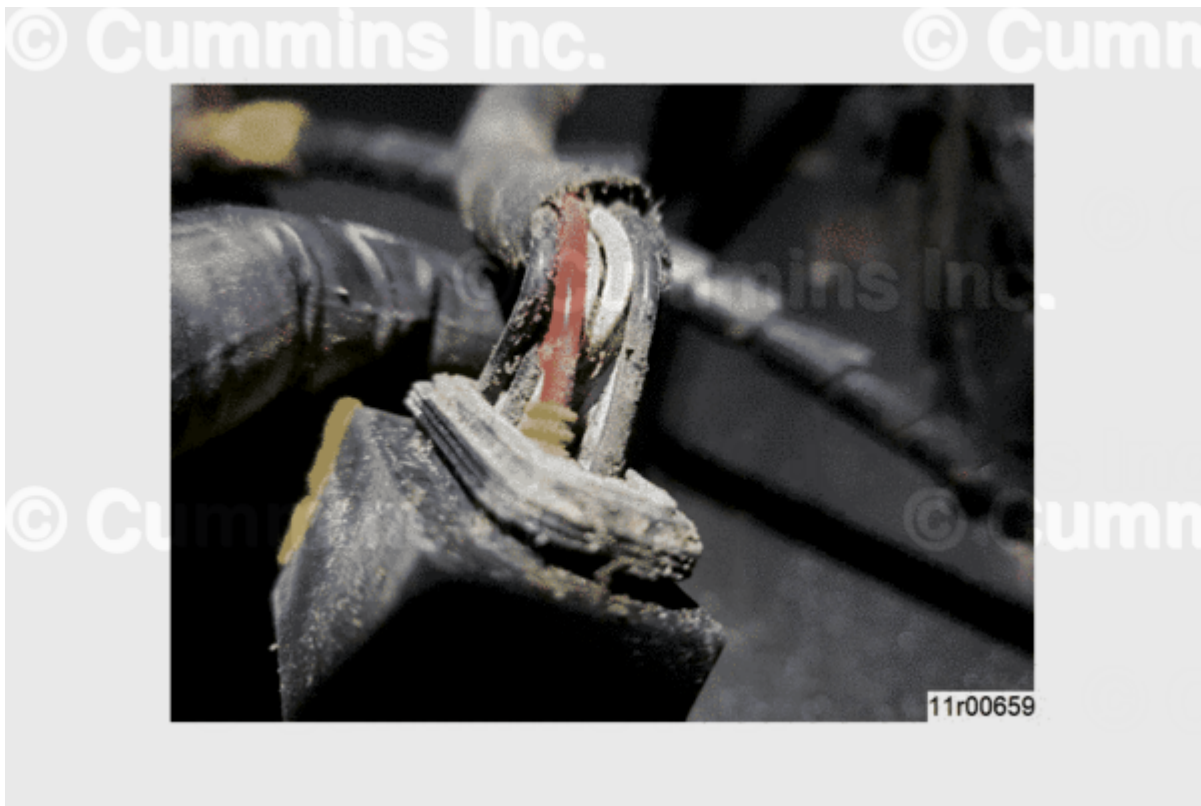
Figure 3, Loose Wire at Back of OEM Wiring Connector to Aftertreatment DEF Dosing Unit.
