Applicable Vehicles					
Model(s)	Year	Eng. Code	Trans. Code	VIN Range From	VIN Range To
Golf R, GTI	2022 - 2023	All	All	All	All

91-23-02 - Various Infotainment Concerns

Release date: 2/13/2023

This procedure resolves the concern(s) listed above by updating the MIB Infotainment System to the latest level **1776**.

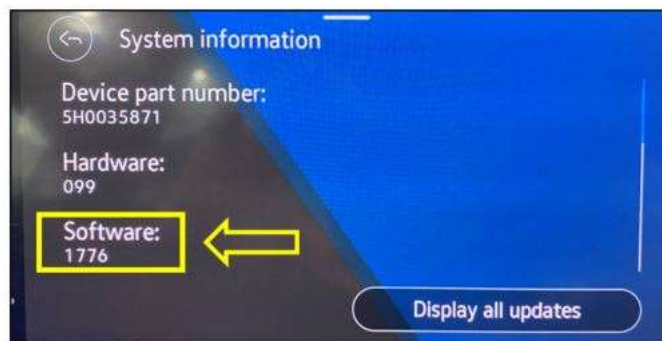
Once in Settings select "System Information" to check the current software level.

If the current software level is lower than **1776**, proceed with this Technical Bulletin.

If the current software level is equal to or greater than **1776**, this work procedure does not apply.
