Service Bulletin

Bulletin No.: 23-NA-006

Subject: Instrument Panel Trim Plate Applique Loose

Brand:	Model:	Model Year:		VIN:		Engine:	Transmission:
		from	to	from	to		
Chevrolet	Suburban	2021	2023				
	Tahoe						
GMC	Yukon Models

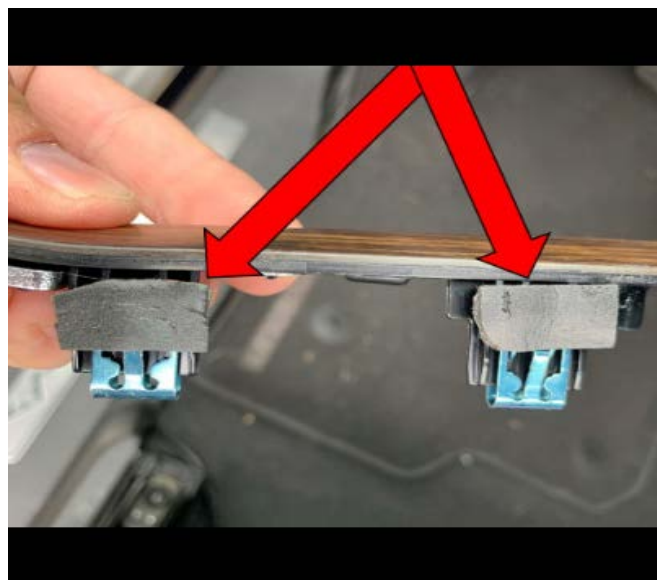
6258556

Involved Region or Country	North America
Condition	Some customers may comment on the instrument panel trim plate applique is either loose and/or has fallen off.
Cause	The cause of the condition may be due to the retention clip coming unsecured.
Correction	Apply foam tape to the tower holding the retention clips and reinstall.

If you encounter a vehicle with the above concern, remove the instrument panel trim plate applique and apply Kent foam tape (or equivalent) to the bottom of the part on the side ribs of the tower holding the clip like illustrated above. Refer to *Instrument Panel Trim Plate Applique Replacement - Left or Right Side*. Once the reinstalled, verify condition is corrected.
