Service Bulletin

Bulletin No.: 23-NA-007

Subject: Black Radio Display Screen (Triangle and Camera with Slash Through it) with DTCs B1A62 82 and 86 Setting Current in Video Processing Module (VPM)

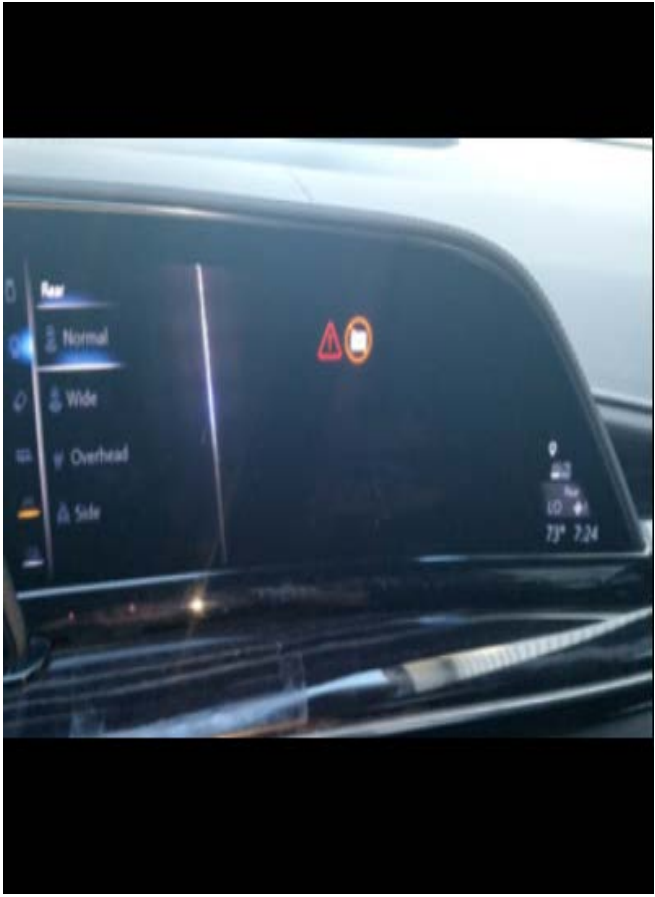
Involved Region or Country	United States, Canada, Mexico, Russia, Middle East, Japan, Cadillac Korea (South Korea)
Additional Options (RPOs)	
Condition	Some customers may comment on a condition present on startup on the radio display where a black screen with a triangle and a camera with the slash through it is displayed.

<p data-bbox="1419 1052 1481 1071">6259342</p> <p data-bbox="540 1081 1182 1171">Technician may find two DTCs set current or in recent history:</p> <ul data-bbox="540 1115 727 1171" style="list-style-type: none"> • DTC B1A62 82 • DTC B1A62 86
<p>Cause</p>	<p>The cause of the condition may be software anomalies in the VPM.</p>
<p>Correction</p>	<p>Reprogram the VPM with the latest software released.</p>

1. Reprogram the Video Processing Module. Refer to *K157 Video Processing Control Module: Programming and Setup in SI*.
