GLOBAL SAFETY FIELD INVESTIGATIONS DCS6457 URGENT - DISTRIBUTE IMMEDIATELY

Subject: N222390510 - Service Update

Body Control Module Connectors

Models: 2023 Cadillac XT4

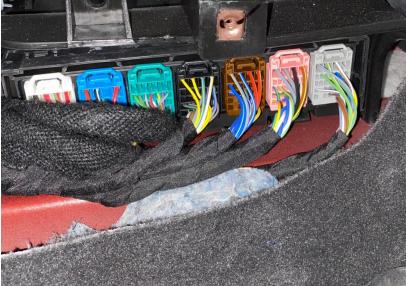
6277792

Condition	Certain 2023 model year Cadillac XT4 and Chevrolet Malibu vehicles may have a condition where one			
	or more of the body control module connectors are not fully seated.			
Correction	Dealers are to inspect the connectors at the body control module and ensure they are all fully seated.

Caution: Do not pull on the wires of the connector to ensure engagement, only pull on the connector housings.

- 8. Verify all of the connectors are fully engaged by slightly pulling on the connectors in the direction of removal.
- 9. Ensure all of the connectors are fully pushed into the Body Control Module by pushing on the connector housings in the direction of installation.
 - If vehicle is a Malibu, proceed to step 10.
 - If vehicle is a XT4, proceed to step 11.
