Technical Service Bulletin

91 Audi connect user management option greyed out or SOS and Roadside with no function, DTCs P169A00, U13EB00

91 23 72 2052299/7 February 10, 2023. Supersedes Technical Service Bulletin Group 91 number 23-69 dated February 6, 2023, for reasons listed below.

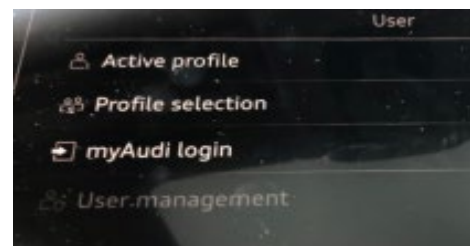
- The Audi connect “User management” screen is greyed out and the customer cannot complete the key user pairing (Figure 1).

Figure 1. User management.

1. Change the adaptation for flight mode in diagnostic address 0075 at, *Self-diagnosis >> Go to address 0075 >> Adaptation values "Basis connect function" >> Flight mode >> Deactivate.*
2. Hit "Apply".
3. Cycle the ignition off and then back on.
4. Within Self-diagnosis go to DTC readout for diagnostic address 0075 and clear the DTC.
5. Cycle the ignition off and then back on again.
6. Verify that the SOS light is green and/or the Audi connect User management option is now selectable.
7. If the issue persists disconnect the tester, roll the windows up, close all doors, and lock the vehicle for 2-3 minutes to allow the car to go through a sleep cycle, then retry steps 4-6 if necessary.
