GLOBAL SAFETY FIELD INVESTIGATIONS
DCS6461
URGENT - DISTRIBUTE IMMEDIATELY

Subject: N222375790 - Customer Satisfaction Program
Park Assist Retrofit

Models: 2022 – 2023 Chevrolet Corvette

N222375790 Park Assist Retrofit

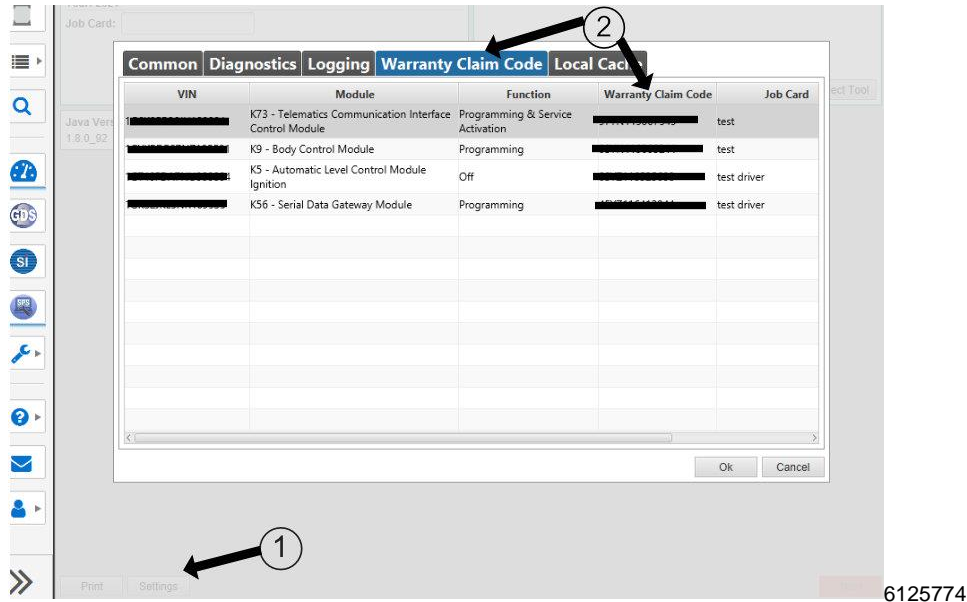
Warranty Claim Code Information Retrieval

If the Warranty Claim Code was not recorded on the Job Card, the code can be retrieved in the SPS2 system as follows:

- Open TLC on the computer used to program the vehicle.
- Select and start SPS2.
- Select Settings (1).
- Select the Warranty Claim Code tab (2).

The VIN, Warranty Claim Code and Date/Time will be listed on a roster of recent programming events. If the code is retrievable, dealers should resubmit the transaction making sure to include the code in the SPS Warranty Claim Code field.

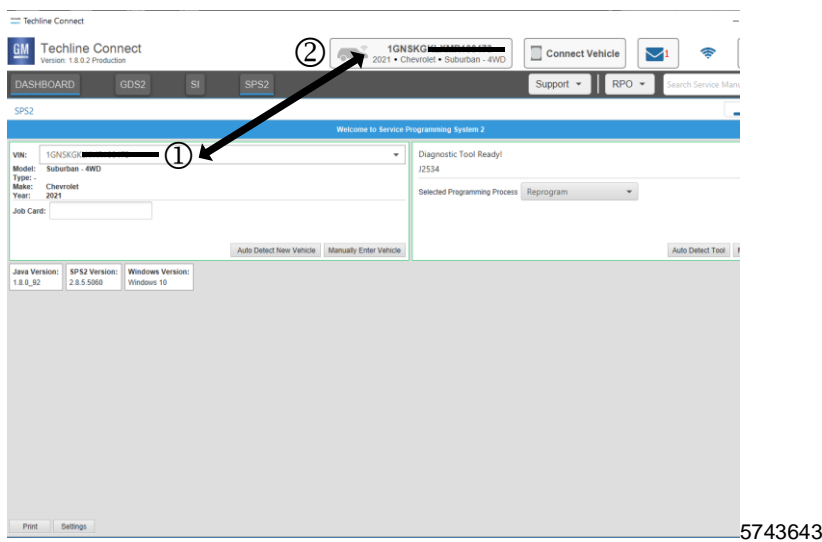
Caution: Be sure the VIN selected in the drop down menu (1) is the same as the vehicle connected (2) before beginning programming.

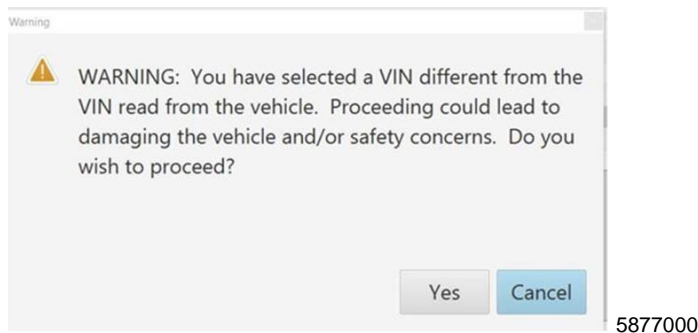
Important: If the vehicle VIN DOES NOT match, the message below will be shown.

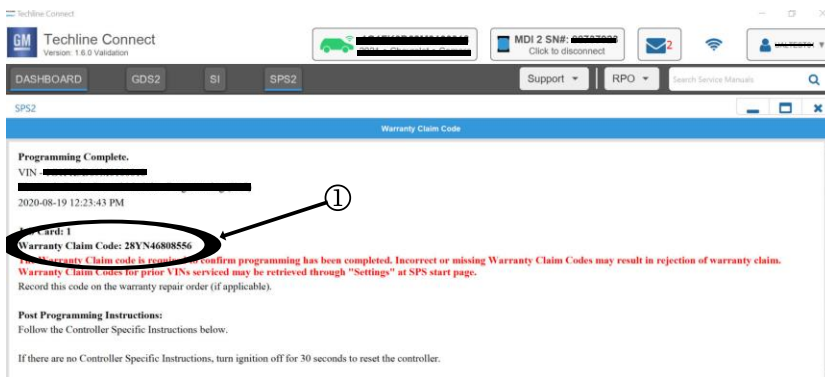
5644478

Note: The screenshot above is an example of module programming and may not be indicative of the specific module that is being programmed. Module selection and VIN information have been blacked out.

Important: To avoid warranty transaction rejections, you **MUST** record the warranty claim code provided on the Warranty Claim Code (WCC) screen shown above on the job card. Refer to callout 1 above for the location of the WCC on the screen.

5. Record SPS Warranty Claim Code on job card for warranty transaction submission.
6. Clear all DTCs.
7. Verify parking assist is now active on vehicle.
