Service Bulletin

Bulletin No.: 21-NA-284

Subject: 60% Rear Seat Will Not Fold Down

Brand:	Model:	Model Year:		Date Breakpoints:		Engine:	Transmission:
		from	to	from	to		
Cadillac	Escalade Models	2021	2022			All	All
Chevrolet	Suburban						
	Tahoe						
GMC	Yukon Models

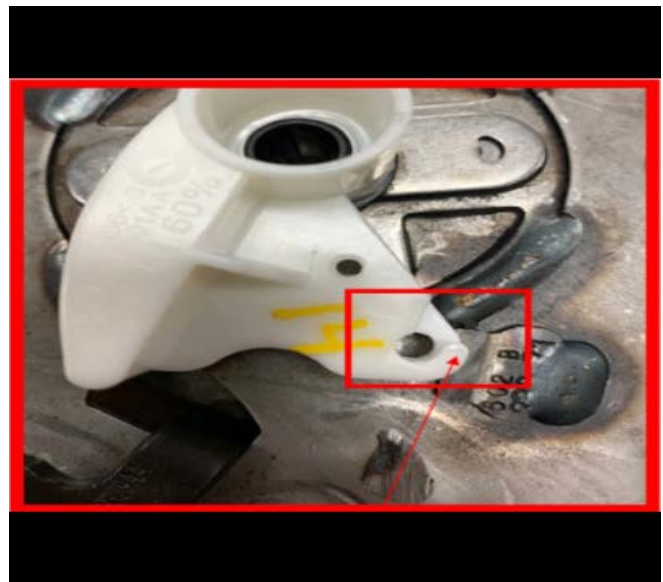
5932660

Note: Inspect outboard white release lever for damage or missing material (1). If damage is found, the entire structure must be replaced.

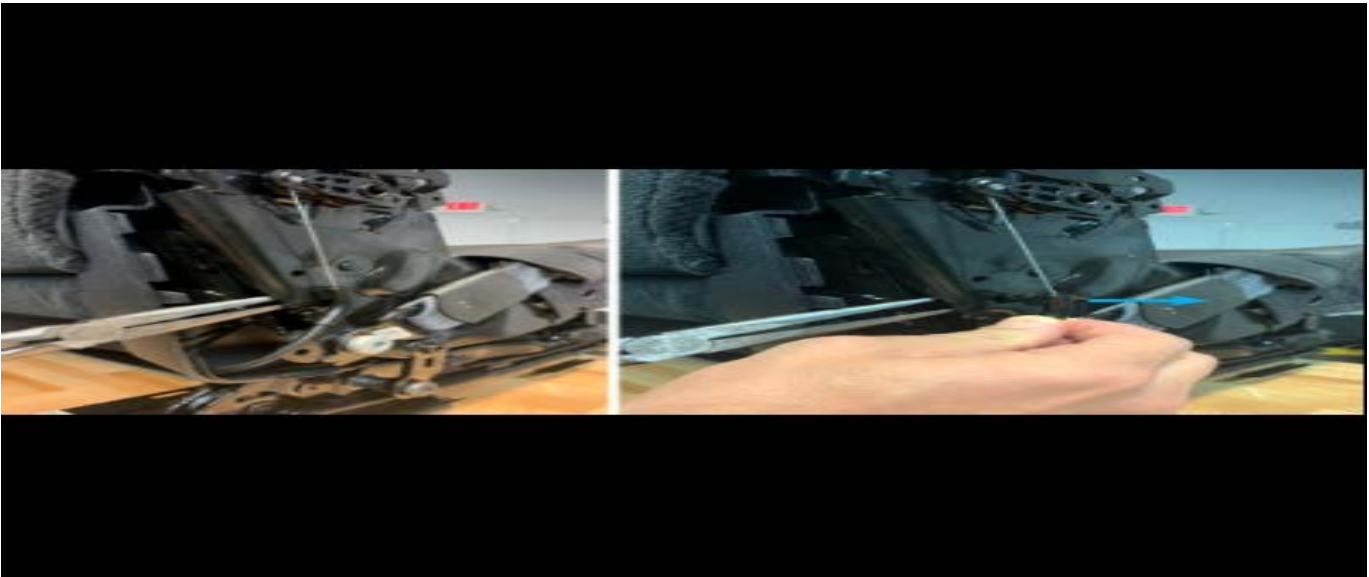
5932665

Note: If the metal cable strand is frayed or kinked, the cable must be replaced.

5.2. Remove fitting by pinching snap fingers and pulling fitting outward.
