Service Bulletin

Bulletin No.: 22-NA-235

Subject: Wireless Charging is Intermittent When Using Samsung Phones at Offset Positions

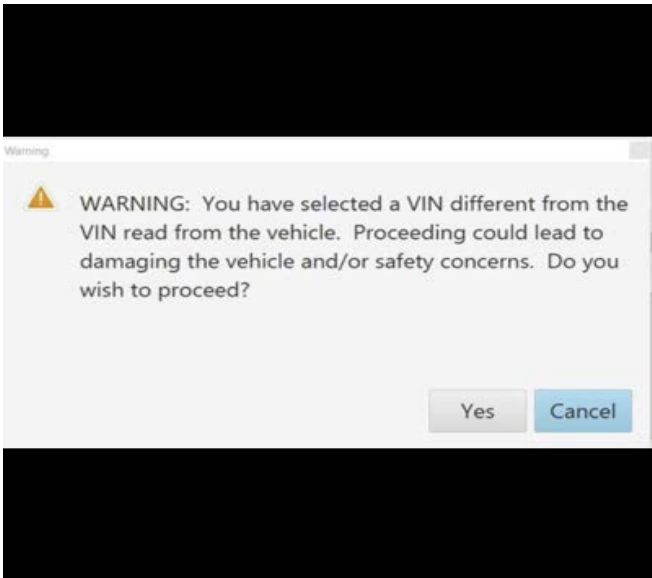
5877000

Important: If the vehicle VIN DOES NOT match, the message below will be shown.
