Technical Service Bulletin

50 Creaking noises heard when body twists during braking or steering maneuvers

50 23 11 2061672/3 February 21, 2023. Supersedes Technical Service Bulletin Group 50 number 21-08 dated September 22, 2021, for reasons listed below.

Model(s)	Year	VIN Range	Vehicle-Specific Equipment
A6, and A7	2019 – 2021	All	Not Applicable
A6 allroad, S6, and S7	2020 – 2021		
RS 6 Avant, A7 e quattro, and RS 7	2021

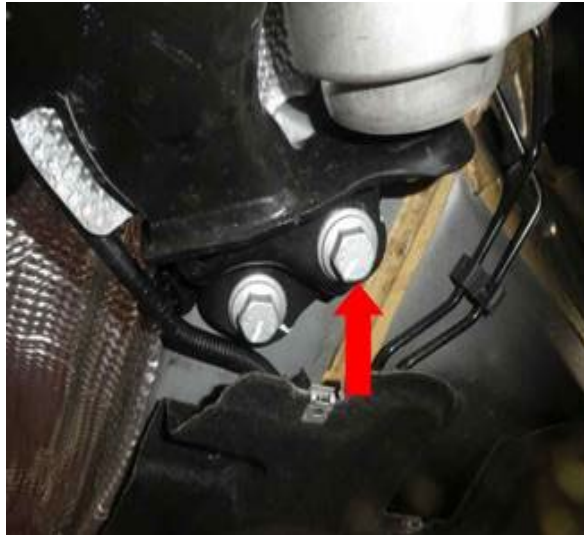
Figure 1. Front most bolt on subframe to be loosened.

1. Duplicate the noise on a test drive preferably with the customer so that the conditions under which this symptom presents are clearly identified. If this noise is duplicated on the test drive confirmation that the source of the noise is from the longitudinal member and that the repair described in this TSB will be effective can be achieved as follows.
2. Begin your diagnosis by loosening the front most bolt on the subframe mounting as indicated in Figure 1. The bolt only needs to be loosened several turns, but not removed.

As specified in the repair manual, it is necessary to replace all loosened subframe bolts at the conclusion of the entire repair.

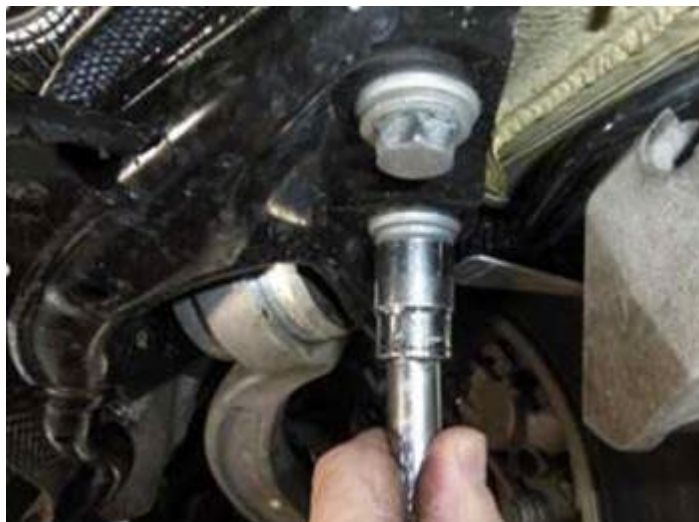
3. In many cases an audible 'cracking' noise can be heard in the course of loosening and tightening the subframe bolt (Figure 2).

Figure 2. Loosening the front most subframe bolt.

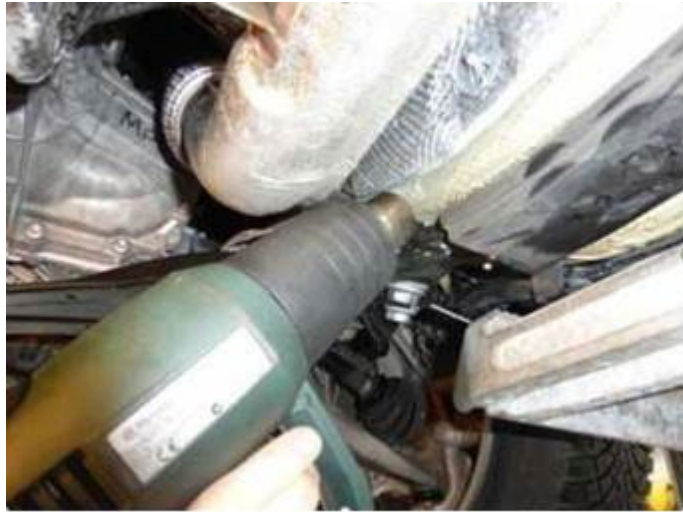
Figure 3. Warming the area of the body near the rear transverse link.

5. Duplication of this noise is difficult when the vehicle is cold. If you suspect that the cold is preventing duplication of this symptom warm up the longitudinal member/body in the area of the rear transverse link bolted connection with a hot air blower set for an outlet temp of approximately 550°C (1022 °F) (Figure 3).

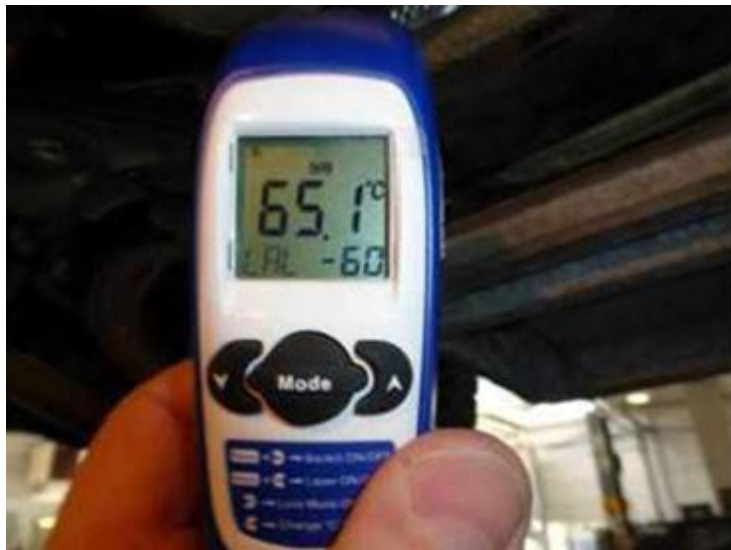
Figure 4. Surface temperature warmed to 65° C (149°F).

6. Warm the surface to approximately 65 °C (149°F) (Figure 4).

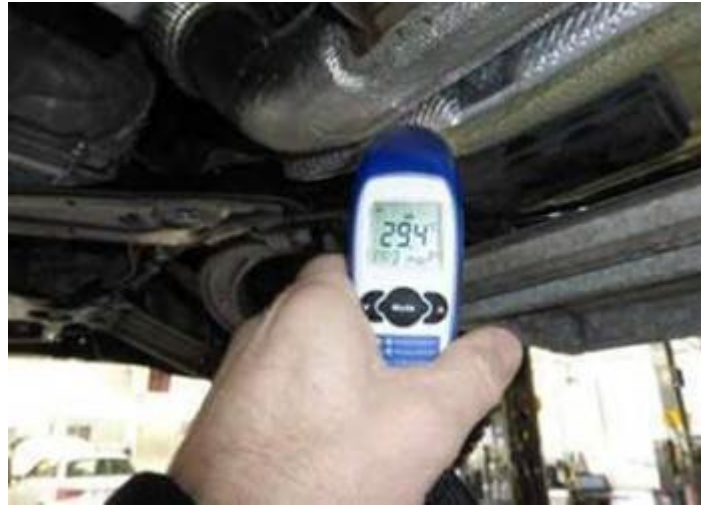
Figure 5. Surface temperature cooled to approximately 30° C (86°F).

7. Allow the surface temperature to cool to approximately 30 °C (86°F) then test drive the vehicle again.

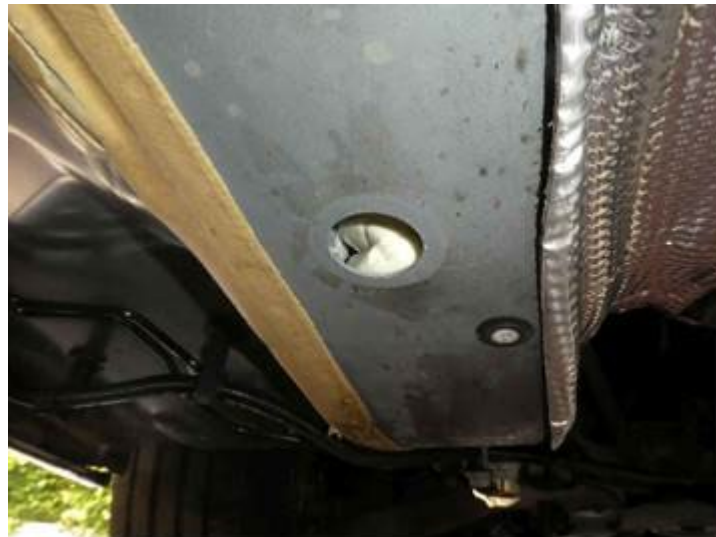
Figure 6. Body plug removed.

8. Merely lowering the vehicle from the hoist can immediately elicit the noise symptom after this warming process.
9. With the symptom confirmed, lower the center cover plate on the affected side. Remove the first body plug aft of the bolted connection for the transverse link (Figure 6).

Replace the body plug removed in this step with 8K0 805 267.

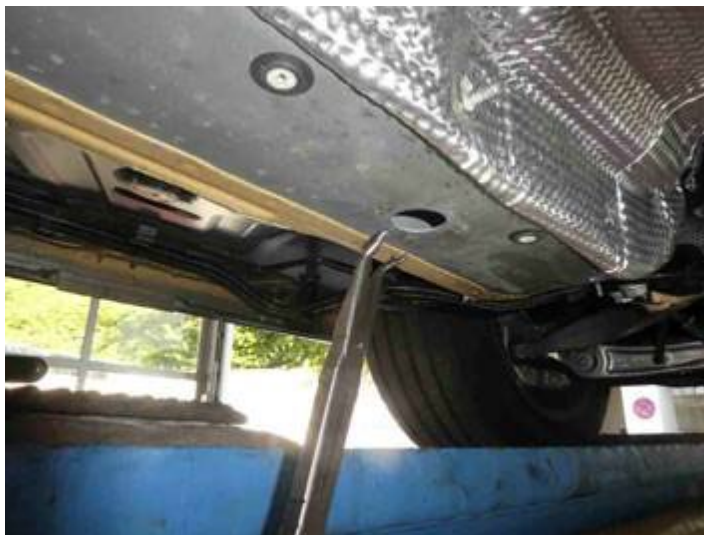
Figure 7. Remove a portion of the acoustic foam.

10. In order to provide appropriate access to the affected area inside the longitudinal member remove sections of the acoustic foam in the longitudinal member area with long needle nosed pliers. It is not necessary to remove all of the acoustic foam and the small amount removed for this procedure will not need to be replaced (Figure 7).

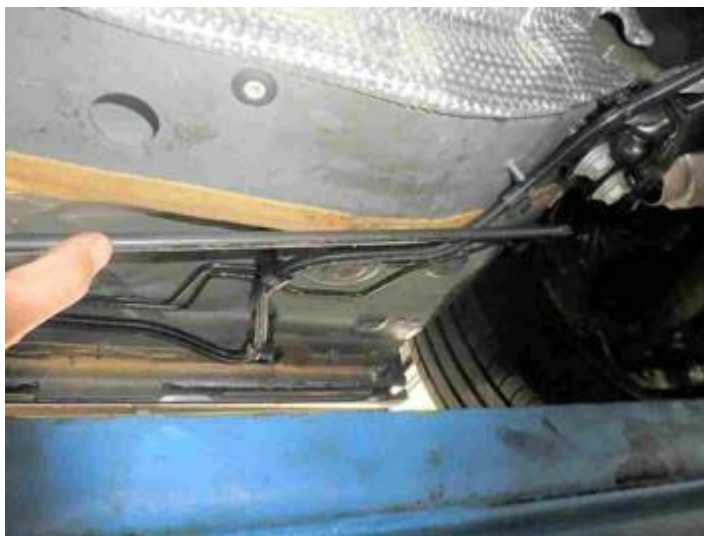
Figure 8. Tool to be fabricated.

11. An improvised tool for this modification will be fabricated. Obtain a steel rod 8mm in diameter and 60 cm long (Figure 8).

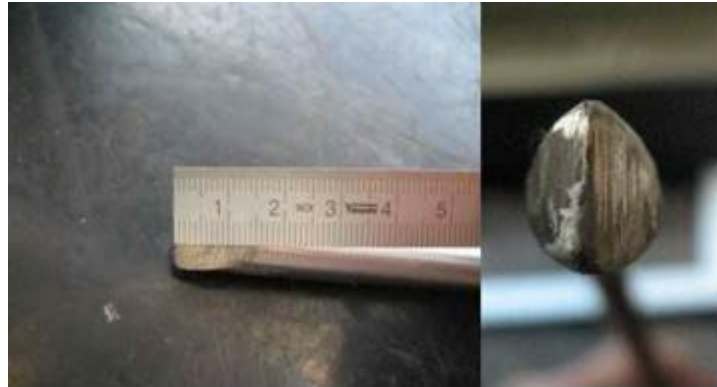
Figure 9. Ground the tip of the steel rod.

12. Grind the tip of one end of the rod into a chisel shape. The length of the grind should be 15mm +/-3mm on each side as shown in Figure 9.

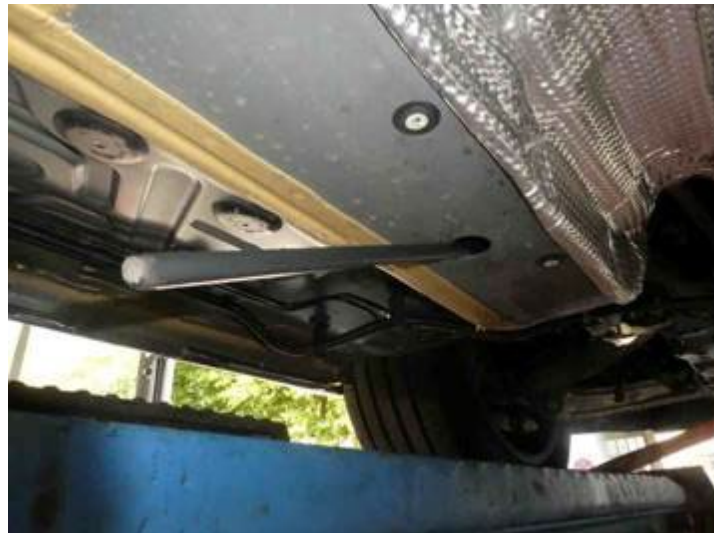
Figure 10. Insert the steel rod.

13. Insert the chisel end of the steel rod into the body opening, through the remaining acoustic foam and far enough to engage the longitudinal member support (Figure 10).

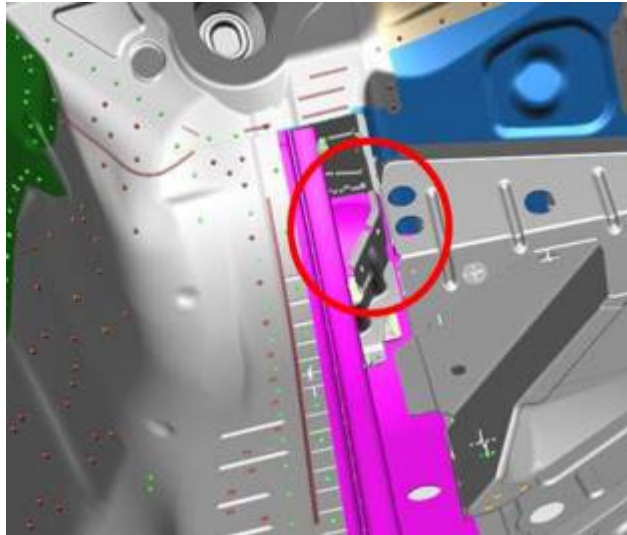
During a cornering or hard braking maneuver the longitudinal members can make contact with their internal support plates.

14. The drawing in Figure 11 shows a cut-away of the area where the longitudinal member support and the longitudinal member housing make contact.

Figure 11. Cut-away drawing of the inside of the longitudinal member.

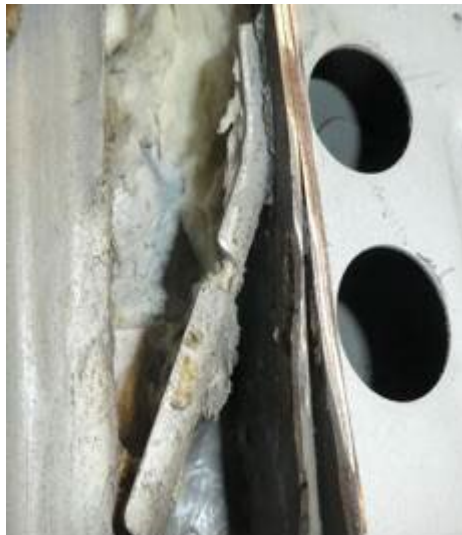
15. Figure 12 shows an opened longitudinal member and support.

Figure 12. Opened longitudinal member and support.

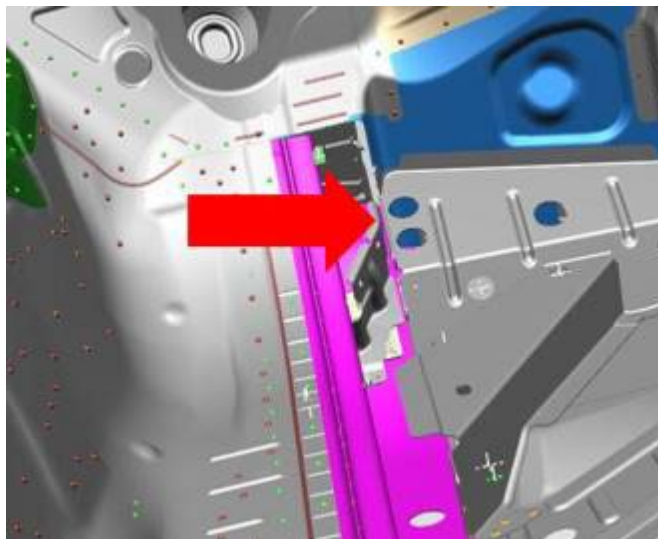
Figure 13. Point of contact for the steel rod.

16. Insert the steel rod to the point of contact indicated by the red arrow shown in Figure 13.

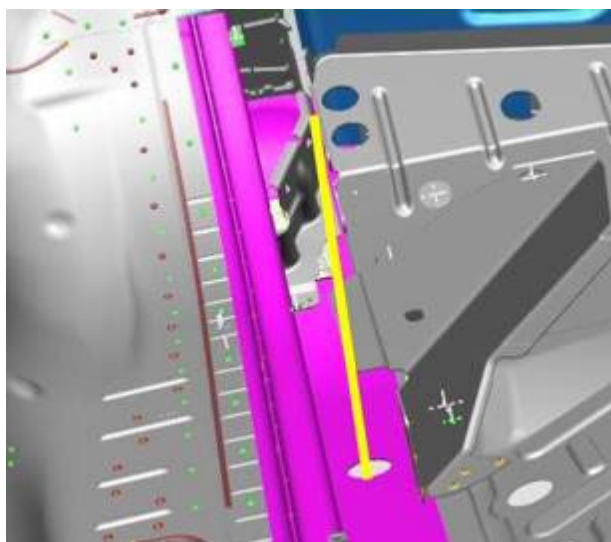
Figure 14. Direction of insertion of the steel rod.

17. The yellow line in Figure 14 shows the position the steel rod will realize after insertion and engagement with the longitudinal member support.

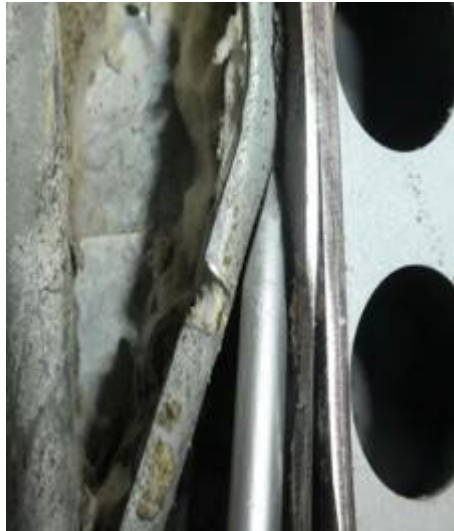
Figure 15. *Correct engagement of the chisel end of the steel rod.*

18. The chisel end of the steel rod must be inserted as shown in Figure 15 with the wedge engaged consistent with the space formed by the longitudinal member support to the longitudinal member housing.

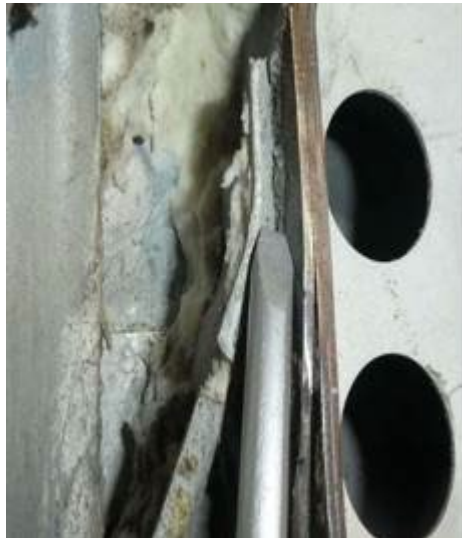
19. Figure 16 shows an incorrect engagement of the chisel end.

Figure 16. *Incorrect engagement of the chisel end.*

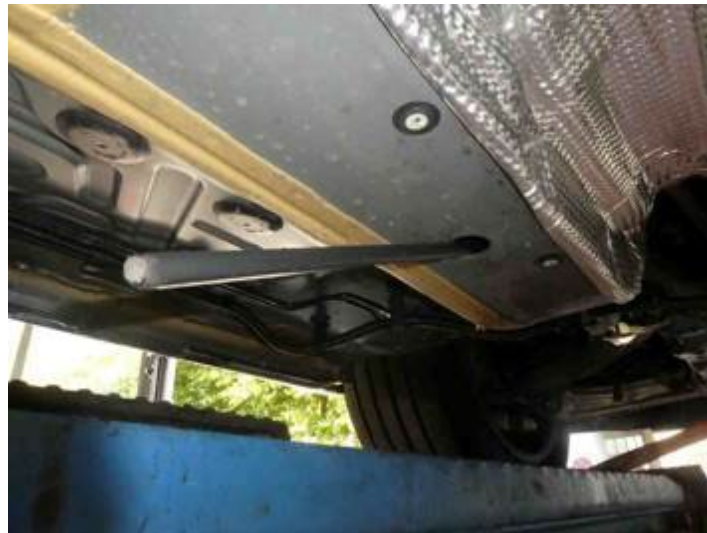
Figure 17. Driving the steel rod into the longitudinal member support.

20. Using a hammer drive the steel rod a distance of 4 – 5 cm. Ensure the correct distance measure and mark this distance on the steel rod with tape (Figure 17). Remove the tool when finished.
