Backup Battery DTC TCAM-U210993

| REF NO: TJ 35602.5.0 | ISSUING DEPARTMENT: Technical Service | CAR MARKET: United States and Canada | |
| FUNC GROUP: 3943 | FUNC DESC: Telematics | Page 1 of 6 | |

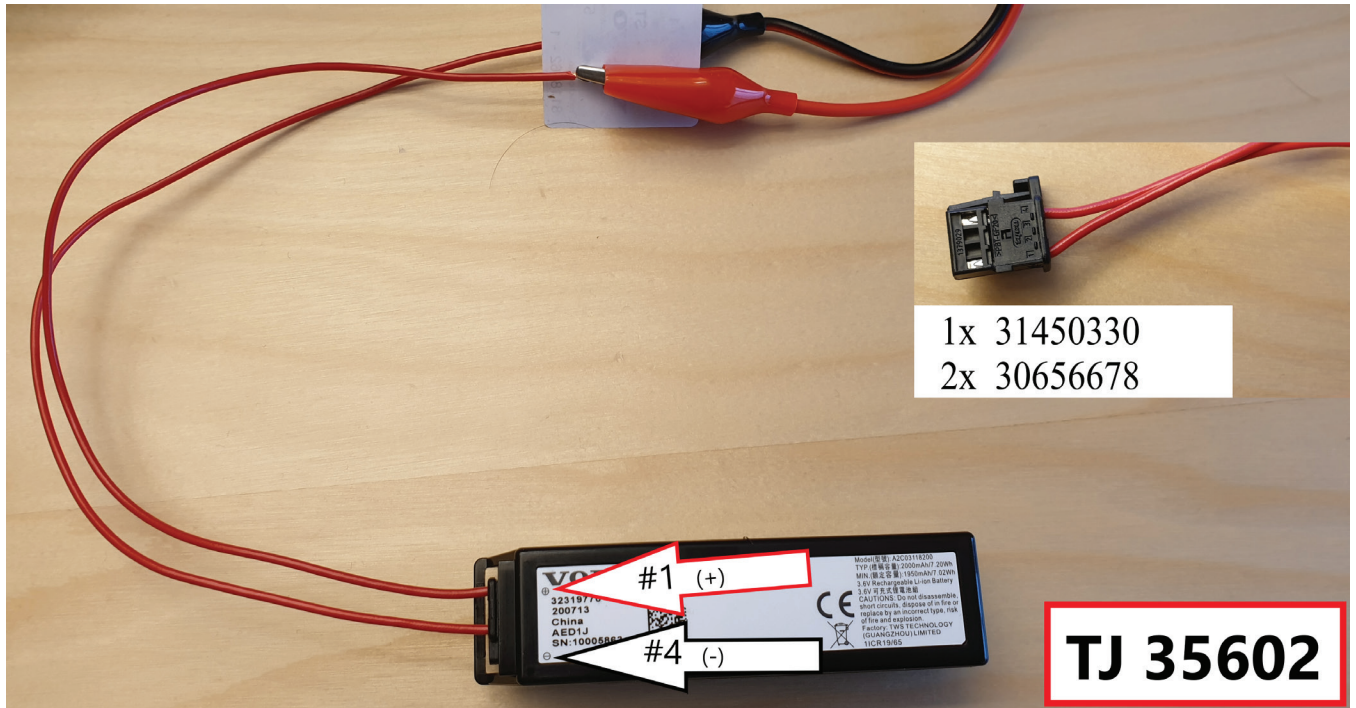
See attached picture "TJ 35602.png".

To make an adapter harness to connect to the BUB, you need following parts:

1x 31450330 RECEPTACLE HOUSING.
2x 30656678 REPAIR TERMINAL.

Connect terminals to:

Pin 1 Positive.

Pin 4 Negative.

It is possible to charge the BUB outside the vehicle using a universal battery charger suitable for 1 cell lithium-ion battery which supplies max 4V and max 1A, the max temperature must not exceed 60°C / 140°F. (There is no suitable Volvo charger for this operation)
