Service Bulletin

Bulletin No.: 01-08-42-001O

Subject: Exterior Lamp Condensation and Water Leak Information and Replacement Guidelines

Models: 2023 and Prior GM Passenger Cars and Trucks (including Medium Duty Trucks)
(Excluding LCF Medium Duty Trucks)

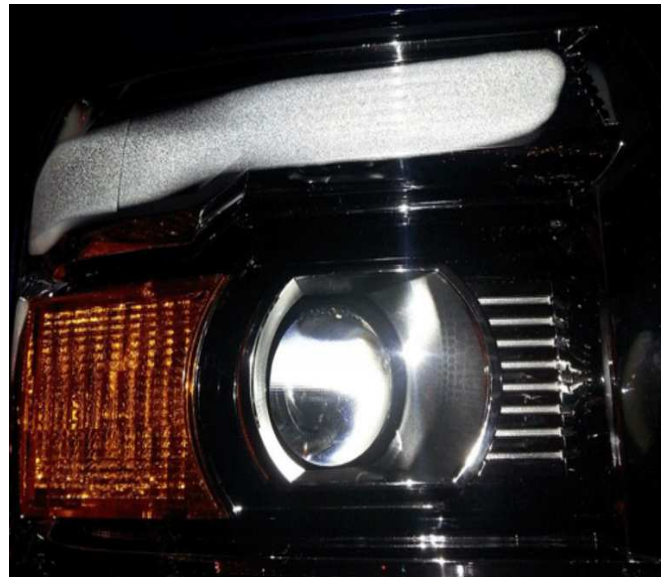
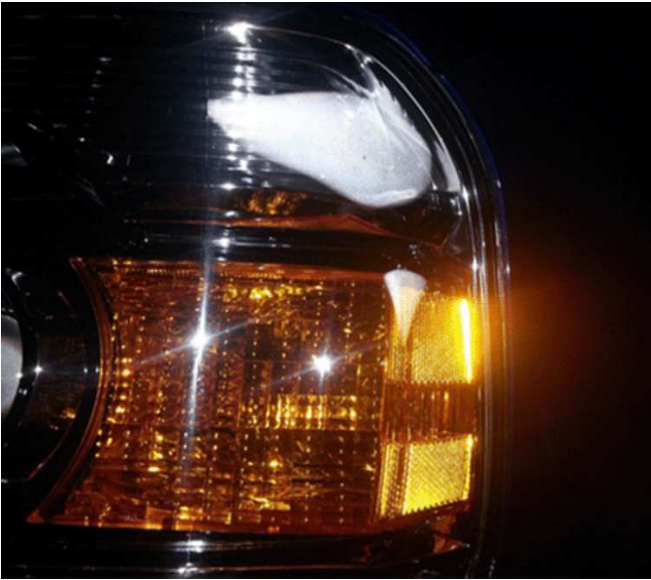
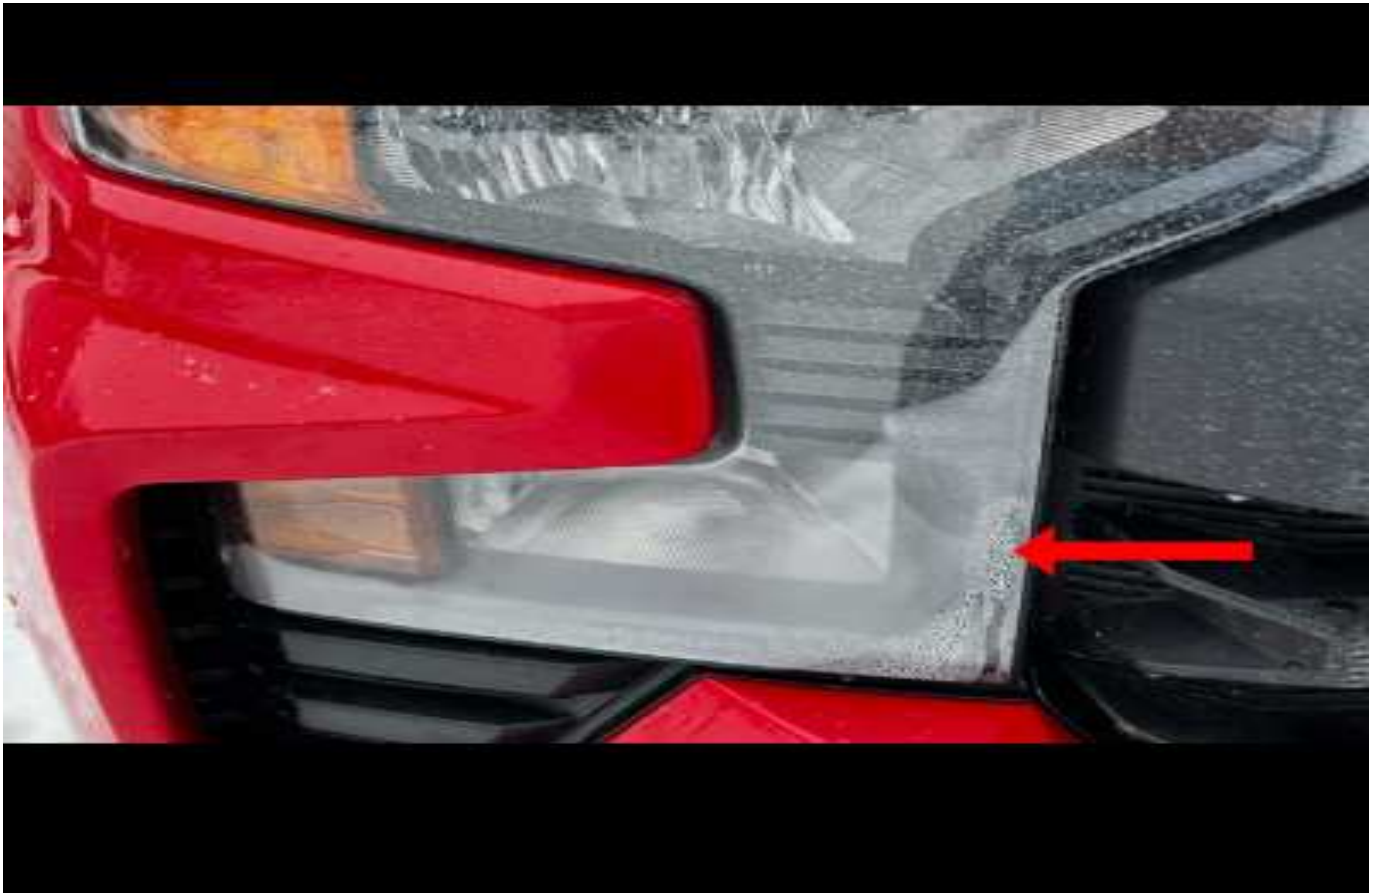
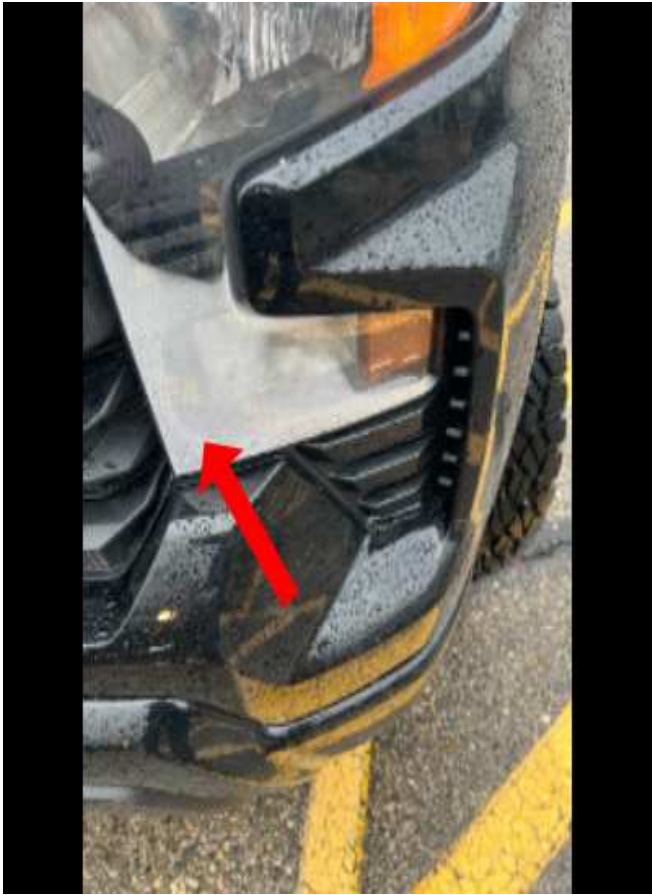
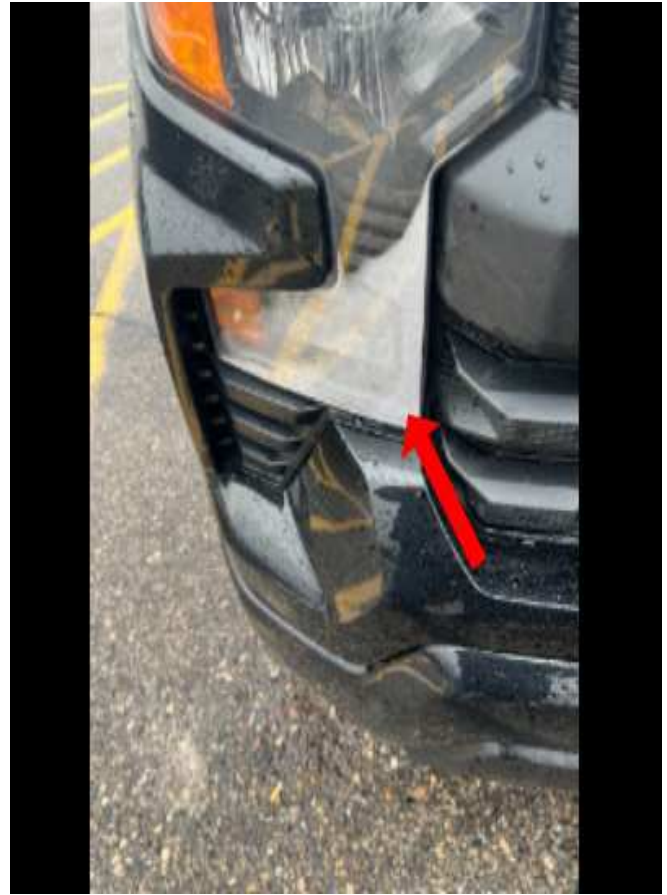
Condensation Examples

Condensation occurs when the air inside the lamp assembly, through atmospheric changes, reaches the "dew point." When this takes place, the moisture in the air within the lamp assembly condenses, creating a fine mist or white fog on the inside surface of the lamp lens.

A Fine Mist or White Fog on the Inside Surface of the Lamp Lens Occurring After a Period of High Humidity

- May be located primarily in the lens corners (near the vents) and SHOULD NOT cover more than half the lens surface.
- The condition should clear of moisture when the vehicle is parked in a dry environment, or when the vehicle is driven with the lights ON.
- A comparison of the equivalent lamp on the opposing side of the vehicle indicates a SIMILAR performance.

If the above conditions are noted, the customer should be advised that replacement of a lamp assembly may not correct this condition.

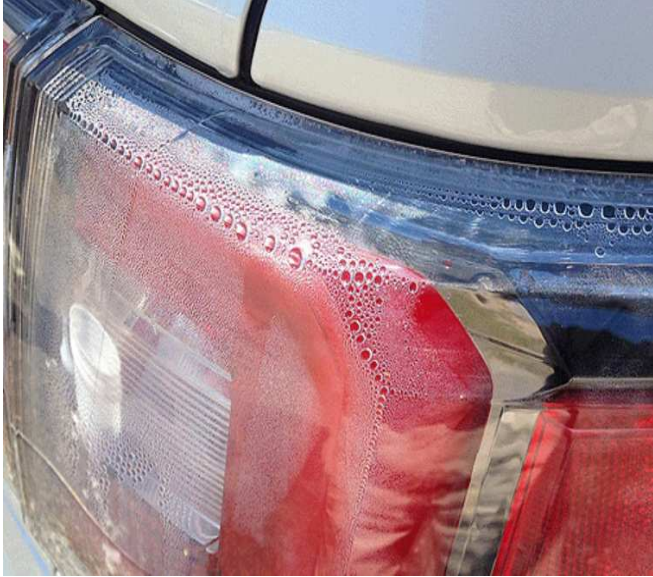
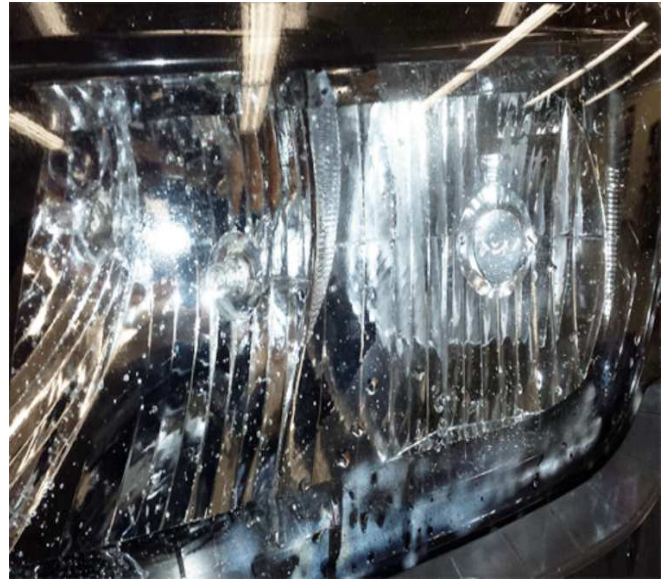
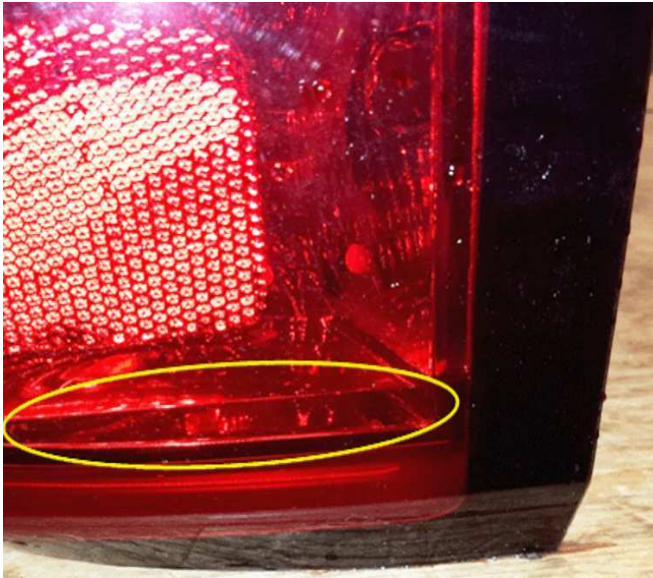
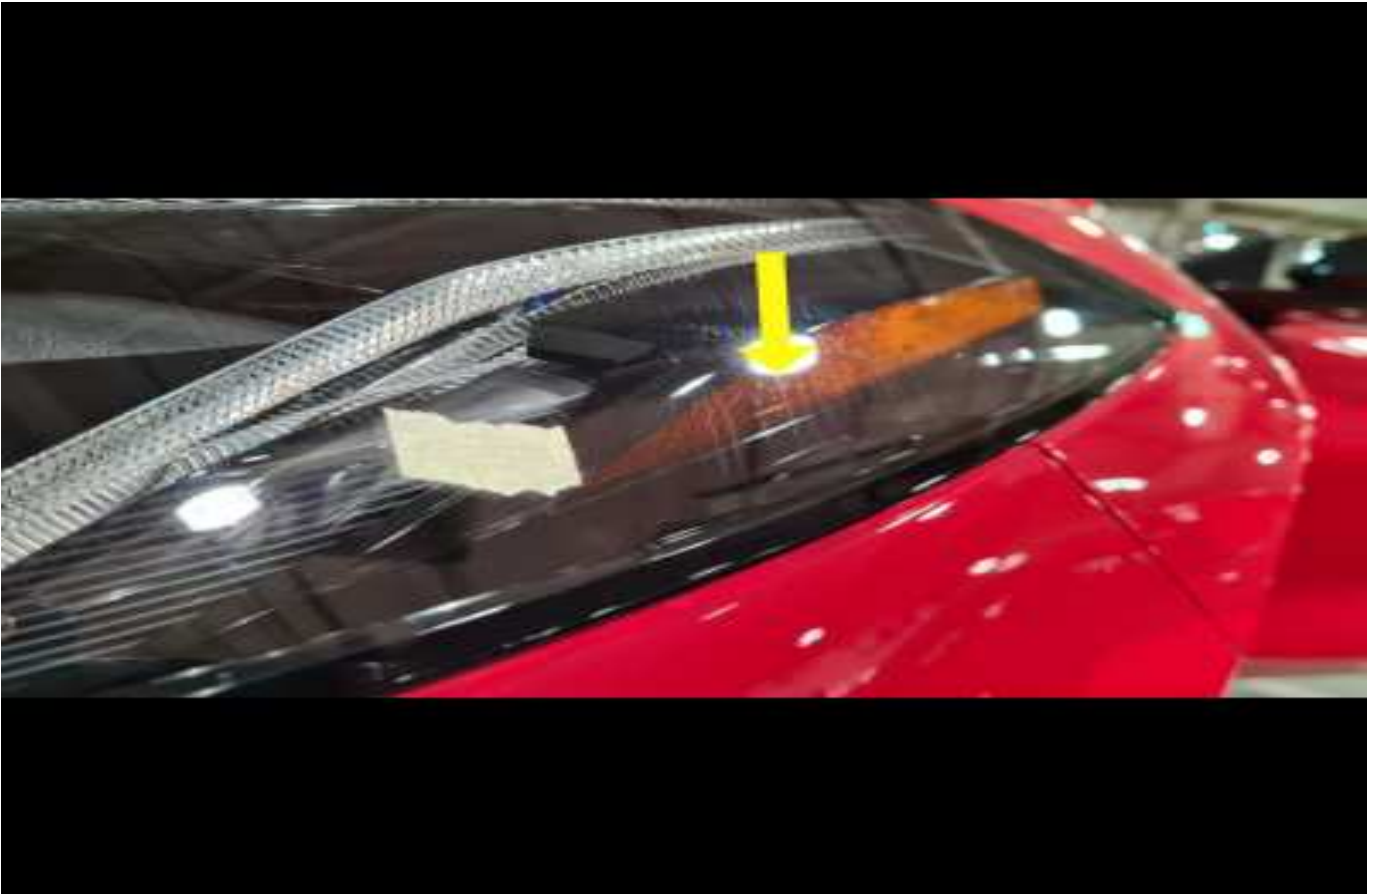
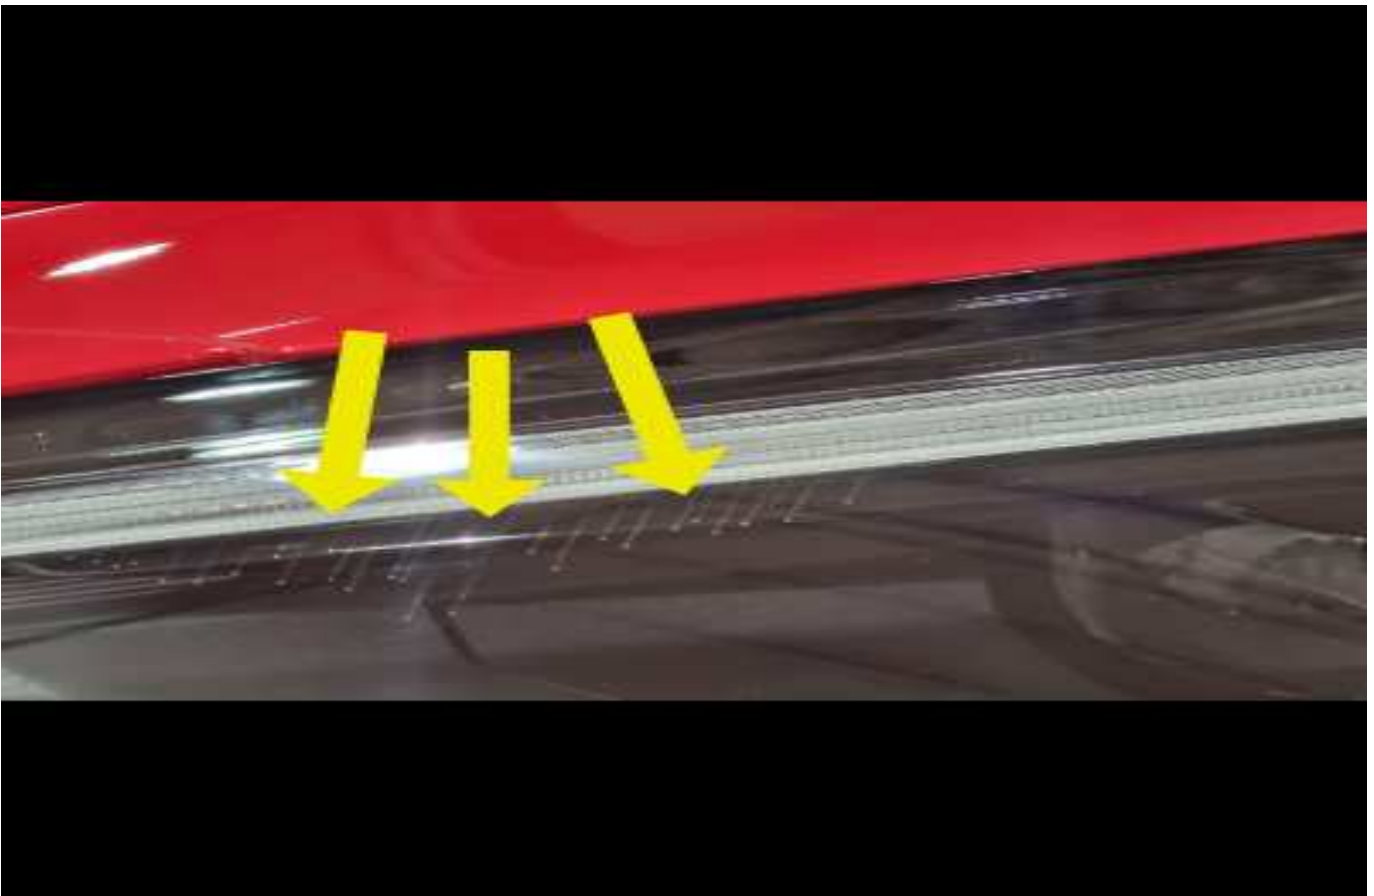
Water Leak Examples

Numerous & Various Size Drops of Water Collecting on the Inside Surface of the Lamp Lens After the Vehicle Has Been Exposed to Rain or a Car Washing Environment

- A condition that covers more than half the surface of the lamp lens.
- An accumulation of water in the bottom of the lamp assembly.
- A condition that WON'T clear when the vehicle is parked in a dry environment, or when the vehicle is driven with the lights ON.
- A comparison of the equivalent lamp on the opposing side of the vehicle indicates a different performance.

Note: Any of the conditions listed below would indicate the need to service the lens or lamp assembly.

If a lamp is found to be exhibiting a leak, review the most recent version of Service Bulletin 02-08-42-001 for information regarding impact damage and modification inspection.

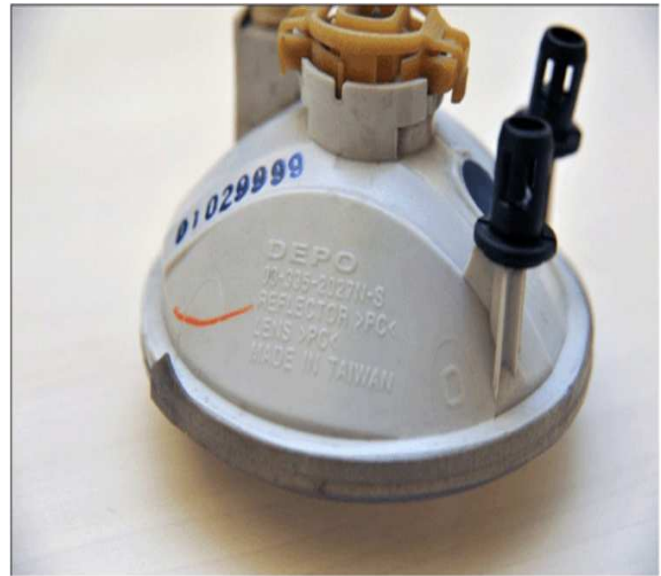
2650251

This fog lamp was returned for retaining moisture. As you can see it is marked with the Depo brand (it is also called out on the front lens).
