# Technical product information

<b>Topic</b>	Bentayga and New Flying Spur Hybrid– DTC P103A00 evident – Engine Oil Fuel Portion Too High
<b>Market area</b>	Russische Föderation (5RU),Australia E04 Bentley rest Asia and Australia (6E04),China 796 VW Import Comp. Ltd (Vico), Beijing (6796),Germany E02 Bentley rest Europe (6E02),Japan E03 Bentley Japan (6E03),United Kingdom E01 Bentley UK (6E01),United States E05 Bentley USA and rest America (6E05)
<b>Brand</b>	Bentley
<b>Transaction No.</b>	2062365/4
<b>Level</b>	EH
<b>Status</b>	Approval
<b>Release date</b>

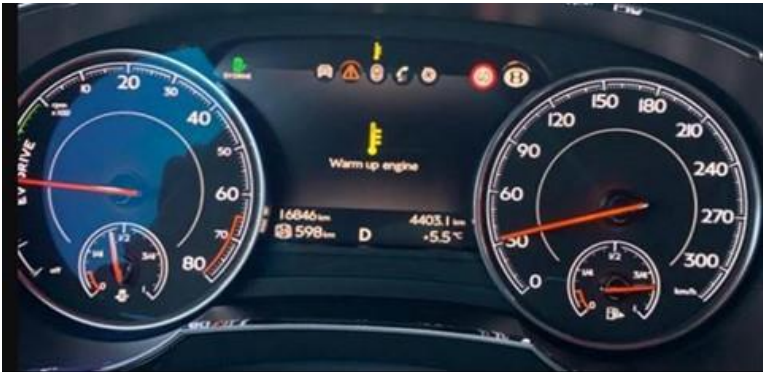
Figure 1

- Warning message within the DIP
- The message asks the customer to 'warm up engine' accompanied by a yellow warning (Figure 1) No other symptoms are experienced.

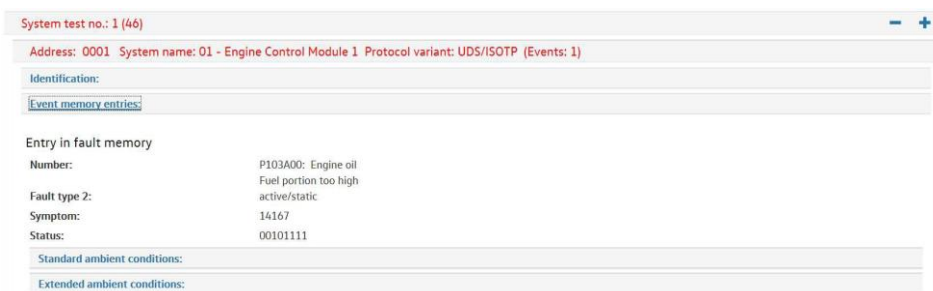
Figure 2

- DTC P103A00 evident - Engine Oil Fuel Portion Too High (Figure 2)

The warning is caused by the level of unburnt fuel in the engine oil. This value is calculated by the Engine Control Module (ECM) and is based on the driver usage pattern

The more cold starts the Internal Combustion Engine (ICE) is exposed to the higher the chance of fuel making its way into the engine oil via the cylinders

When the fuel calculation reaches the pre-programmed amount this then causes the DTC to be triggered

- IDE10063 – Engine oil current value **NOTE: Must be 100% or less other wise the DTC cannot be deleted**
- IDE09531 - Total mass of gasoline and alcohol in the oil (Level of fuel within the engine oil - Calculated by the ECM) **NOTE: If the value is larger than > 250 grams, the error cannot be deleted.**

2) Referring to the Rep.Gr 17- Check the engine oil level *NOTE: Ensure the method within Rep.Gr 17 is followed*

- **IMPORTANT:** In the event the engine oil level is deemed as excessively high, the oil level should be reduced/corrected - Refer to Rep.Gr 17 - Drain the required amount of engine oil to adjust the oil level to specification

3) Drive the vehicle in SPORT mode for 30 KM (***Observing all local speed limits***) with enthusiastic driving to reduce the fuel MWB value (IDE09531) to less than 50 grams

- In the event the MWB value (IDE09531) has been successfully reduced (Lower than 50 grams) Erase the applicable DTC's
