## Technical product information

### New Continental GT/GTC and New Flying Spur

Knocking noise from the front (Driving over an uneven road surface) - Front trailing arm hydraulic mount damaged/leaking

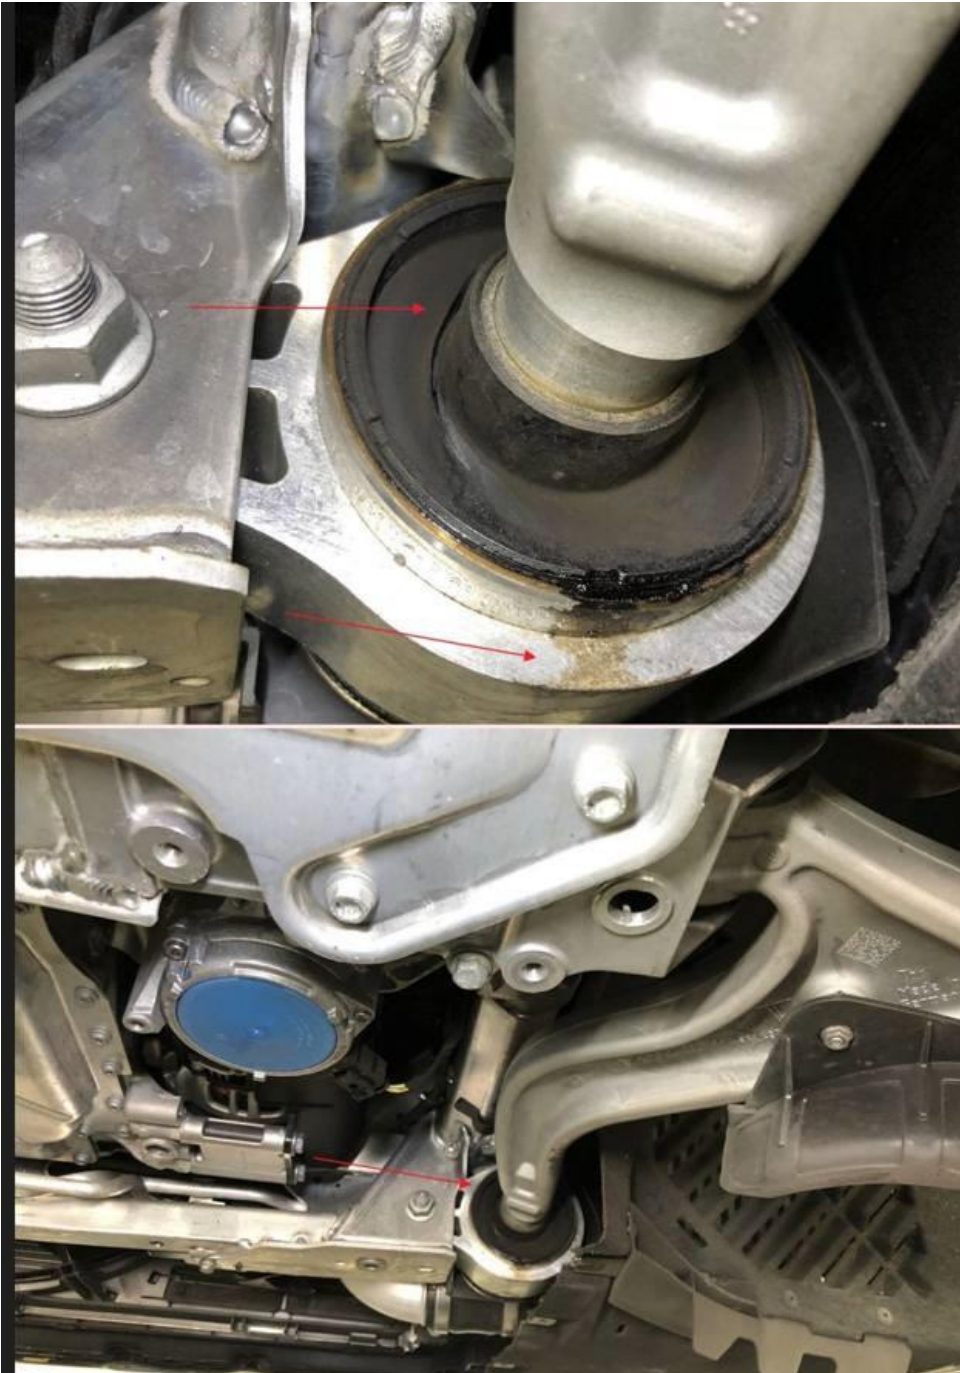
Figure 1

Front trailing arm hydraulic mount found damaged/leaking as shown in Figures 1 and 2

1) Referring to Rep.Gr 40 - Lower suspension lever hydraulic mount - To replace - Replace the applicable front lower trailing arm hydraulic mount

**NOTE:** The front lower trailing arm hydraulic mounts should not be replaced in pairs (unless both are damaged/worn) only the damaged/leaking trailing arm hydraulic mount should be replaced
