Technical product information

Topic	Mood lighting operational issues
Market area	Bentley: worldwide (2WBE)
Brand	Bentley
Transaction No.	2051511/9
Level	EH
Status	Approval
Release date

New Continental GT - New Continental GTC and New Flying Spur

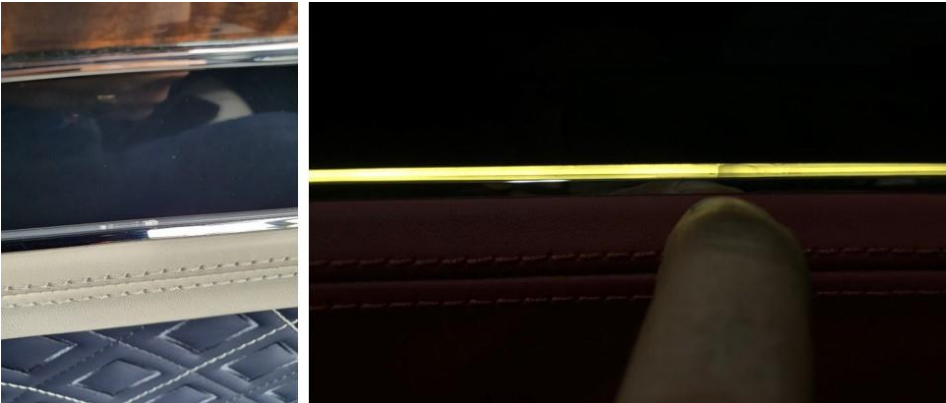
Figure 1

- Mood Lighting strip is faulty/incorrect illumination due to the strip being cracked and/or irregularities in the strip (Figures 1 and 2)

- 3) Should the connector or mood light strip be found to be damaged, replace the mood lighting strip Refer to Elsa pro – Rep.Gr 96 - Mood lighting strips - To remove and fit

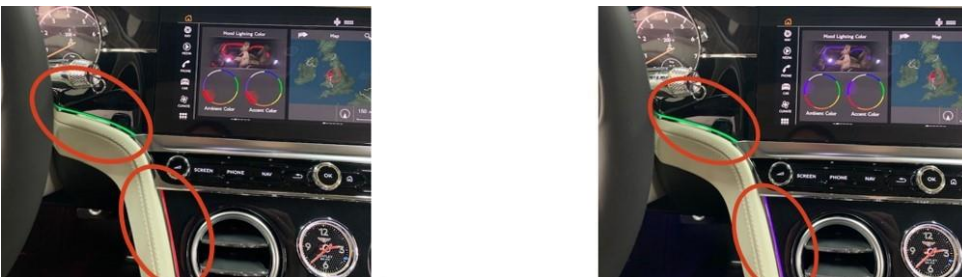
Figure 3

- Mood lighting strip has incorrect colour synchronization and/or sticks to one colour (not changing) (Figure 3)

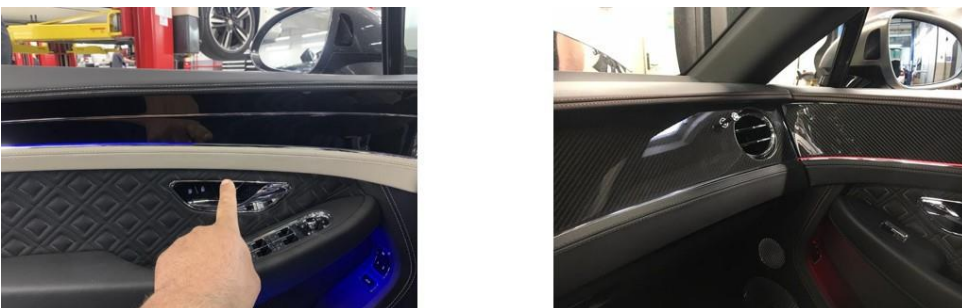
Figure 4

- Mood lighting strip has partial illumination and does not light at all (Figure 4)

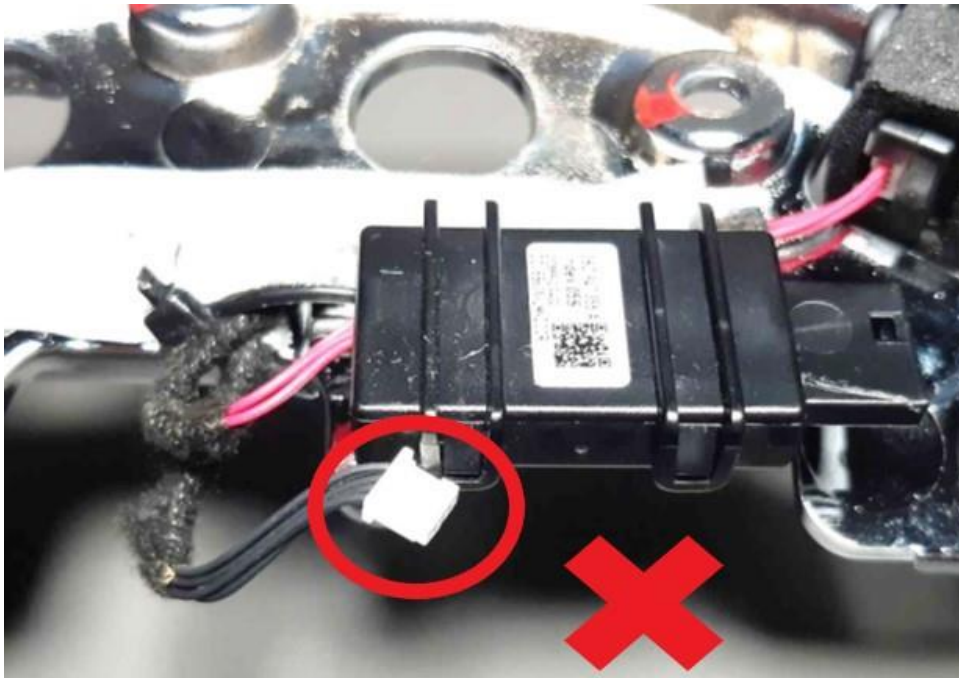
Figure 5

- 1) Check the integrity of the applicable mood light strip electrical circuit - Refer to Elsa pro wiring diagrams
- 2) Check the mood light strip electrical connections are correctly made to the affected mood lighting strips, if not connected correctly (Figure 5) refit and confirm connection (Figure 6) and retest
