Service Bulletin

PRELIMINARY INFORMATION

Subject: Rear and Side Tempered Glass Spots (Quench Marks)

Models: 2023 and Prior GM Passenger Cars and Trucks

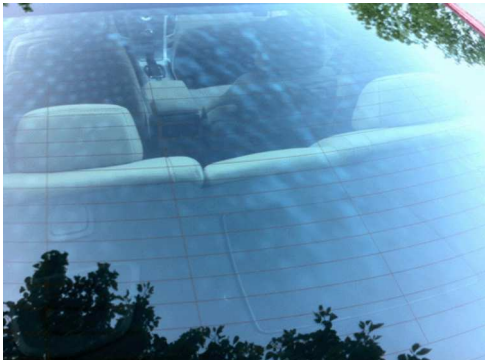
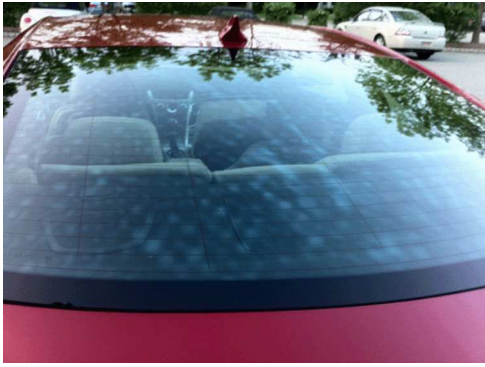
Shown in the pictures above are examples from the Cadillac CT4 and CT5 models, which are different from the typical "cheetah" spots.

Some customers may comment on spots showing on the rear and side windows when the vehicle is in the sunlight. When wearing polarized glasses/sunglasses, these spots may be more magnified.

The spots are due to the manufacturing process and are “quench marks” in the glass. Quench marks are an unintentional side effect of the tempering process.

Technicians should explain to the customer that this is a normal condition and part of the manufacturing process for tempered glass. Do not replace the window(s) for this condition.
