Check engine warning light active - fault P300CA8 and P300CA9 "Hot film mass air flow sensor malfunction" present in engine control unit

Topic number	LI14.30-N-075882
Version	1
Function group	14.30 - Secondary air injection
Date	2/3/23
Validity	Model 907 with engine 654
Reason for change	Remedy adjusted

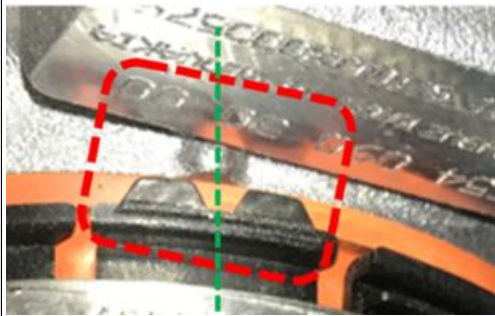
1b.JPG

For a single-stage turbocharger, the cast lug must be cleanly aligned with the counterpart profile (see Picture 1b).

When carrying out repair and installation work, replace the seal in this area.

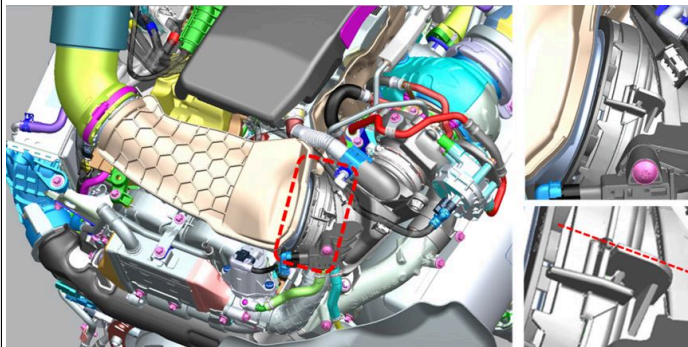
2a.JPG

Relevant area of right-hand clean air line to center clean air line (connector coupling - Picture 2a):

- Operate connector coupling as far as end stop rib (open position). See Picture 2b.
- Hold connector coupling open until left-hand clean air line is pushed into the connector coupling as far as the end stop and lies flush all round. See Picture 2c
- Release connector coupling and actively slide it back to the closed position.
- Check correct seating of clean air line using the lock position. If the lock position is not visibly reached as in Picture 2d, the clean air line must be repositioned.

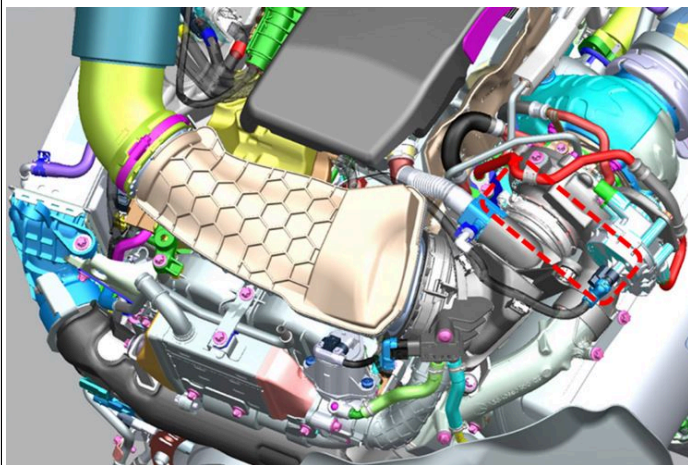
1a.JPG

Relevant area of exhaust gas turbocharger to right-hand clean air line (Picture 1a):

Check that right-hand clean air line is correctly aligned with exhaust gas turbocharger.

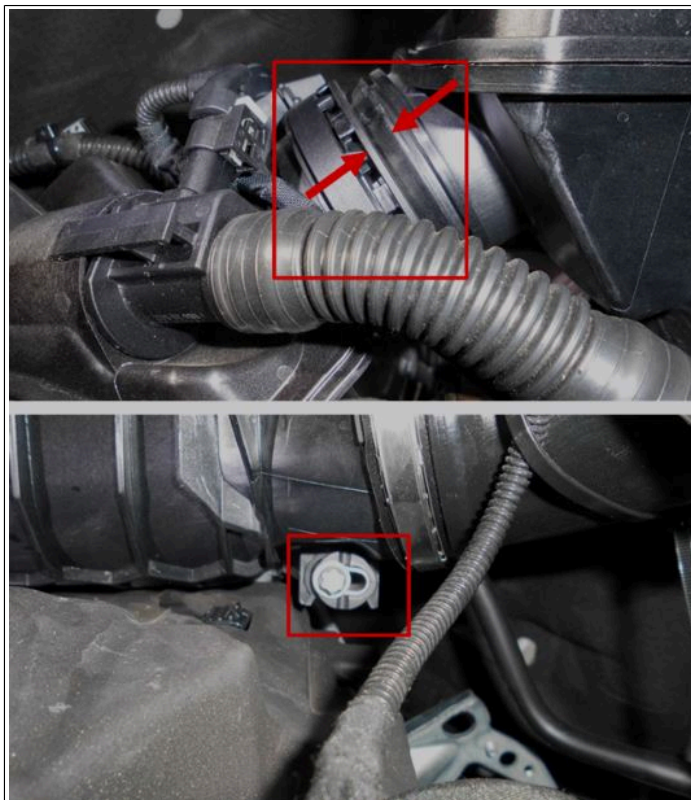
For example images of good and poor installation, see Picture 3 and Picture 4.
