**Noise Symptom - Creaking Noise from Body Front Area of the Vehicle: Replacing Upper Trailing Arm (SY 32/17)**

Model Line: **Panamera (971)**

Model Year: **As of 2017 up to 2023**

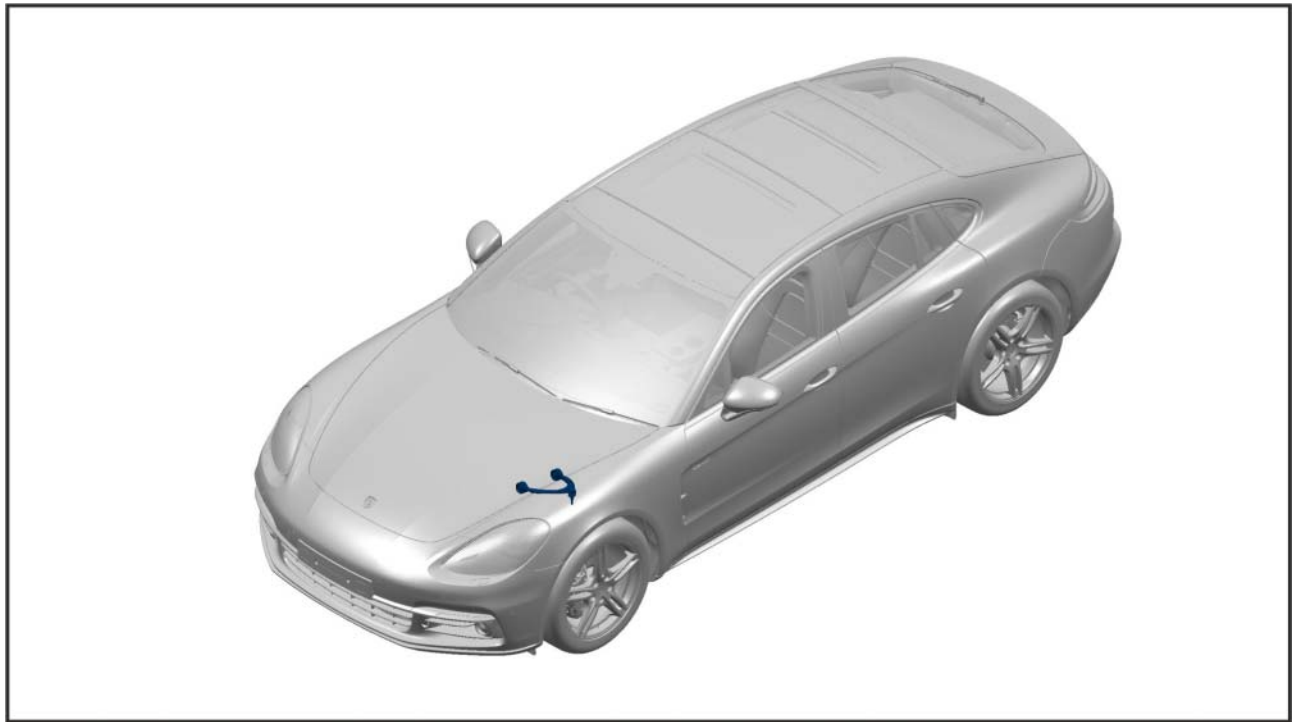
Cause: Under certain conditions, the attachment of the upper trailing arm rubber bearings to the body side can cause creaking noises.  
Temperatures below -5 °C can increase these noises.

*Installation position of upper trailing arm*

Remedial Action: A new component status is available for the upper left and right trailing arms on the front axle.  
In the event of a comprehensible customer complaint, replace the upper left and right trailing arms on the front axle.
