Complaint - Cylinder Head Cover Near the Injector Holes Leaking: Subsequent Work on Cylinder Head (180/18)

Vehicle Types: **Panamera (971) / Panamera 4 (971) / Panamera 4 Sport Turismo (971) / Panamera 4S (971) / Panamera 4S Sport Turismo (971) / Panamera 4 E-Hybrid (971) / Panamera 4 E-Hybrid Sport Turismo (971) / Panamera 4S E-Hybrid (971) / Panamera 4S E-Hybrid Sport Turismo (971)**

Concerns: **Cylinder head cover**

Cause: **Complaint about injector hole leaks**

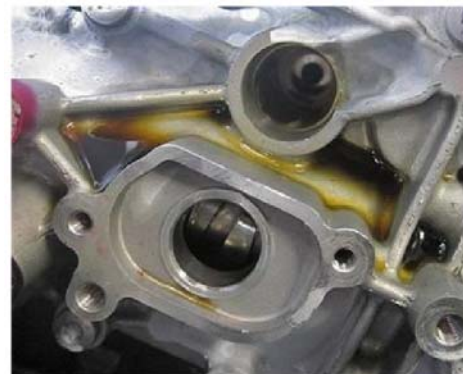
Fault type 2: Cylinder head cover leaking

- 2.2 Remove insulation on bottom of the cylinder head cover.
- 2.3 **Identify the affected cylinder(s) by a visual inspection:**
 - 2.3.1 Oil must have collected in the vicinity of the injector of the affected cylinder and the insulation on the bottom of the cylinder head cover should be fully soaked.
 ⇒ *Fault type 2: Cylinder head cover leaking*
