Complaint - Cylinder Head Cover Near the Injector Holes Leaking: Subsequent Work on Cylinder Head (180/18)

Vehicle type: **Macan S (95B) / Macan GTS (95B) / Macan Turbo (95B)**

Concerns: **Cylinder head cover**

Cause: **Complaint about injector hole leaks**

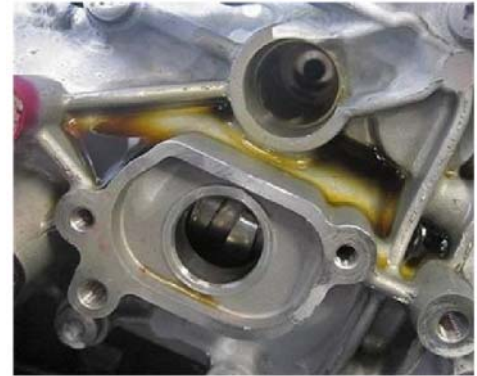
Fault type 2: Cylinder head cover leaking

- 2.1 Remove fuel collection pipe **and** fuel injectors on the affected cylinder head, see ⇒ *Workshop Manual '243019 Removing and installing fuel collection pipe'* and ⇒ *Workshop Manual '244019 Removing and installing fuel injector (V6 Turbo)'*.
- 2.2 Remove insulation on bottom of the cylinder head cover.
- 2.3 **Identify the affected cylinder(s) by a visual inspection:**
 - 2.3.1 Oil must have collected in the vicinity of the injector of the affected cylinder and the insulation on the bottom of the cylinder head cover should be fully soaked.

⇒ *Fault type 2: Cylinder head cover leaking*

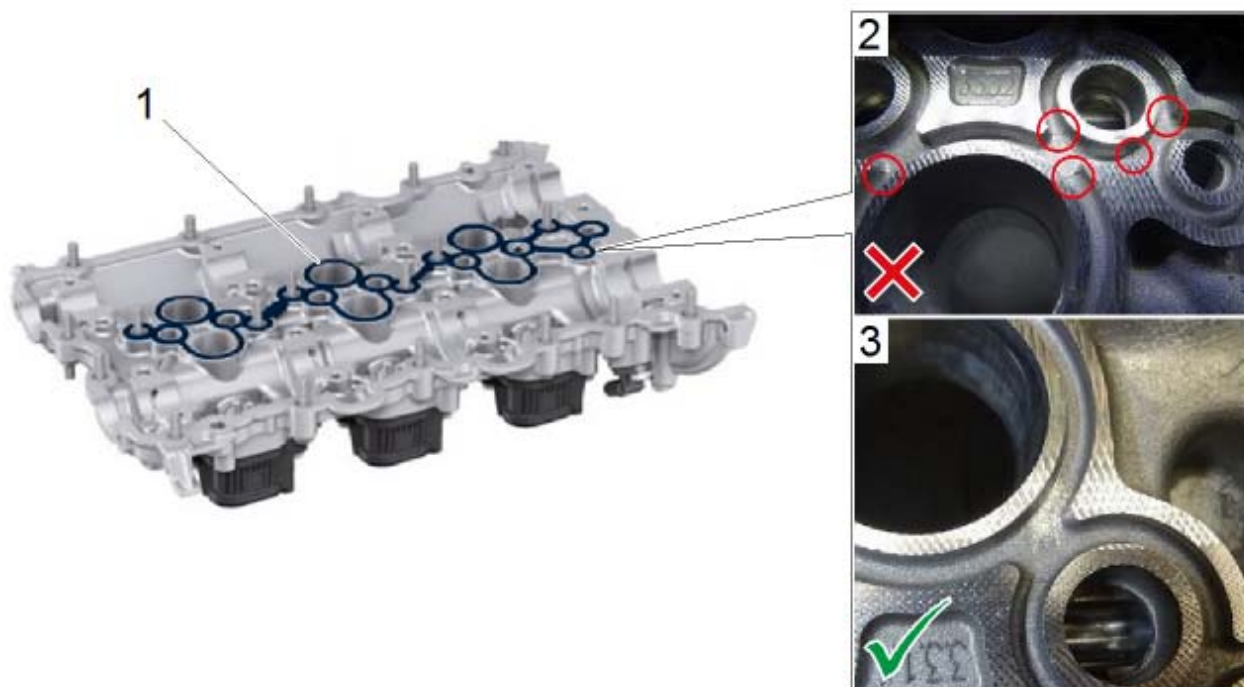
Cylinder head cover sealing groove

- The casting procedure may have caused cast residue in the cylinder head cover sealing groove.
- This cast residue may cause the injector holes to leak.

- 2.6 Check the sealing groove (⇒ *Cylinder head cover sealing groove -1-*) of the cylinder head cover visually. Be particularly meticulous when doing this especially in the vicinity of the affected cylinder.

- 2.7 Carefully remove any cast residue (⇒ *Cylinder head cover sealing groove -2-*) using a small flat screwdriver, ensuring that the sealing groove is not damaged. There must be no more cast residue in the sealing groove after machining (⇒ *Cylinder head cover sealing groove -3-*).
