**Complaint - Cylinder Head Cover Near the Injector Holes Leaking: Subsequent Work on Cylinder Head (180/18)**

Vehicle Types: **Cayenne (9YA) / Cayenne Coupé (9YB) / Cayenne E-Hybrid (9YA) / Cayenne E-Hybrid Coupé (9YB) / Cayenne S (9YA) / Cayenne S Coupé (9YB)**

Concerns: **Cylinder head cover**

Cause: **Complaint about injector hole leaks**

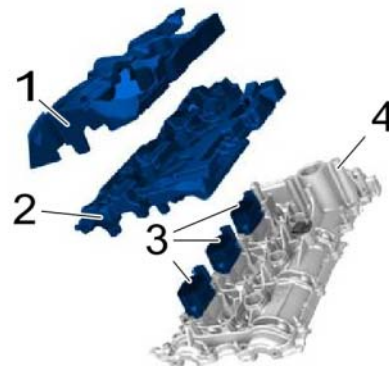
*Cylinder head cover component overview*

- 1 – Insulation on top of cylinder head cover
- 2 – Insulation on bottom of cylinder head cover
- 3 – Solenoid hydraulic valve for valve lift adjustment
- 4 – Cylinder head cover

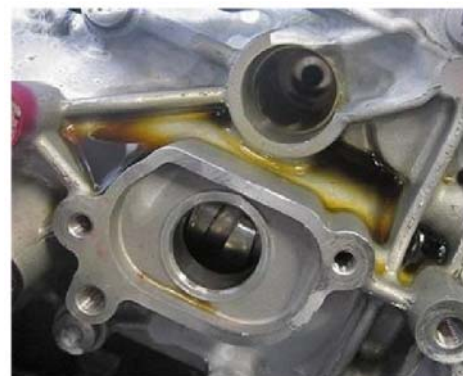
*Cylinder head cover sealing groove*

- The casting procedure may have caused cast residue in the cylinder head cover sealing groove.
- This cast residue may cause the injector holes to leak.

- 2.5 Clean cylinder head cover.
- 2.6 Check the sealing groove (⇒ *Cylinder head cover sealing groove -1-*) of the cylinder head cover visually. Be particularly meticulous when doing this especially in the vicinity of the affected cylinder.  
*Fault type 2: Cylinder head cover leaking*

- 2.7 Carefully remove any cast residue (⇒ *Cylinder head cover sealing groove -2-*) using a small flat screwdriver, ensuring that the sealing groove is not damaged. There must be no more cast residue in the sealing groove after machining (⇒ *Cylinder head cover sealing groove -3-*).
