# TECHNICAL SERVICE BULLETIN

## Whistle Noise At Lower Left Windshield Area

**23-2032**

Ford 2021-2022 Bronco
--------------------------

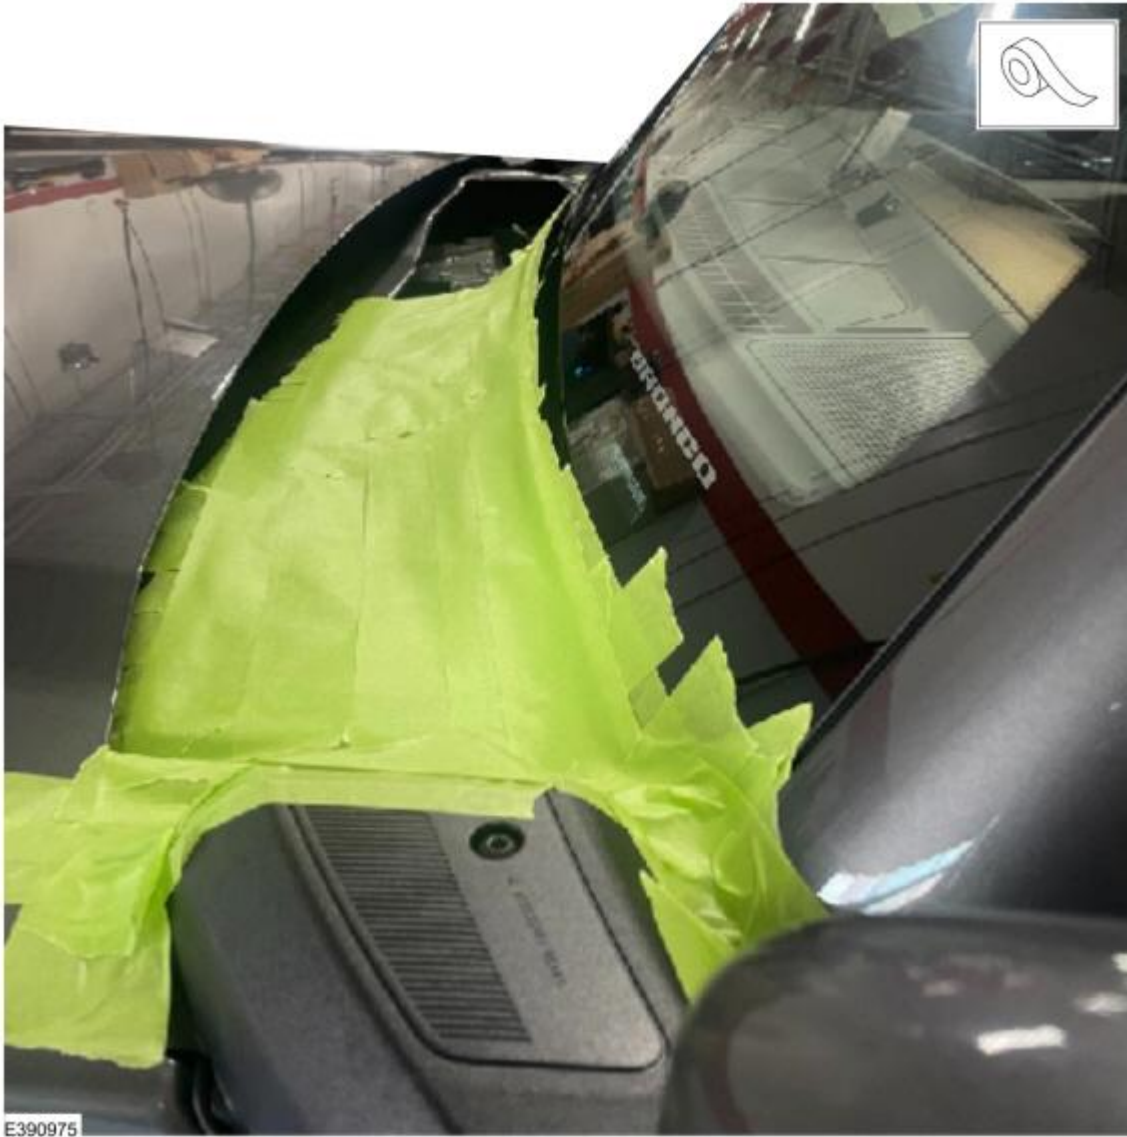
Figure 1

1. Tape off the left side of the cowl panel and drive the vehicle above 50 mph (80 km/h). Did taping off the cowl resolve the whistle noise? (Figure 1)

(1). Yes - proceed to Step 2.

(2). No - this article does not apply. Refer to Workshop Manual (WSM), Section 100-04.

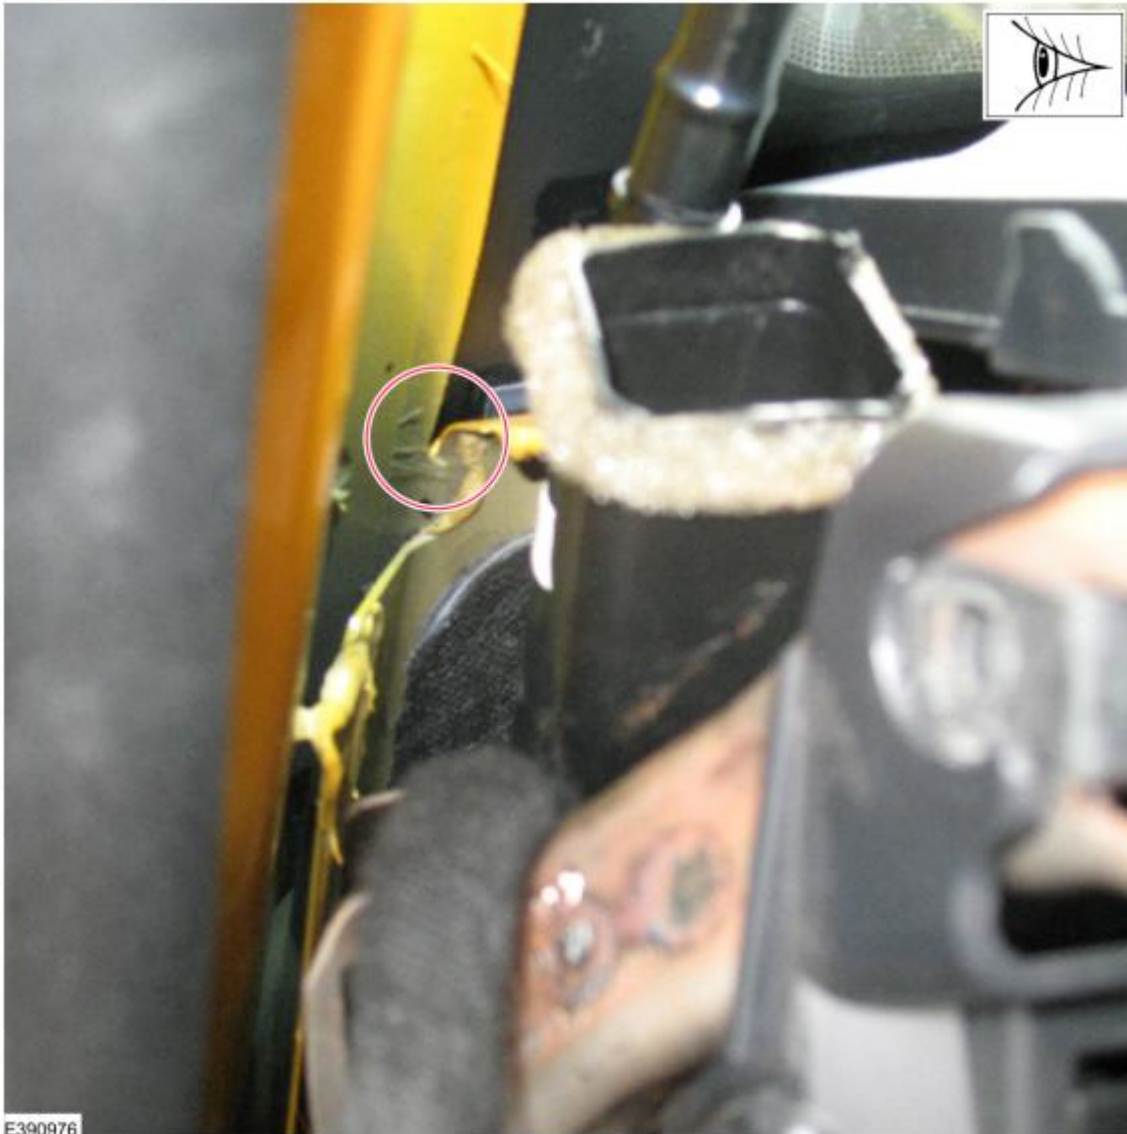
Figure 2

**Issue:** Some 2021-2022 Bronco vehicles may exhibit a whistle noise below the lower left windshield area at the bottom of the A-pillar. This may be due to a missed body sealer application at the factory. To correct this condition, follow the Service Procedure to reseal the affected body seam.

**3.** Visually inspect for a gap in the sheet metal at the bottom of the A-pillar where it joins the rear engine compartment wall. Is a gap present? (Figure 2)

**4.** Apply a liberal amount of butyl to fill the gap between the two metal panels and eliminate the air entry.
