Technical product information

Topic	Right and/or left hand front rearmost lower suspension lever inner hydraulic mount replacement guidelines
Market area	Russische Föderation (5RU),Australia E04 Bentley rest Asia and Australia (6E04),China 796 VW Import Comp. Ltd (Vico), Beijing (6796),Germany E02 Bentley rest Europe (6E02),Japan E03 Bentley Japan (6E03),Korea, (South) E08 Bentley South Korea (6E08),United Arab Emirates E06 Bentley Middle East and Africa (6E06),United Kingdom E01 Bentley UK (6E01),United States E05 Bentley USA and rest America (6E05)
Brand	Bentley
Transaction No.	2069493/1
Level	EH
Status	Approval
Release date

Bentayga series

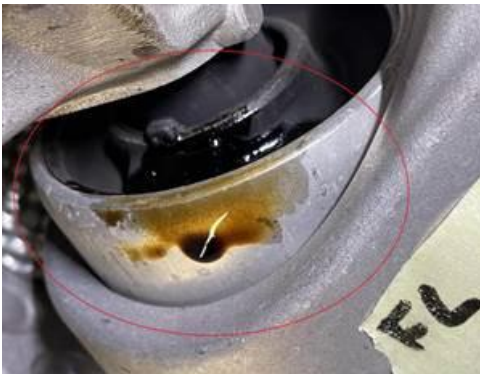
Figure 1

The right and/or left hand front rearmost lower suspension lever inner hydraulic mounts are leaking oil or showing signs of dry oil stains

- If a leak is identified by the customer (Figure 1) - Replace the right and/or left hand front rearmost lower suspension lever inner hydraulic mounts as per all instructions within Rep.Gr 40

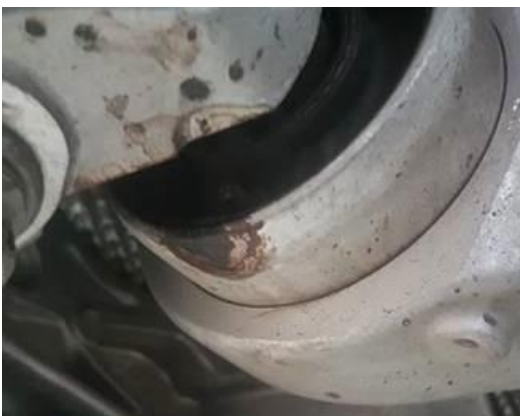
Figure 2

A dry oil stain mark (Figure 2) is evident on the right and/or left hand front rearmost lower suspension lever inner hydraulic mounts

Do not replace the hydraulic mounts
