Technical product information

Topic	Night vision camera - Washer jet leaking
Market area	Bentley: worldwide (2WBE)
Brand	Bentley
Transaction No.	2051045/7
Level	EH
Status	Approval
Release date

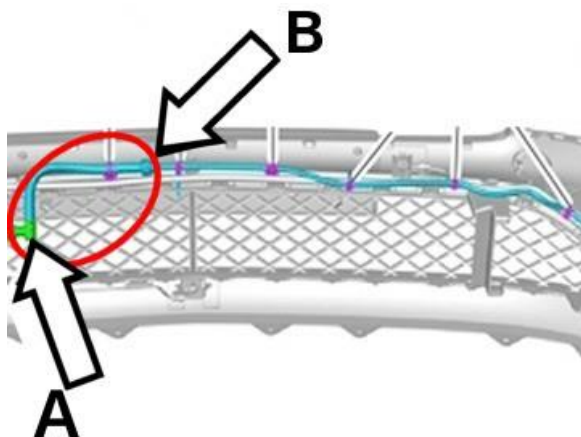
Washer fluid dripping/leaking from the night vision camera washer jet

Referring to Figure 1 - In the event the afore mentioned symptom is evident the operative should refer to the Measure section of this TPI to replace the night vision washer jet (short link hose -Circled) which connects the night vision camera washer jet (A) to the washer jet supply hose connector (B)
