INFINITI

# TECHNICAL SERVICE BULLETIN

<b>Classification:</b> BT09-053J	<b>Reference:</b> ITB09-039J	<b>Date:</b> February 27, 2023
-------------------------------------	---------------------------------	-----------------------------------

## WINDSHIELD CRACKING

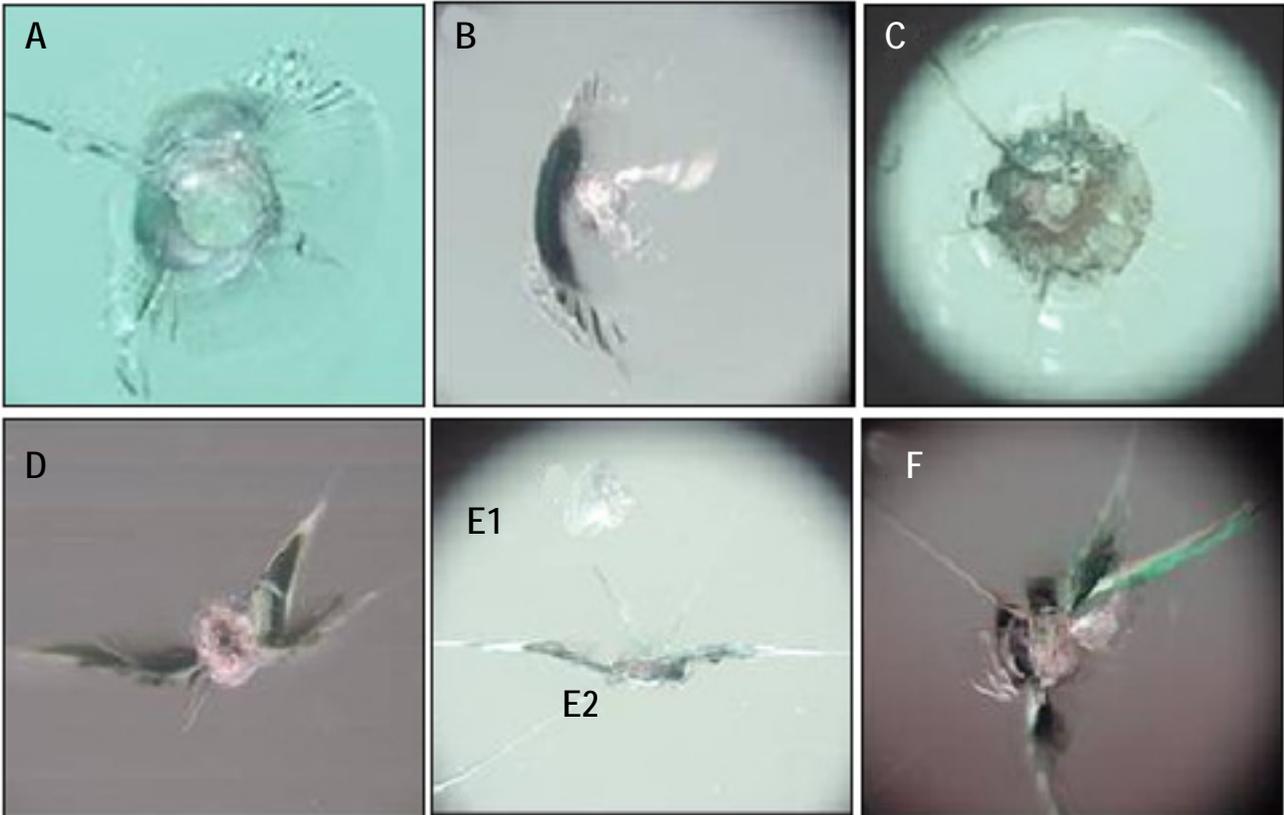
Most windshield damage that occurs due to impact is easily identified as shown below:

- Cone shaped break (A, B, C)
- Crush mark (D, E1, F)
- Star shape crack (C, D, E2, F)

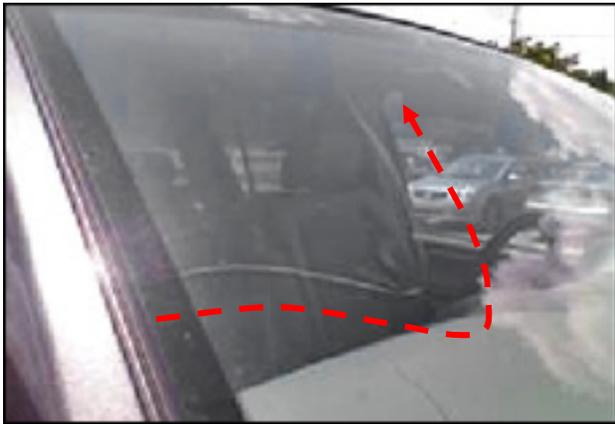
Single cracks must be inspected along the entire crack for impact marks.

Single crack with **no** impact mark:  
**Warranty**

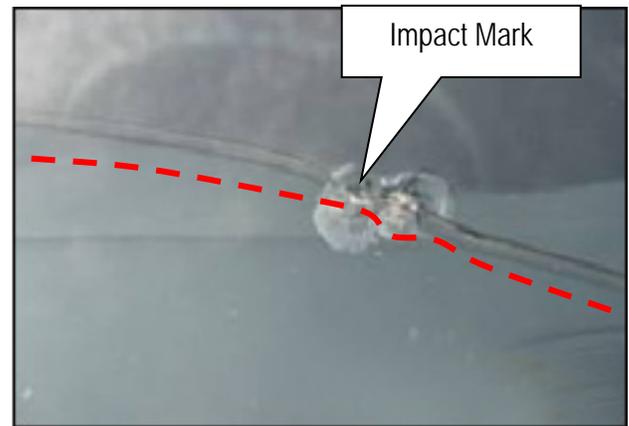
- If any impact mark is found anywhere along the crack, it indicates the damage occurred from an object striking the windshield. This is not covered under warranty.
- The tip of a ball point pen can be run along the crack in the windshield to find the impact point.
- A magnifying glass (10X magnification) may be necessary to identify impact marks that may be less than 1 mm in diameter.

Single crack with impact mark:  
**Not Warranty**

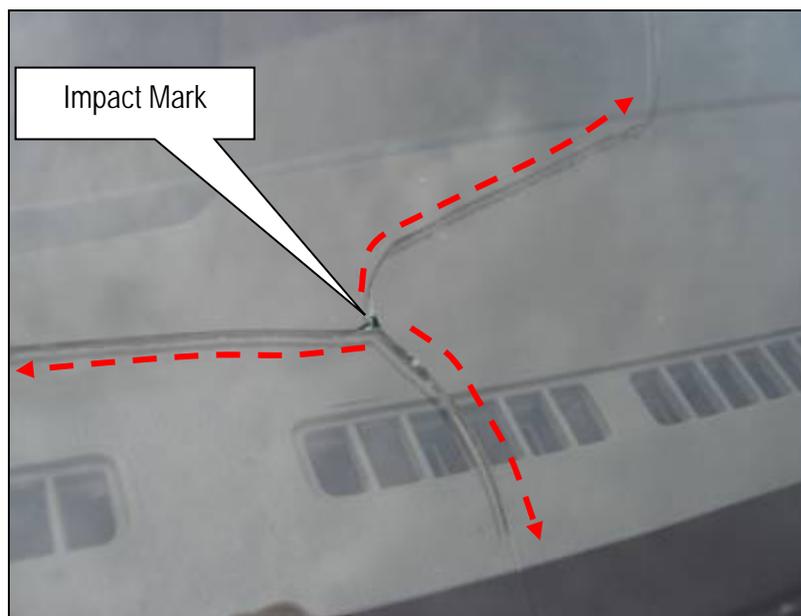
This type of crack is always caused by impact to the glass. The point of impact is located where the crack "branches out".

Compound crack: **Not Warranty**

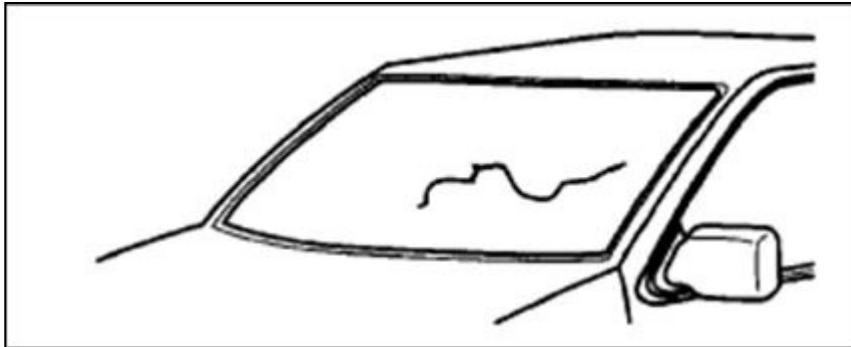
- These cracks are always caused by an impact to the glass and are not covered under warranty.

Cracks not reaching edge: **Not Warranty**

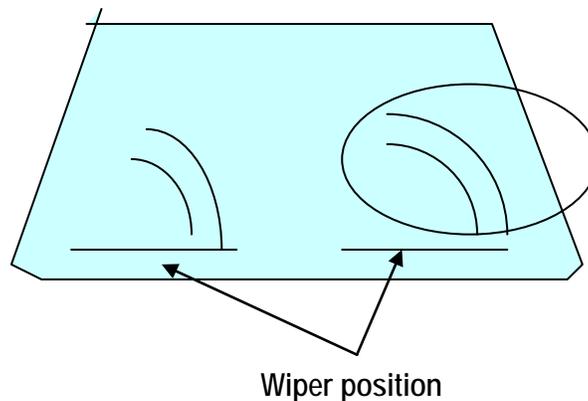
- Inspect the wiper paths (may be a single scratch of a group of scratches).
- Small scratches can cause a small rupture in the outer glass surface, which can lead to a crack from thermal conditions, vehicle vibration during driving, or wind pressure.

Scratch from sand/stone: **Not Warranty**

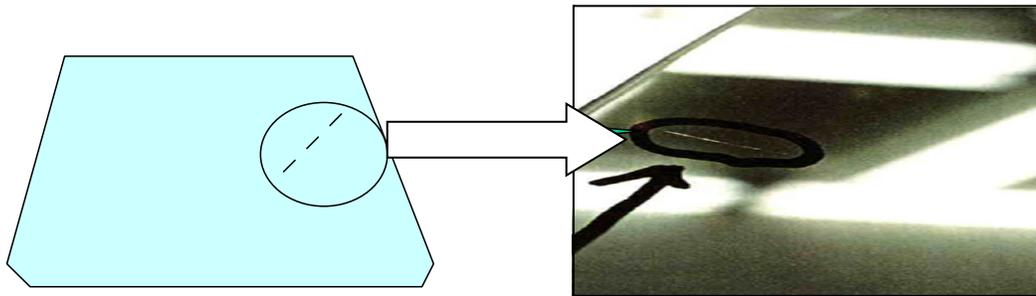
- Scratches can occur from metal objects such as keys and metal buttons. These scratches are typically sharp and can be found anywhere on the glass surface.
- Thoroughly examine the entire length of the crack to identify any scratch as a start point.
- Small scratches can cause a small rupture in the outer glass surface, which can lead to a crack from thermal conditions, vehicle vibration during driving, or wind pressure.

Scratch from metal objects: **Not Warranty**

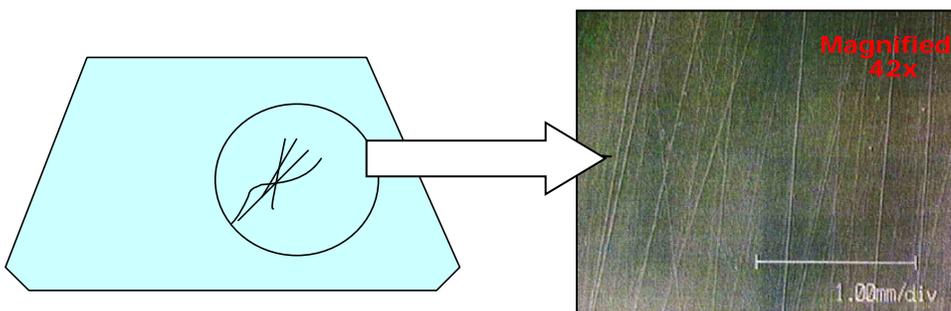
- Scratches can occur from wiping the glass with a towel that has sand particles or dirt on it.
- These scratches are typically long and have several scratches concentrated together.
- These scratches can be found anywhere on the glass surface.
- Thoroughly examine the entire length of the crack to identify any scratch as a start point for cracks in the glass.

Scratch from dirty towel/cloth: **Not Warranty**

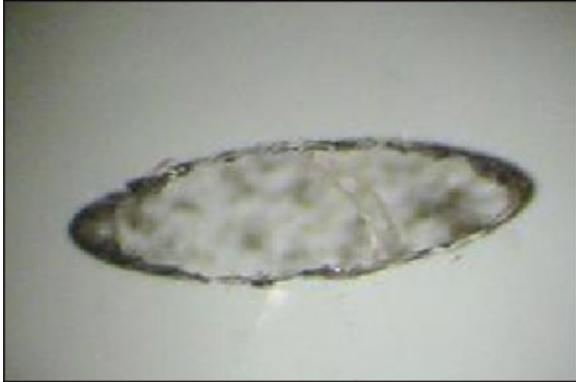
Open bubble – Warranty

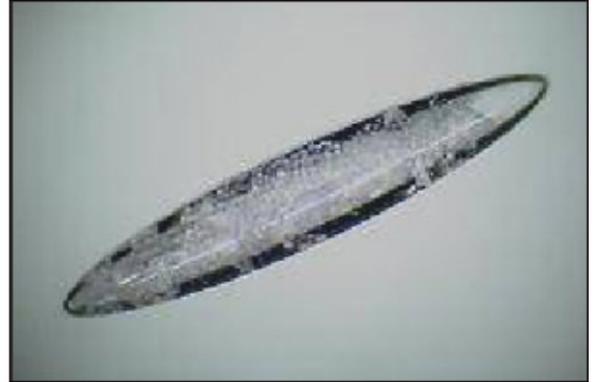
Surface blister - Warranty

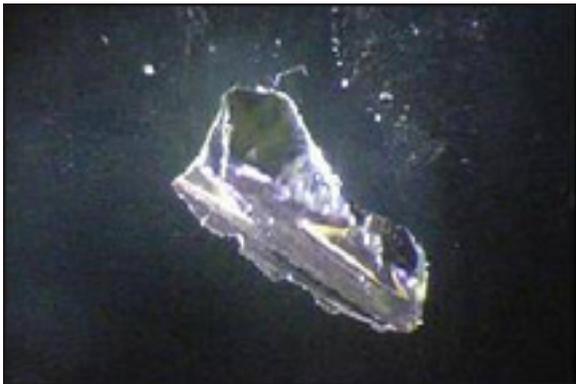
Adhesion chip – Warranty

(Can occur from a manufacturing issue such as adhesion of molding to the glass surface along the glass edge.)

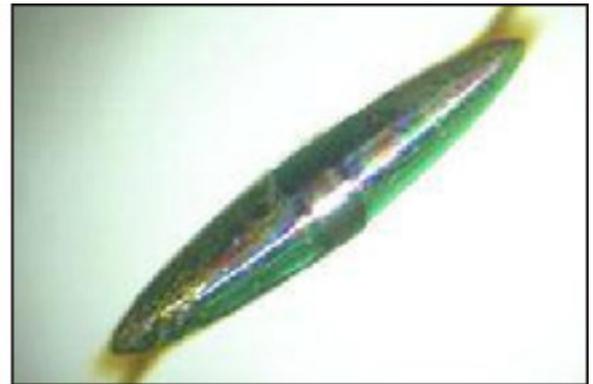
Surface blister – Warranty
