TECHNICAL SERVICE BULLETIN

Classification: FA10-007C	Reference: ITB10-067C	Date: February 22, 2023
------------------------------	--------------------------	----------------------------

WHEEL BEARING COLLISION DAMAGE

APPLIED VEHICLES: All Infiniti

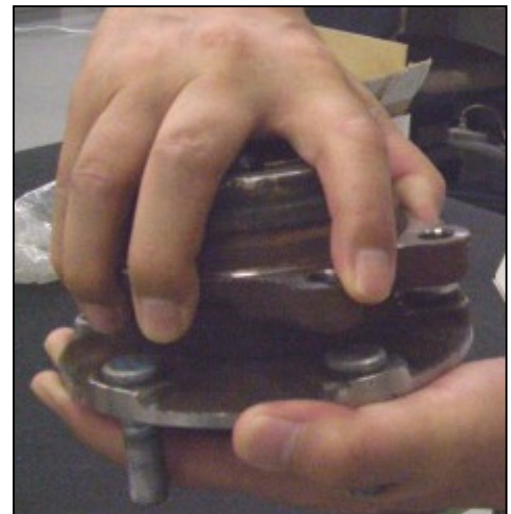
Figure 1

Impacts to wheel bearings (such as a collision or other suspension damage) may create slight indents in the bearing surfaces. These indents may not be visible but can cause bearing noise.

If a vehicle has visible wheel or suspension damage due to impact (collision or other suspension damage), it is recommended that the wheel bearing assembly be inspected as follows:

1. Remove the hub/bearing assembly from the vehicle.
2. Hold the hub/bearing assembly with both hands.
3. Rotate the hub/bearing assembly in both directions (clockwise and counterclockwise).
4. If any gritty or rough feeling is detected in the bearing, replace it with a new one.
