Subject: REVISION: N192266181-01 – Special Coverage
Wiper Transmission Arm Linkage Failure
Population Update

Models: 2010-2012 Chevrolet Equinox
2016-2017 Chevrolet Equinox
2010-2012 GMC Terrain
2016-2017 GMC Terrain

N192266181 Wiper Transmission Arm Linkage Failure – USA Only

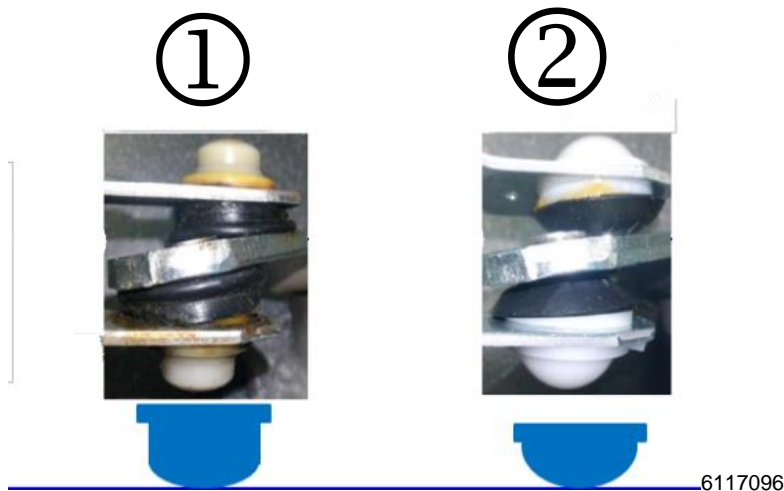
There are two types of nylon pivot cups.

- If the module has a “top hat” design (1), proceed with the link replacement procedure.
- If the module has “dome shaped” design (2), Replace the module assembly.

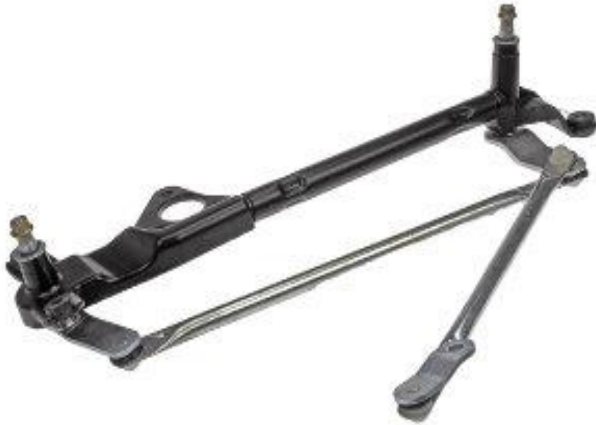
6055971

- **NON-GM Wiper Module Assembly Example.** If the wiper module is determined to be a non-GM unit, replace the complete windshield wiper system module assembly. Refer to *Windshield Wiper System Module Replacement* in SI.

Black painted aftermarket module frame

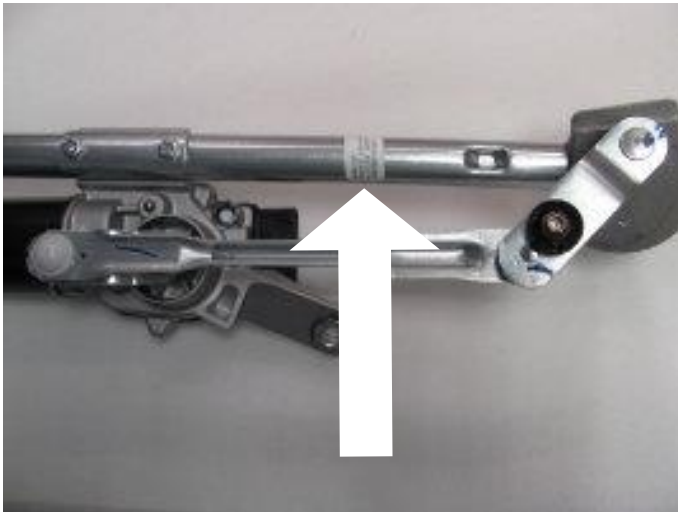
6055973

- **OE-GM Wiper Module Identification.** If the wiper module is determined to be a GM unit, proceed to step #2.

GM OE parts will have a part number tag

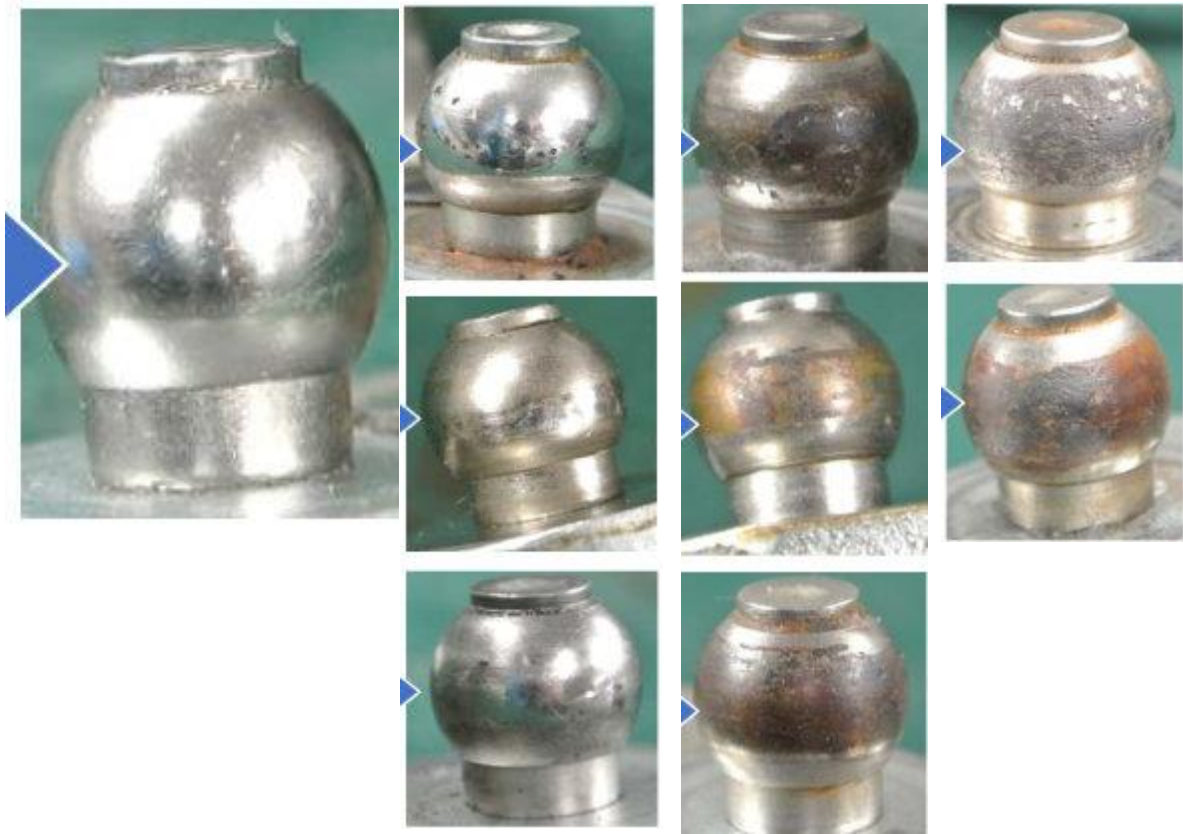
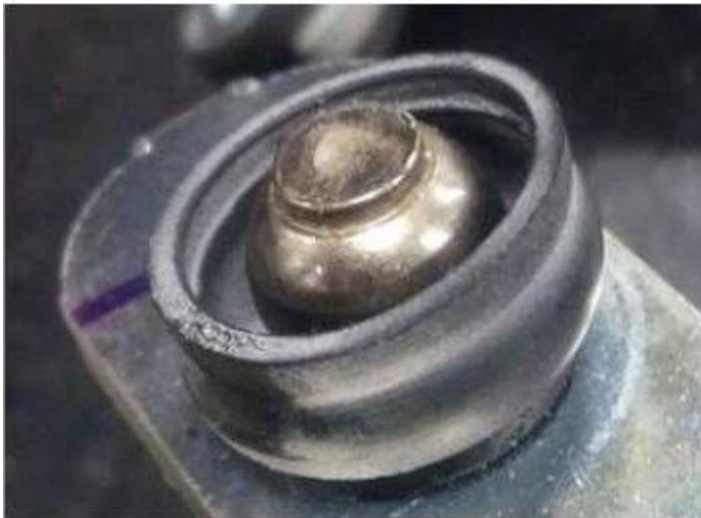
- Using a suitable aerosol solvent and a small wire brush or abrasive pad, clean the old grease and debris from the ball joints. Wipe the ball joints clean with a suitable disposable towel.
- With the ball joints cleaned, inspect the surface for severe damage (material missing).

The below examples are acceptable levels pitting, flaking and rust residue
