TECHNICAL SERVICE BULLETIN

| Classification: EL22-011A | Reference: NTB22-051A | Date: February 22, 2023 |

HORN INOPERATIVE

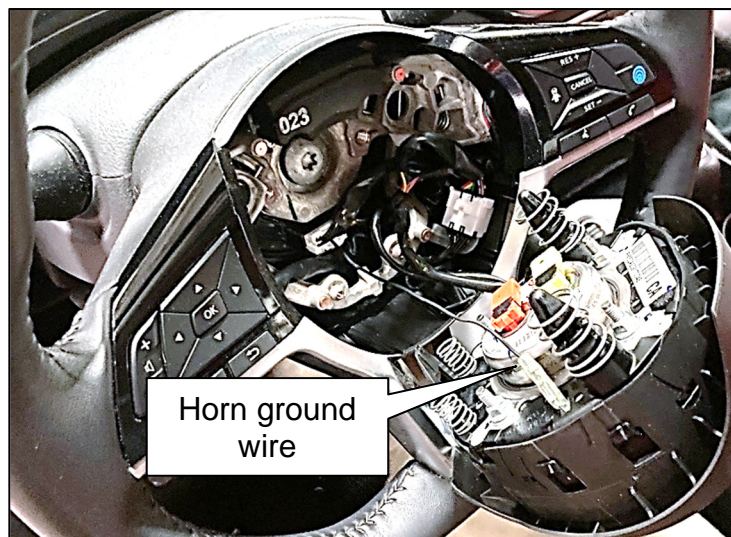
Figure 7

9. Inspect the horn ground wire for signs of pinching.
 - If signs of a pinched ground wire are present, proceed to step 10 to replace the high and low horns.
 - If signs of a pinched ground wire are not present, skip to step 11 on page 6 to install the driver airbag module.

10. Replace the high and low horn.
 - Refer to the ESM: **DRIVER CONTROLS > HORN > REMOVAL AND INSTALLATION – HORN: Removal and Installation**

The pinched ground wire does not require a wire repair. When installing the driver airbag module to the steering wheel, rotate the driver airbag module 360° to remove excess slack from the ground wire and to prevent the ground wire from becoming pinched.
