Preliminary Information

PIT5946C Check Engine Lamp With DTC: P0606 set in the Body Control Module

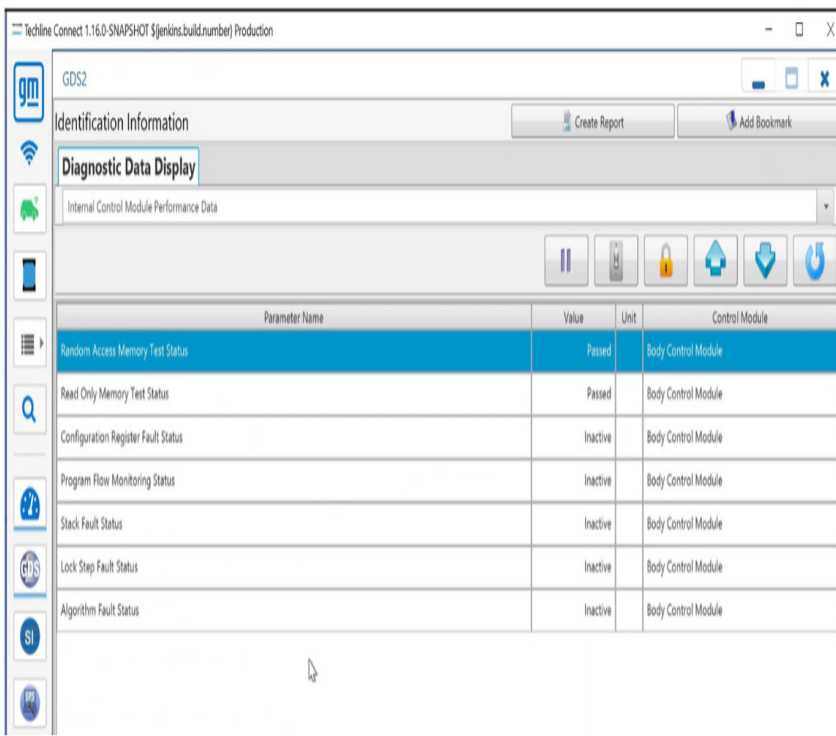
Connect an MDI2 to the vehicle and navigate to GDS2 and select the following: > Module Diagnostics > Body Control Module > Identification Information > Internal Control Module Performance Data

Review the parameters. If only the "Program Flow Monitoring Status" is active and all other parameters are inactive, please attempt to program the BCM with the latest calibration in Techline Connect under the SPS Tab.

If the BCM software is up to date or an update was just performed, review "Program Flow Monitoring Status" parameter once more.

If the "Program Flow Monitoring Status" parameter is still "Active" with all other parameters reading inactive, then clear codes and take no further action.
