PIT5921A Rear View Camera Coaxial Related Issues-B395A - B395B - B395C - B101E - B101D

Product Investigation Review Required

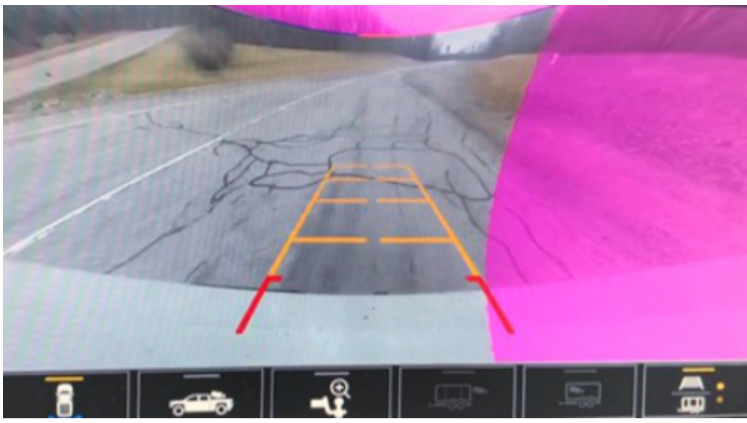
Pink Colored Image Issue

Pink on the screen will be most likely an intermittent Coax issues caused by damaged or frayed coax cables.

Some intermittent conditions can be caused by wire terminal fretting corrosion, which is a build-up of insulating, oxidized wear debris that can form when there is a small motion between electrical terminals.

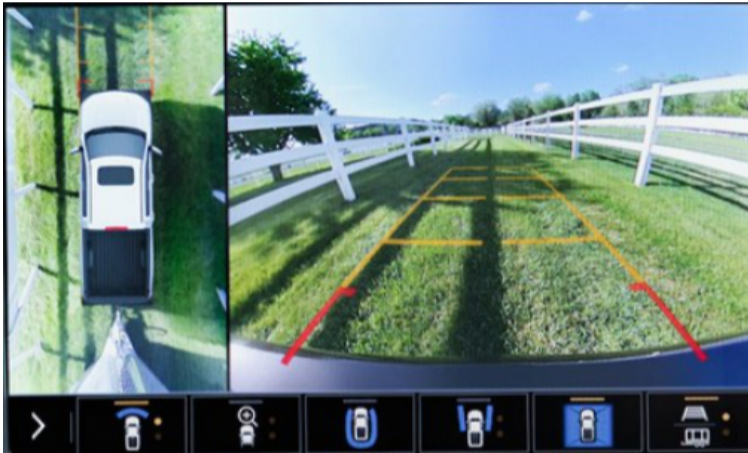
Flicker Issue

- If the "Cameras" Icon is greyed out and not working. The connection issue may be between the VPM and Radio.
- If the touch buttons are working properly, it could be an issue with the coax cable connection from the VPM to the Rear Vision Camera.

Note: Before testing the coax cable, check the cable's exterior for being pinched, cut, damaged, or having loose connections at the components, all of which can cause reception issues.

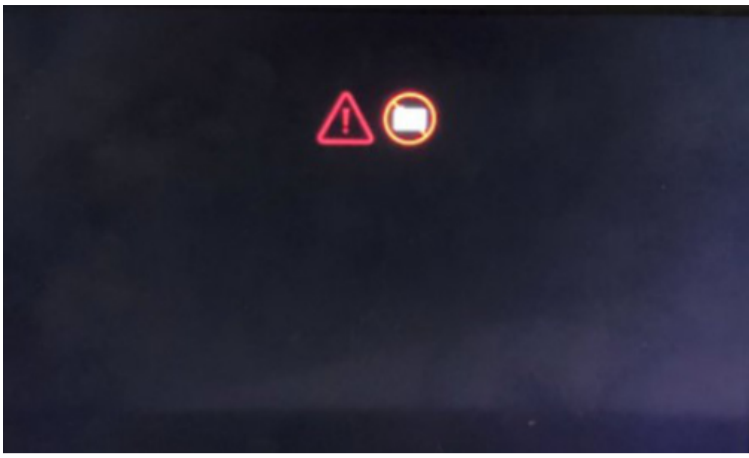
If the rear camera or the VPM do not provide the rolling counter, you will see the following black screen with an icon:

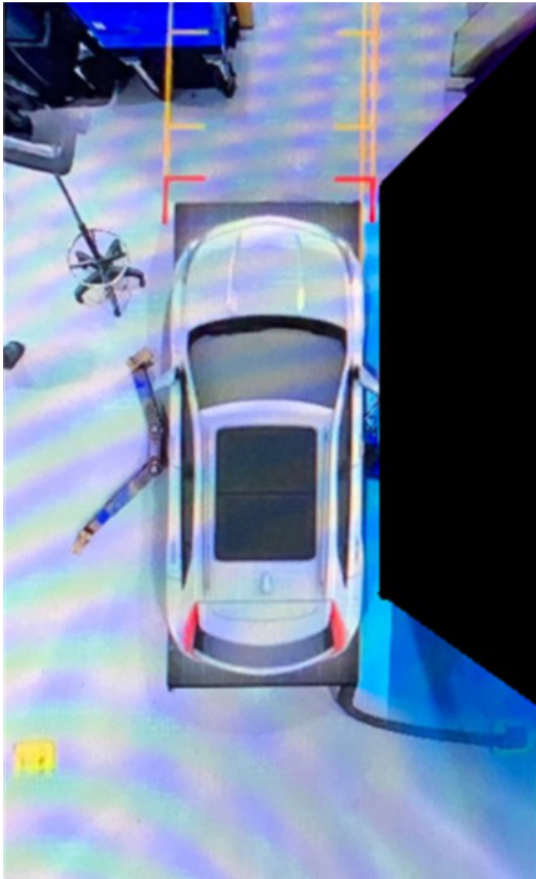
The VPM does not monitor the left, right or front cameras with a rolling counter. These camera's will display in black on their perspective side if there is an issue.

Figure below is of a right camera issue:
