Bulletin No.: PIT5930A  
Published date: 02/7/2023

### PIT5930A Hood Paint Damage At The Edges Of The Hood Center Molding

Brand:	Model:	Model Years:	VIN:		Engine:	Transmissions:
			from	to		
Chevrolet	Silverado 1500 New(RPO J22, VIN Digit 5 = A or D)	2022	All	All	All	All
Chevrolet	Silverado 1500	2023	All	All	All	All

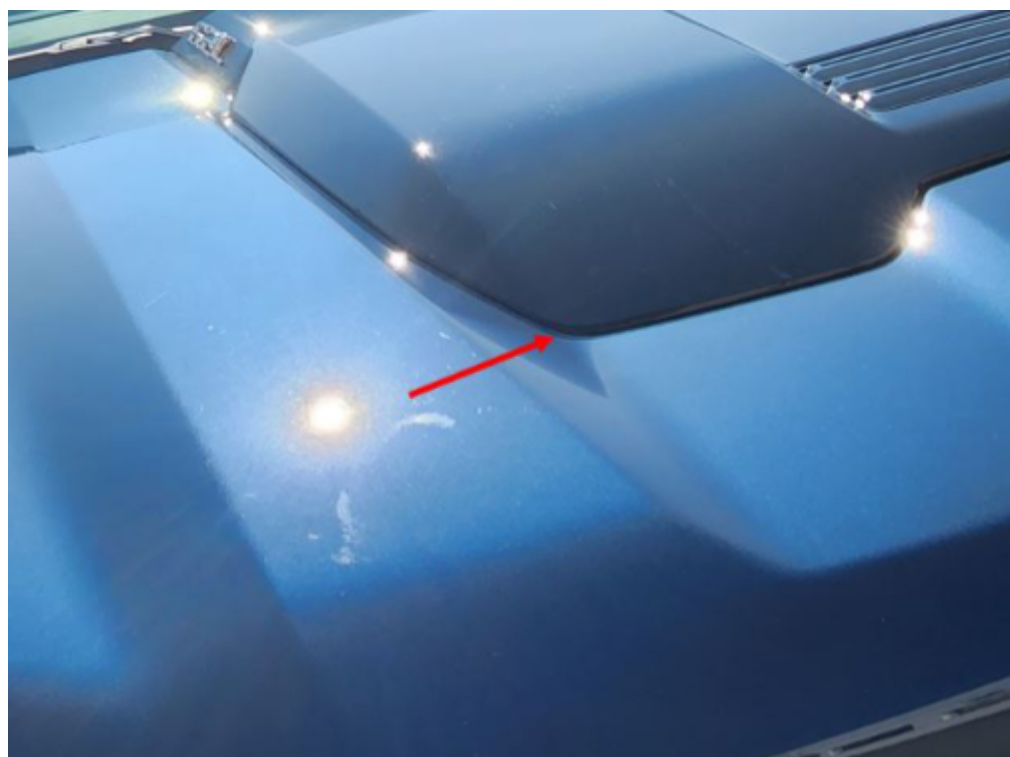
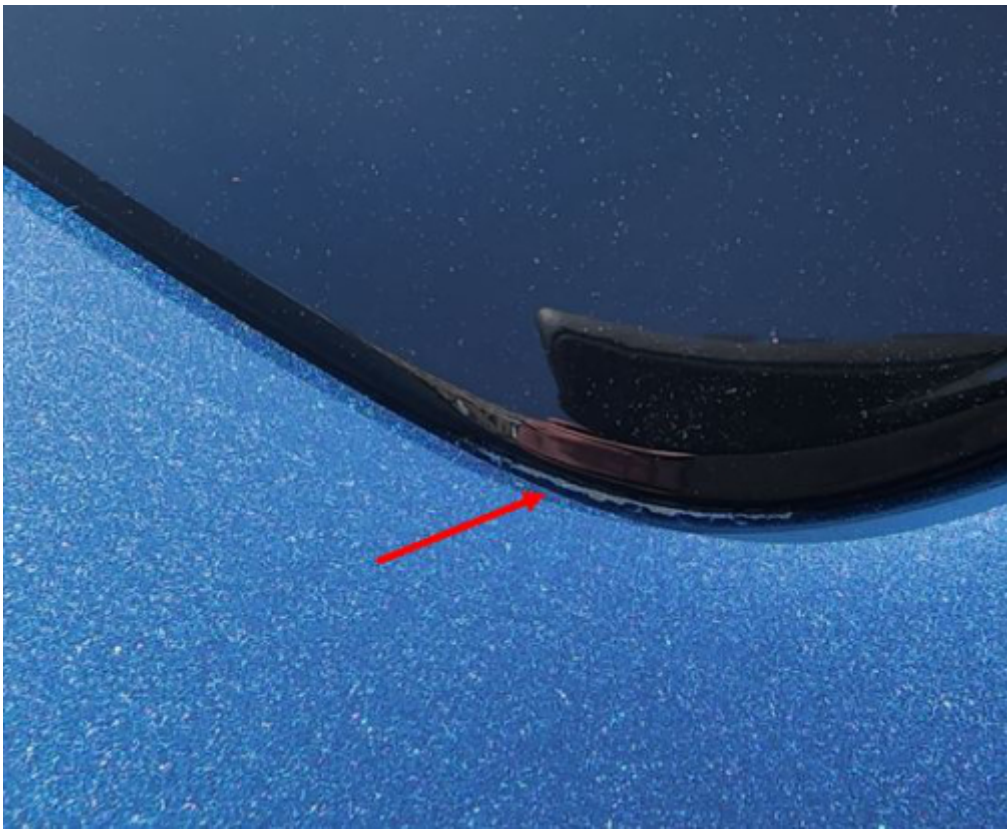
Involved Region or Country	North America
RPO	ZR2 Or Trail Boss
Condition	Some customers may notice that the hood paint is damaged or chipped where the edge of the center hood molding contacts the hood, as shown below.
Cause	Insufficient clearance between the center hood molding and hood.

To correct this concern, perform the following repairs:

1. Remove the hood insulator blank (if equipped) and hood center molding (hood scoop) following SI Document "Hood Center Molding Replacement (ZR2 or Trail Boss)". The hood center molding will be reused.
