## Preliminary Information

**PIT5391F No Crank / Start then Immediate Stall / SES MIL / Service 4WD / Relay Clicking / Rearview Camera Inop / DTC (Inspect Ignition 1 voltage)**

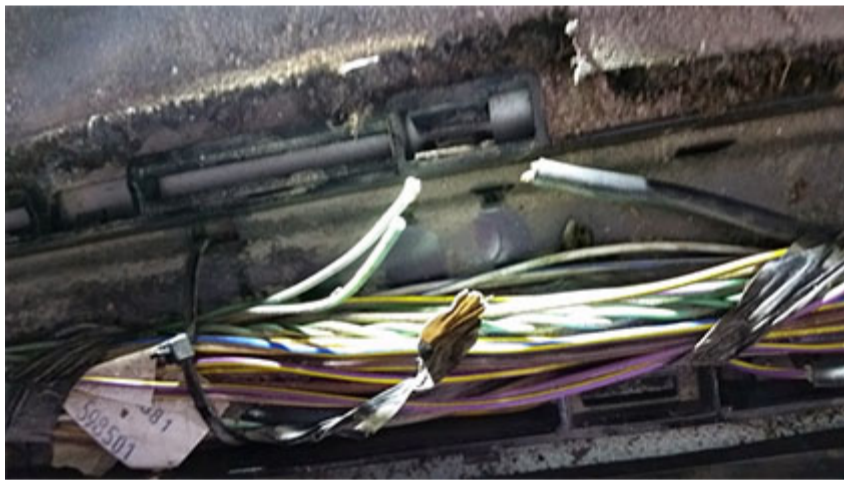
3. Circuit 5199 under the driver's sill plate for being damaged/corroded, as shown below.

Repair any wiring / terminal issues using the appropriate SI wiring repair documentation.
