Technical product information

Topic	Unable to open the glovebox when using the key or the key does not enter the lock fully
Market area	Bentley: worldwide (2WBE)
Brand	Bentley
Transaction No.	2069554/1
Level	EH
Status	Approval
Release date

Bentayga

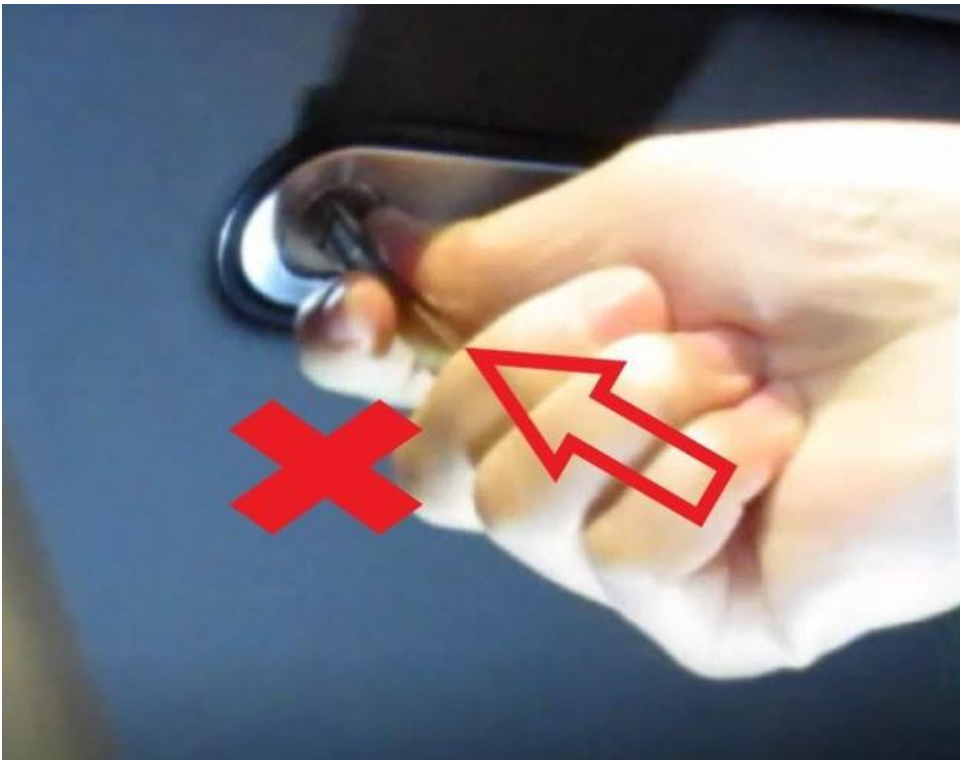
Figure 1

Unable to open the glovebox when using the key or the key does not fully enter the lock (Figure 1)

- 1) Using a suitable lock lubricant - Apply a small amount of lubricant into the glovebox lock
- 2) With care attempt to install the key into the glovebox lock
 - Remove the key
- 3) Rotate the key 180 degrees and attempt to install the key into the glovebox lock
- 4) Once successfully installed the operative attempt to unlock/lock the glovebox using the key
 - Should the issue now be resolved no further action is required

5) Should the issue still be evident the operative should repeat steps 1,2 and 3 twice more

Should the issue not be resolved the operative should raise a DISS query and await feedback before conducting any further work
