SIB 41 01 23

## POPPING SOUND AT THE TOP OF THE C-PILLAR

E-Series	Model Description
G07	X7 Sports Activity Vehicle

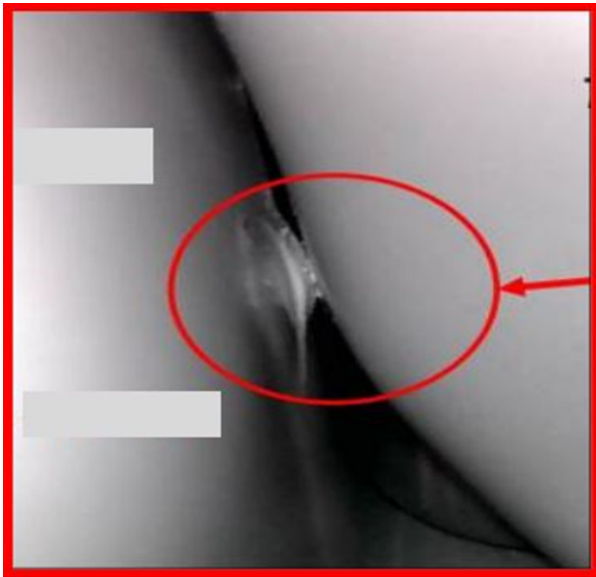
A spot weld burr between the side frame and the top of the inner C-pillar contacts the C-pillar reinforcement at the top.

Remove the existing weld burr following the procedure below.

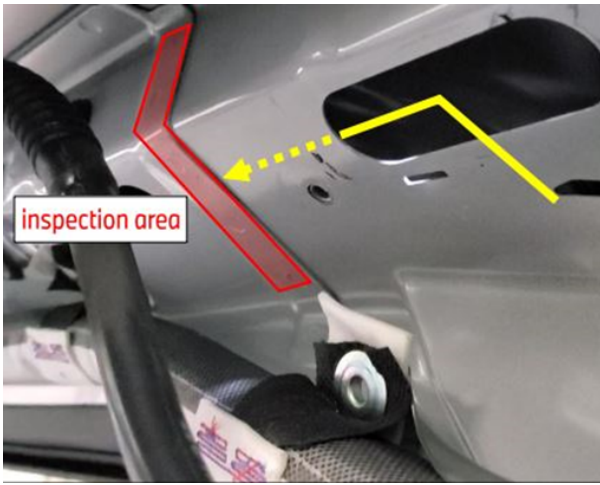
1. Remove the headliner following the repair instructions listed in AIR/ISTA (51 33 013).
2. Using a borescope, look through the elongated hole in the C-pillar towards the front of the vehicle.

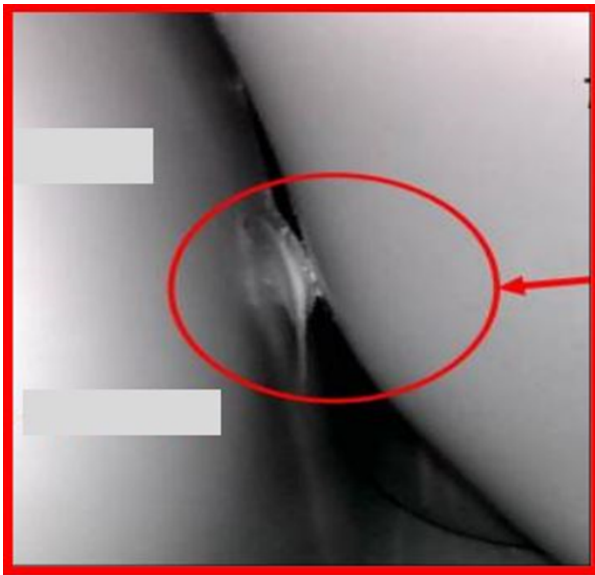
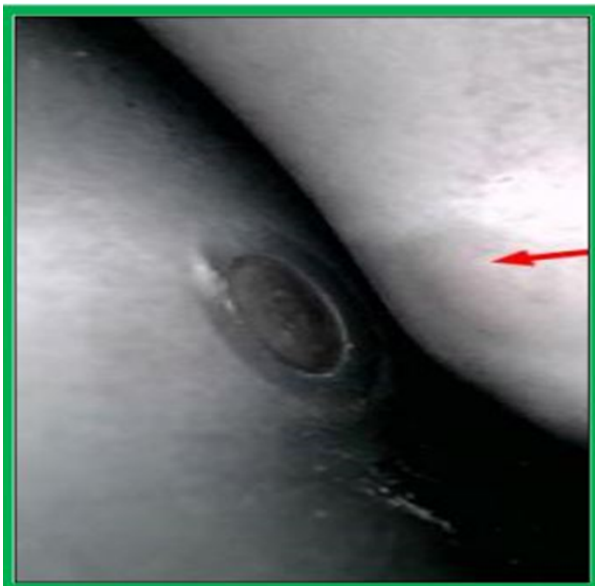
3. Determine whether the weld spot in the area marked in red have a weld burr and/or are in contact with the reinforcement panel.

**Red** photo: Not acceptable

**Green** photo: Good
