REFERENCE:	Nova Bus Manuals
SECTION:	12: Interior Furnishing
RS N°:	MQR 7621-2414
EFFECTIVE IN PROD.:	NA

SUBJECT:	Lexan panels cracking at mounting holes.
JUSTIFICATION:	Need to change the attachment of Lexan panels due to apparent cracks observed in production.

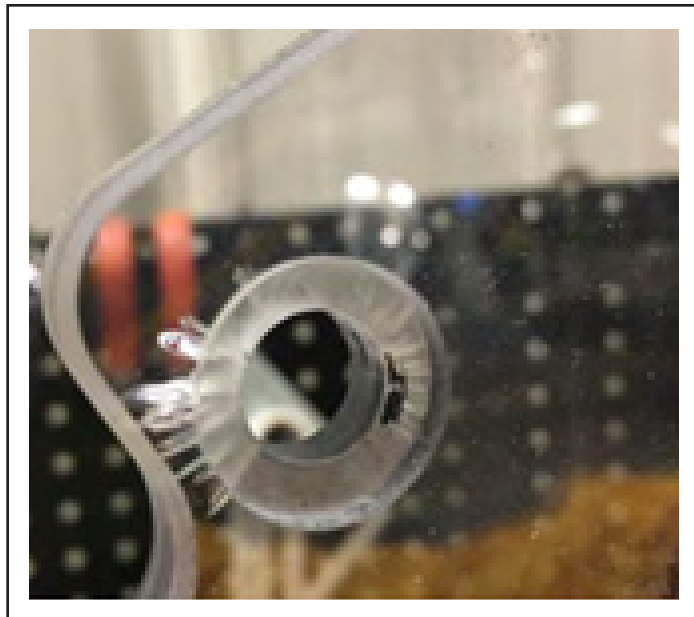
- 1.6. Inspect the lexan panels for cracking around the corners where the brackets are mounted to the lexan panels. Replace lexan panel if there are any visible cracks, use level 2 BOM (see figure 3).

Figure 3 - Cracks on the Lexan Panel
