REFERENCE:	Nova Bus Manuals
SECTION:	10: Transmission and control
RS N°:	MQR 7621-2275
EFFECTIVE IN PROD.:	NA

SUBJECT:	Coolant pipe assy failing.
JUSTIFICATION:	The adaptor on the Coolant pipe assembly between the engine and circulation pump broke in service at the beginning of the copper thread.

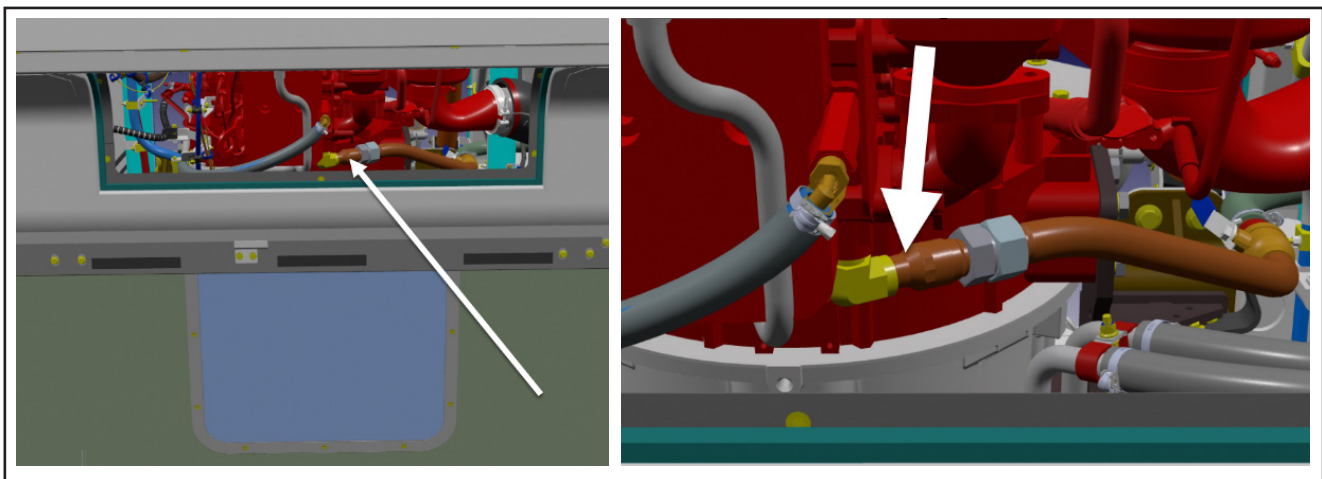
Figure 2 - View of Adaptor between Elbow and Copper pipe

- 1.5. Locate and inspect the adaptor located between the elbow and the copper pipe (see figure 2).

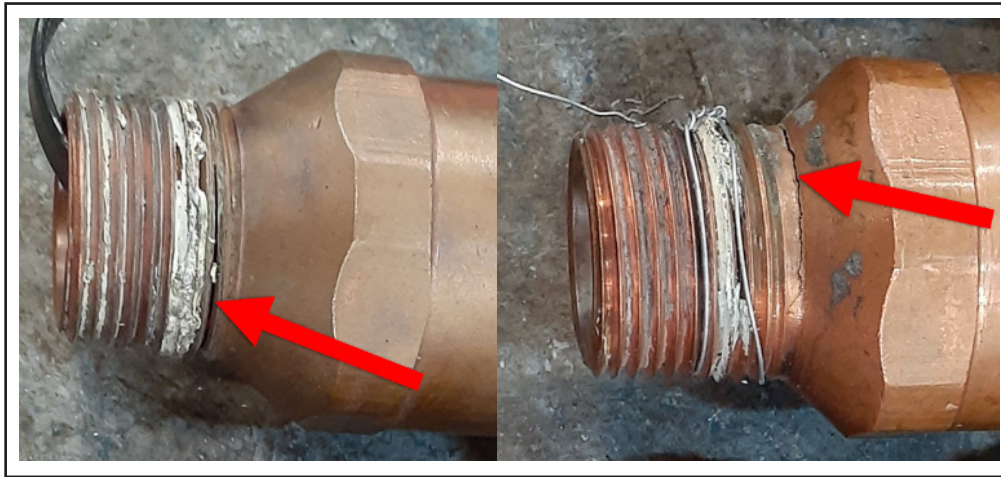
Figure 3 - View of Cracked Adaptor

- 1.6. Check for any sign of crack initiation, leakage at the bottom of the threads or at the geometry change of the adaptor and replace if found (see figure 3).
