96-18-01TT - Faulty Driving Profile Selection Control Head -E881-

Release date: 3/23/2023

Model(s)	Year	Eng. Code	Trans. Code	VIN Range From	VIN Range To
Atlas, Atlas Cross Sport	2018-2023	All	All	All	All

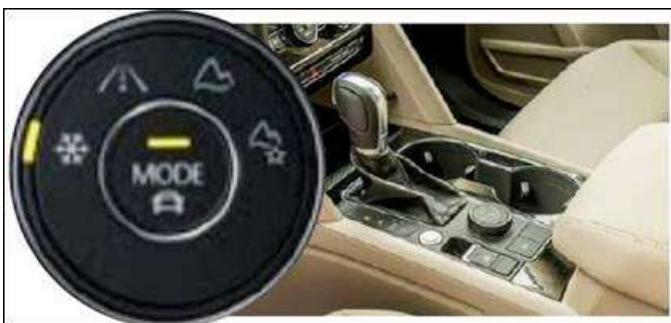
Figure 1: shows the location of the driving profile selection control head.

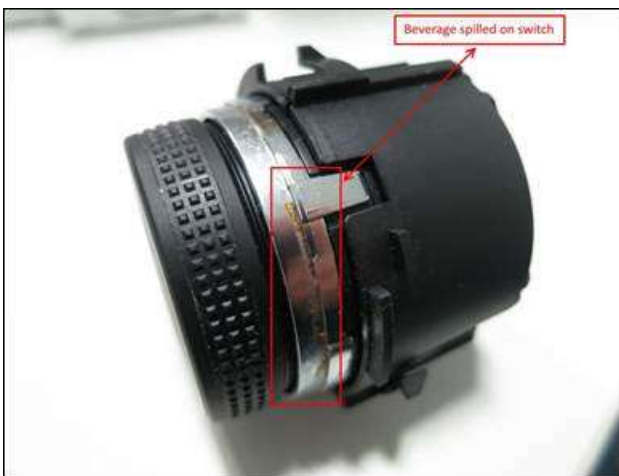
Figure 2

Information only: Driving Profile Selection Control Heads -*E881*- are being replaced due to outside influence, which is causing them to not operate.

Refer to figures 2 and 3 below for examples of beverage spilled on the control head.

- Ensure there is no outside influence causing the control head not to operate.
