Technical product information

Topic	New Continental GT and GTC - Window drop glass concerns
Market area	Bentley: worldwide (2WBE)
Brand	Bentley
Transaction No.	2067436/7
Level	EH
Status	Approval
Release date

New Continental GT and GTC

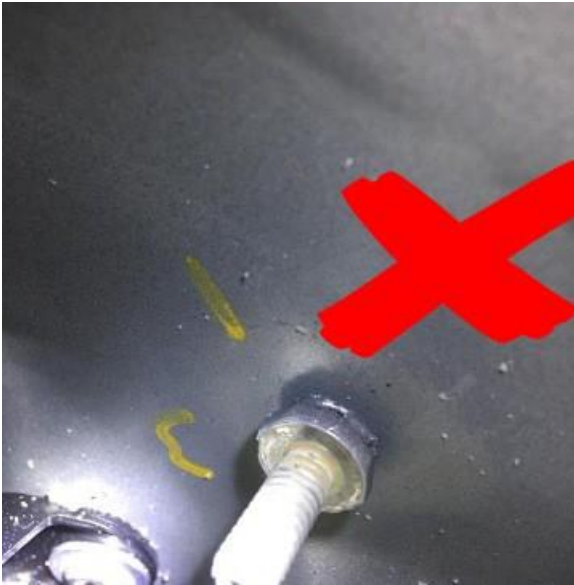
- Earth point 736 RHR and Earth point 738 LHR
- Check for cleanliness and security of both earth points Figure 2 shows an example of a contaminated earth point (dirt/paint/debris)

- Remove any dirt/paint/debris from the earth points using suitable abrasives/wire brush ensuring no damage is caused to the earth stud threads as shown in Figure 3

- Secure the earth point fixings to (9Nm)

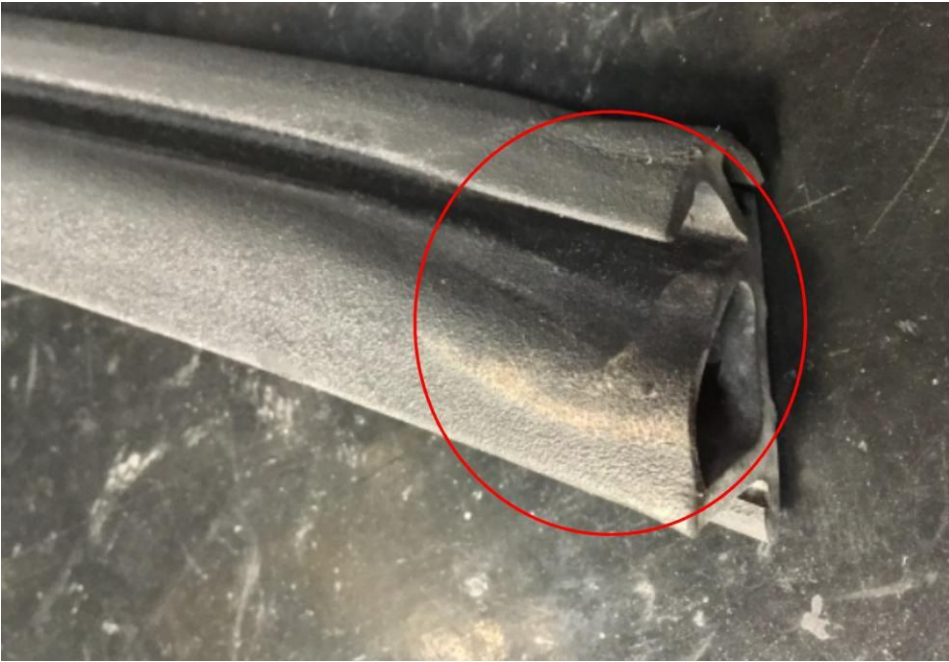
Figure 4

- Drop glass seal deformation (see Figures 4 and 5 as examples)

NOTE: Any issues found with the window seals must be rectified before conducting the remaining steps
