## Technical product information

<b>Topic</b>	New Continental GT - Boot fails to power open/close
<b>Market area</b>	Bentley: worldwide (2WBE)
<b>Brand</b>	Bentley
<b>Transaction No.</b>	2052413/8
<b>Level</b>	EH
<b>Status</b>	Approval
<b>Release date</b>

Power boot operation stops during the open and/or close cycle

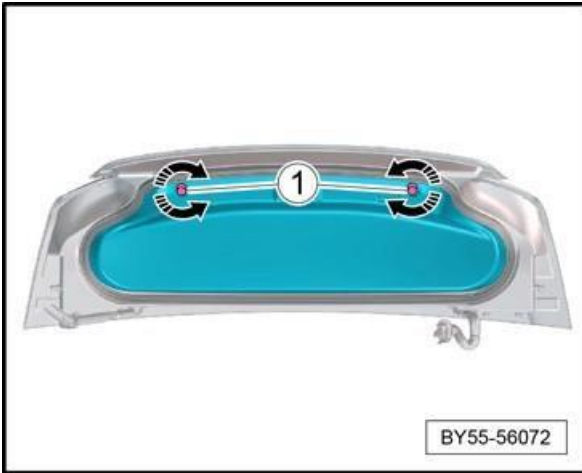
Figure 1

### Boot does not open (unlatches then latches)

- Within the Boot lid to set procedure - Ensure the boot bump stops are adjusted to specification (Figure 1)
- The bump stops should be in contact with the cover lock carrier

HINT: The interaction should be strong enough to give a positive popping noise on opening however if this is not the case, incorrect adjustment could be the direct cause of this particular issue
