Technical product information

Topic	Coolant leaking from the mechanical coolant pump - Low coolant level warning - Engine overheating - DTC's evident
Market area	Russische Föderation (5RU),Australia E04 Bentley rest Asia and Australia (6E04),China 796 VW Import Comp. Ltd (Vico), Beijing (6796),Germany E02 Bentley rest Europe (6E02),Japan E03 Bentley Japan (6E03),Korea, (South) E08 Bentley South Korea (6E08),United Arab Emirates E06 Bentley Middle East and Africa (6E06),United Kingdom E01 Bentley UK (6E01),United States E05 Bentley USA and rest America (6E05)
Brand	Bentley
Transaction No.	2065919/7
Level	EH
Status	Approval
Release date

W12 Bentayga - New Continental GT/GTC - New Flying Spur

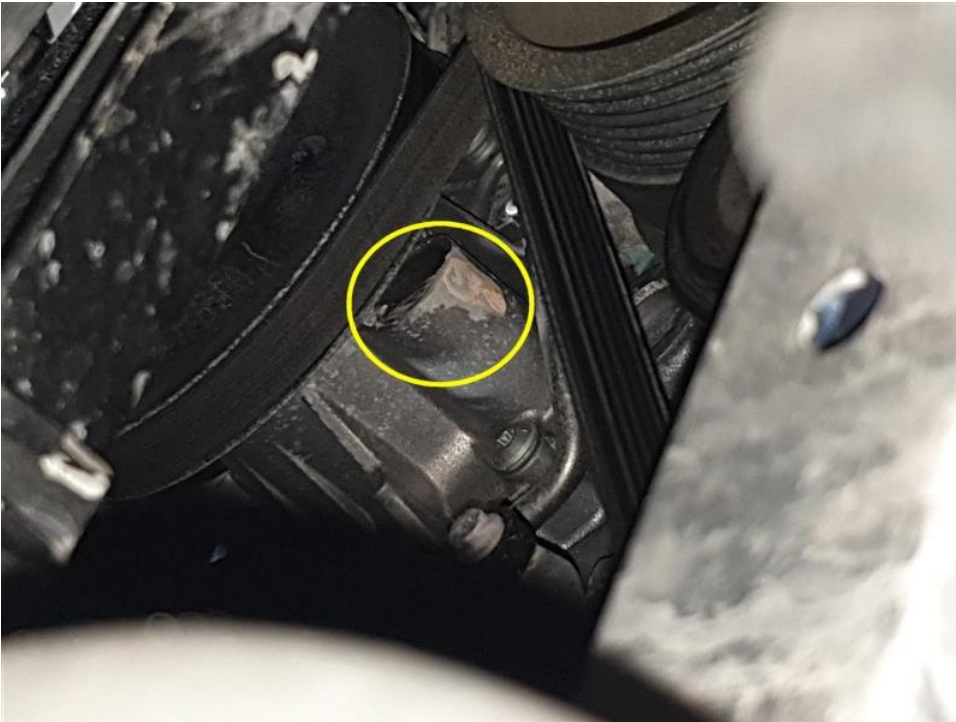
Figure 2

Refer to the video located within the Bentley Hub reference TPI 2065919/- this video shows an example of a coolant pump with no leak although there is a small coolant witness mark evident (Figure 2) in this scenario the coolant witness mark should be cleaned off (using a suitable cleaning agent) to the condition shown in Figure 3
