Technical Service Bulletin

27 48V Vehicle electrical system warning, DTC P0CA700 and/or U046900 stored in the starter/generator control module/ECM

27 23 49 2058831/6 March 23, 2023. Supersedes Technical Service Bulletin Group 27 number 22-45 dated September 27, 2022, for reasons listed below.

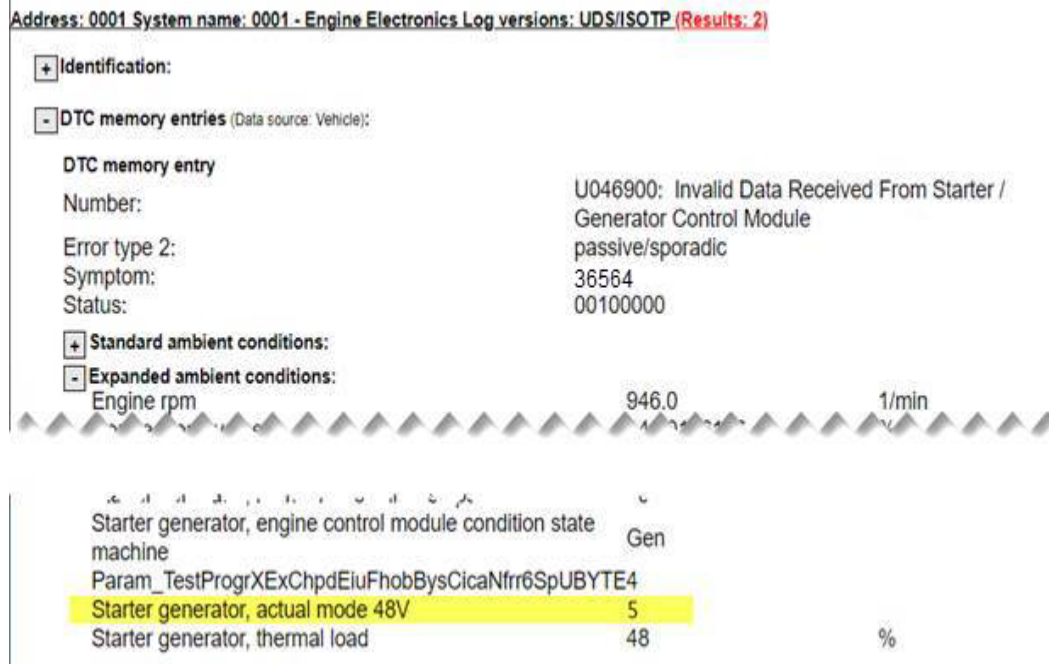
If the value displayed for *Starter generator, actual mode 48V* is not shown, or a value other than 5 is displayed (see Figure 1) please check the software version of the BSG (address word 00CC).

Figure 1: Extended ambient data in ODIS GFF log.

If the software is older than, but not including SW 0527, please update the BSG via the SVM update instructions at the end of this TSB, then follow up with the checks listed under Criterion 2.
