Service Alert

Mazda North American Operations
Irvine, CA 92618-2922

Subject: CONNECTED VEHICLE SYMPTOM TROUBLESHOOTING	Service Alert No.: SA-009/23
	Last Issued : 03/01/2023

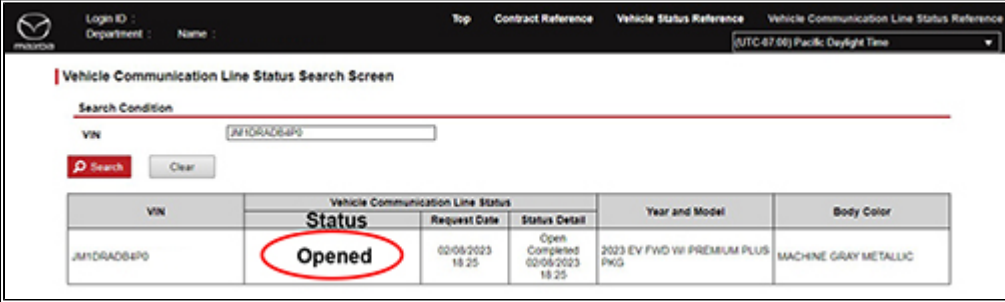
<p>Deactivation Mode Status</p>	<ul style="list-style-type: none"> • TCU Active (Status -> Opened)

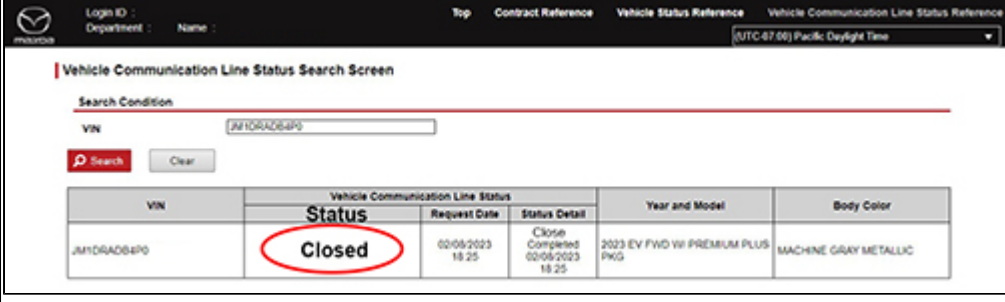
- TCU in Deactivation Mode (Status -> Closed)

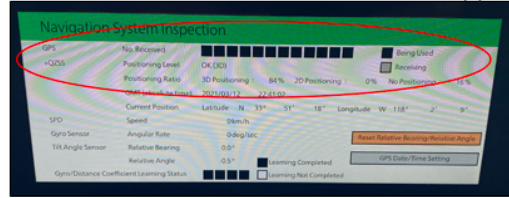
Good - Contact Hotline for technical support
