# TECHNICAL SERVICE BULLETIN

## Level 3 Charging, Illuminated Charger Service Required Indicator In The IPC And/Or Multiple DTCs

**23-2014**01 March  
2023

<b>Ford</b> 2022-2023 e-Transit
2022-2023 F-150 Lightning
2021-2023 Mustang Mach-E

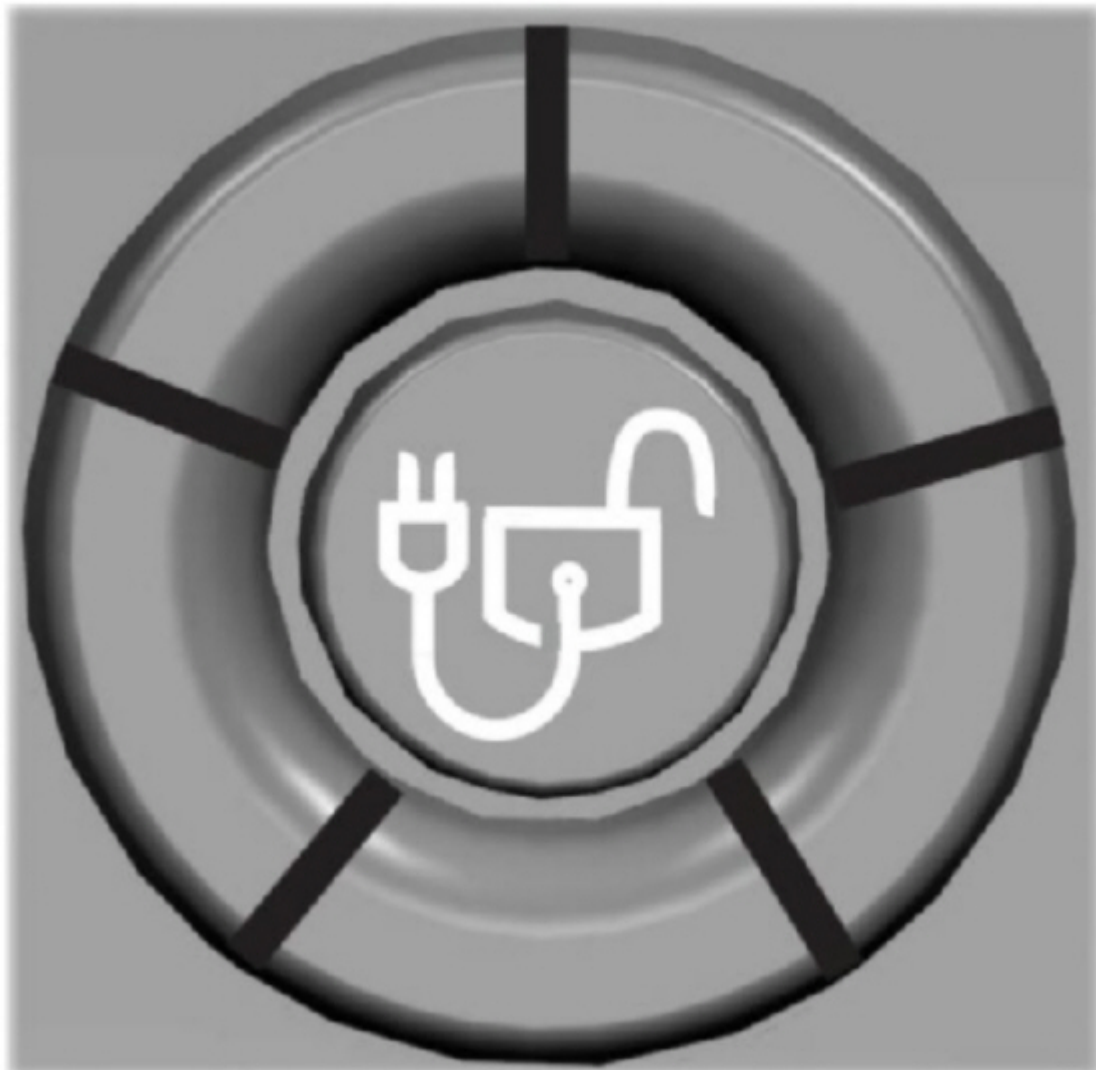
Figure 1

**NOTE: To prevent repeat concerns with the charge port lock actuator, fully press the charge port lock/release button before disconnecting the charge cord. (Figure 1) The charge port lock actuator may also be released through the vehicle's center display screen or pressing the release button located on the level 3 direct current (DC) fast charger.**

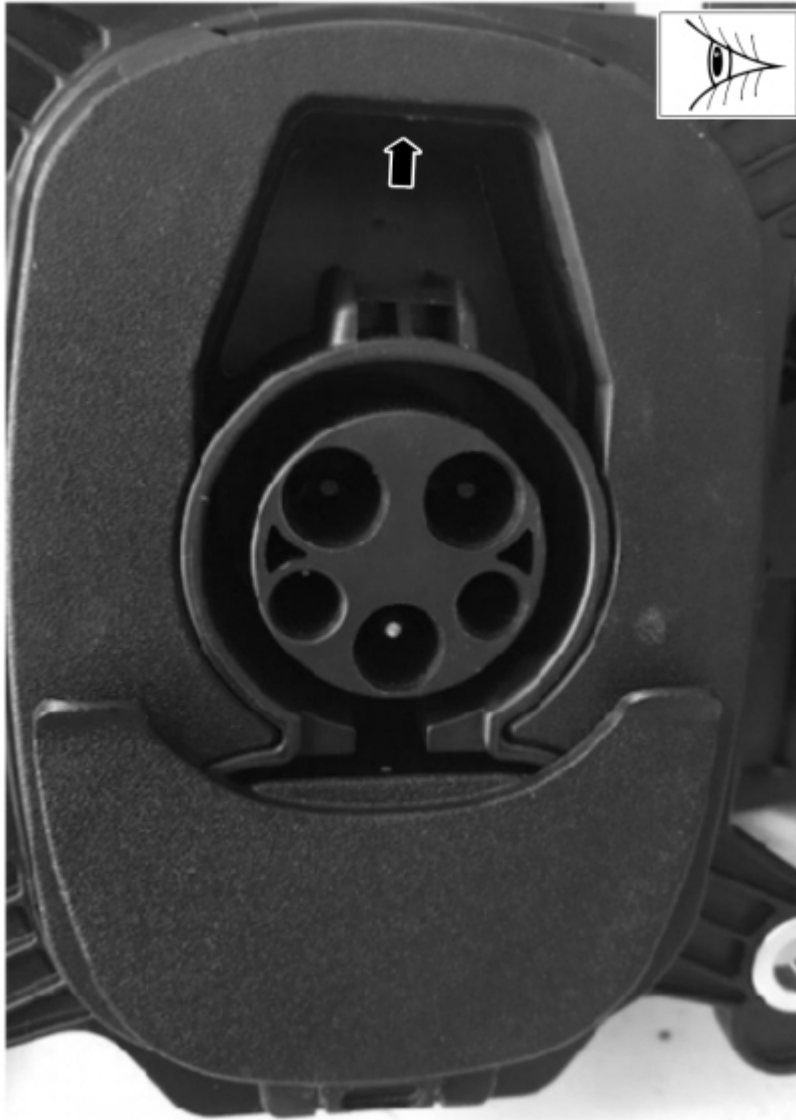
Figure 2

1. Inspect the charge port lock actuator pin. (Figure 2) Is the charge port lock actuator pin missing or loose?

- (1). Yes - proceed to Step 2.
  - (2). No - this article does not apply. Refer to Workshop Manual (WSM), Section 414-03B High Voltage Battery Charging System.
2. De-energize the high voltage system. Refer to WSM, Section 414-03A High Voltage Battery > Mounting and Cable > General Procedures.
3. Gain access to the charging port.
- (1). For e-Transit vehicles, remove the front bumper cover. Refer to WSM, Section 501-19 Front Bumper Cover > Bumpers > Disassembly and Assembly.
    - Remove the retainers and the charge port cover. (Figure 3)
