TECHNICAL SERVICE BULLETIN

Soft Top Roof - Loose Exterior Fabric On Rear Window

23-2091

Ford 2021-2022 Bronco

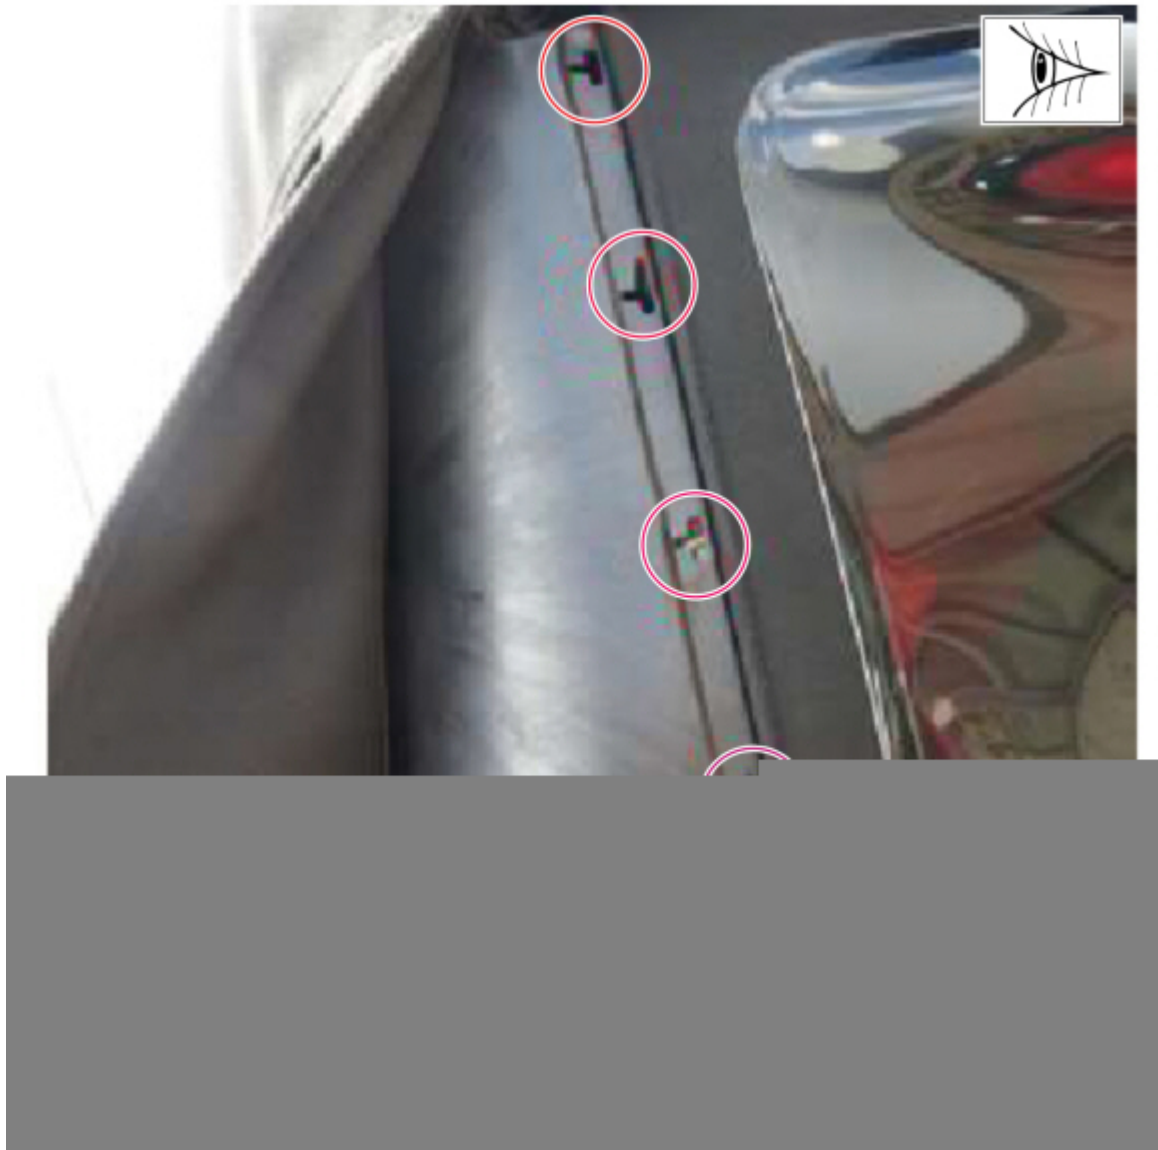
Figure 1 - Right D-pillar shown, left side similar

1. Visually inspect the 5 clips that run vertically along each D-pillar on the rear window.

2. Are any of these clips broken causing the rear window fabric to become loose?
