# Technical Service Bulletin

**90 Instrument cluster: various malfunction LEDs are lit sporadically without DTCs stored in any modules**  
90 23 19 2064789/3 March 23, 2023. Supersedes Technical Service Bulletin Group 90 number 22-33 dated January 7, 2022, for reasons listed below.

Model(s)	Year	VIN Range	Vehicle-Specific Equipment
A4 allroad, A4, S4, A5, A5 Cabriolet, A5 Sportback, S5, and S5 Sportback	2020 – 2024	All	Analog Instrument Cluster
RS 5, and RS 5 Sportback	2021 – 2024

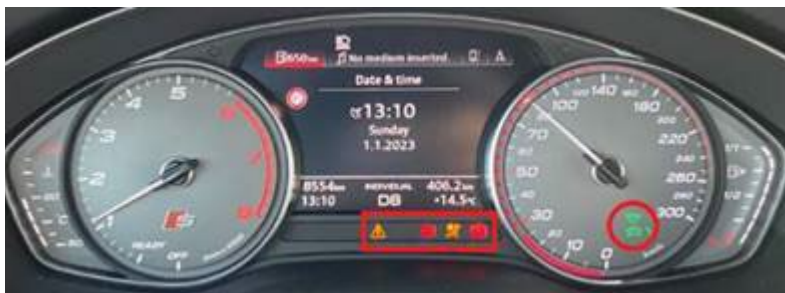
Due to a deviation in the current draw of the LEDs for the adaptive cruise control lamp, the warning lamps shown in *Figure A* may unintentionally illuminate.

Various warning lamps may be illuminated (Figure 1); in this case, **NO DTCs** will be stored. Please replace the instrument cluster according to the instructions in the Elsa Repair Manual.

**Figure 1:** The warning lamps illuminated in the red rectangle are unintentional.
