Technical Service Bulletin

93 Vehicle does not start and/or charging handle may not function correctly. DTC: U019B00 stored in 8C 93 23 96 2069853/1 March 27, 2023.

Model(s)	Year	VIN Range	Vehicle-Specific Equipment
A7 e quattro	2021 – 2022	All	PHEV

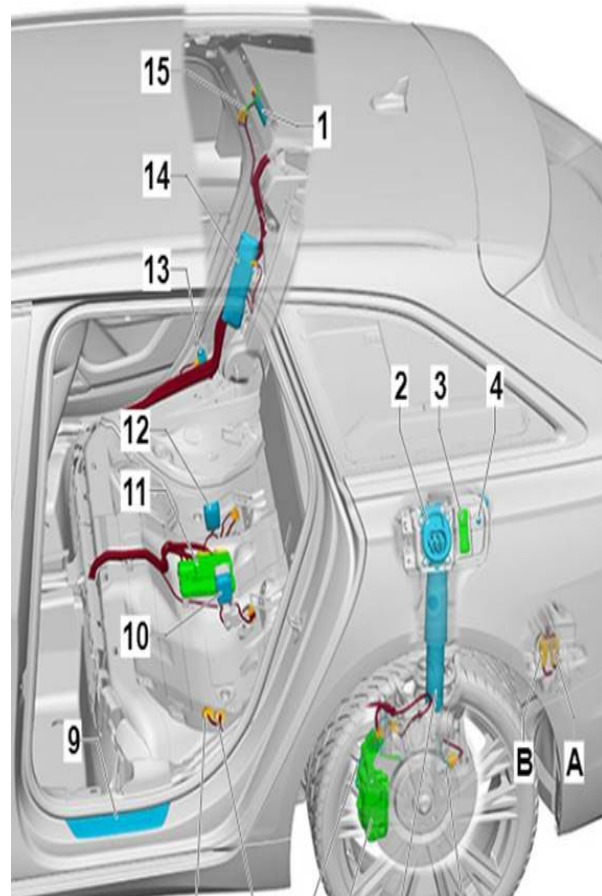
Damage to wires at coupling points T6bl and T8bd due to environmental influences.

Check the connection points T6bl and T8bd for damaged wires. (positions A and B in figure 1)

Figure 1: Inspect connectors at location A and B.

If you discover any damage to the wires, repair both connectors as follows:

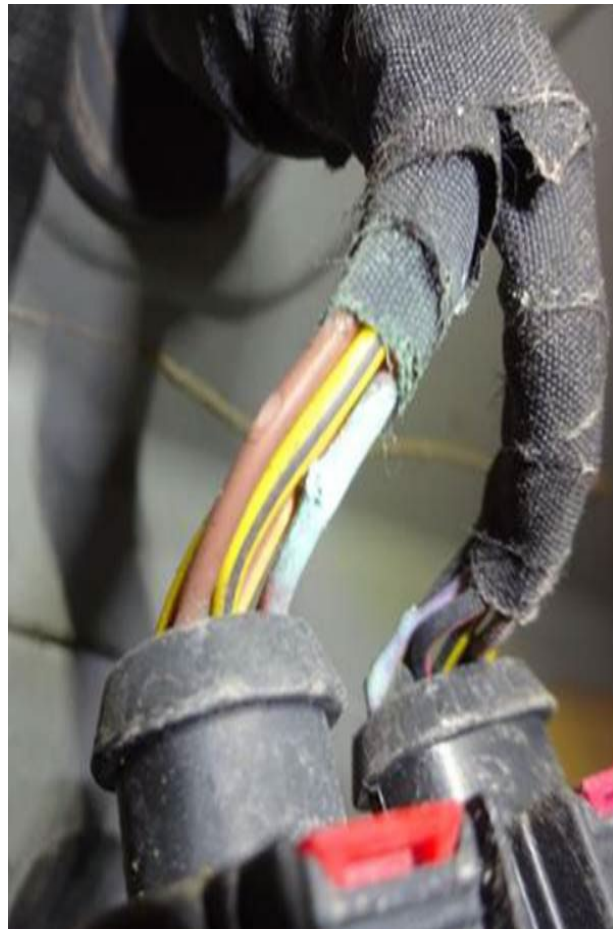
Figure 2: Damaged wires at T6bl and T8bd.

Using a seam ripper, remove the fabric tape between both connectors and body grommet.

Repair damaged wires using the wiring harness repair set **VAS 1978 B**.

If there is not enough space to repair the damaged wires between the connector and body grommet, the crimp connectors must be placed on the inside of the vehicle. The body grommet must then be sealed off again using butyl.

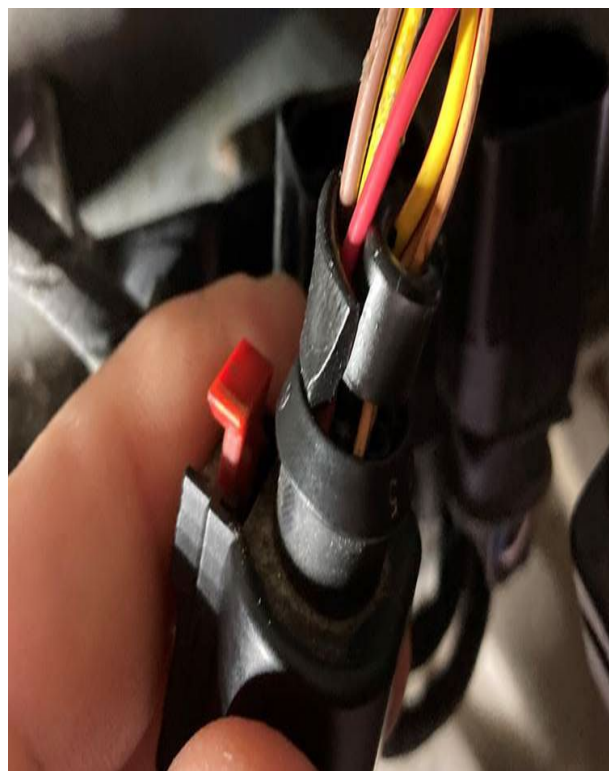
Figure 3: T6bl and T8bd butyl applied.

Apply approximately 4 cm of butyl around the wires and connector housings as seen in Figure 3.

Perform this step to both connectors T6bl and T8bd.

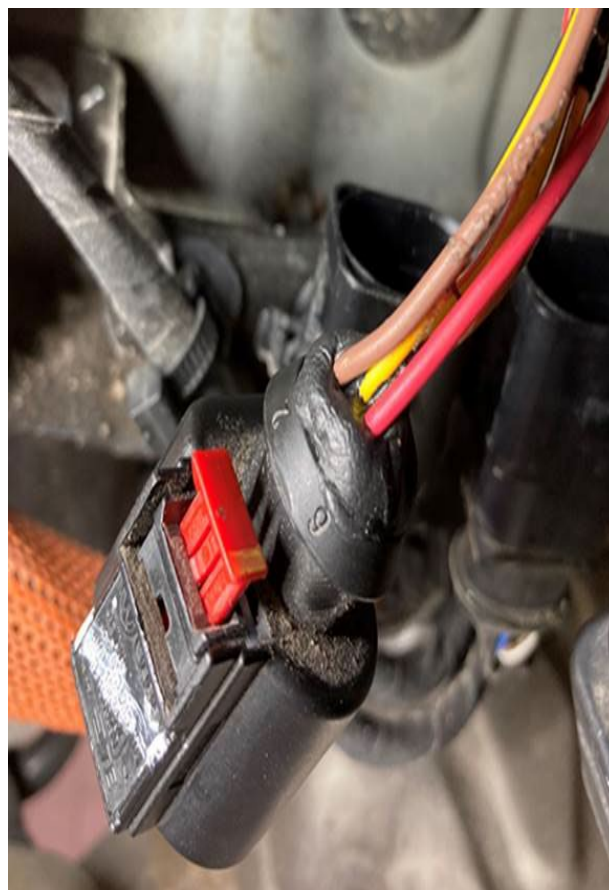
Figure 4: T6bl and T8bd butyl installed.

Press the butyl into the connector as seen in Figure 4.

Perform this step to both connectors T6bl and T8bd.

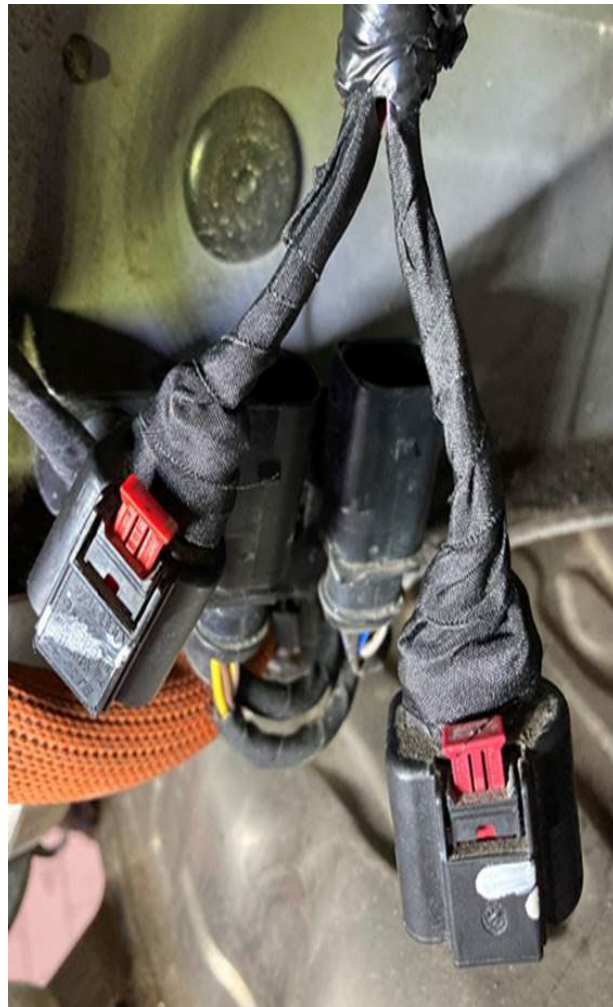
Figure 5: T6bl and T8bd harness wrapped.

Wrap harness with fabric tape **N 10592002** from both connectors to the body grommet as seen in Figure 5.

Make sure to start wrapping on the connector and wrap upwards towards grommet with 50% overlap.

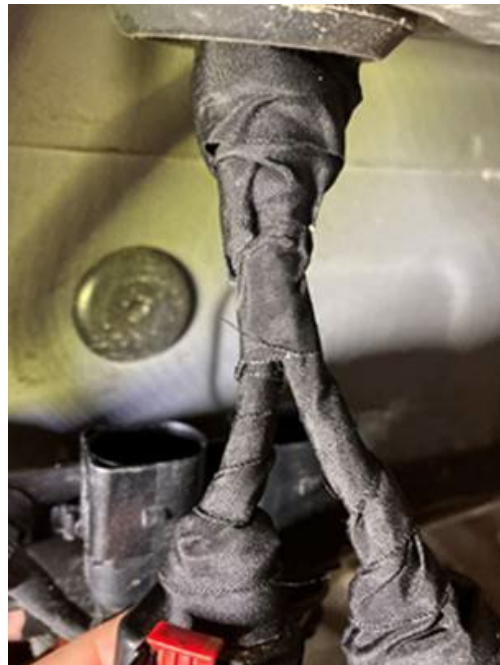
Figure 6: Harness fully repaired.

Finally, wrap the two bundles of wires together as seen in Figure 6.

Apply the cloth tape starting on the harness halfway point and then wrapping with 50% overlap towards the grommet.
