Excessive Resistance of Door Side Windows When Being Raised and/or Lowered, Cracking and Squeaking Noises

Topic number	LI72.00-P-076031
Version	1
Function group	72.00 - General
Date	3/8/23
Validity	MODEL
	V177
	H/X247
	X243
	up to production September 30, 2022

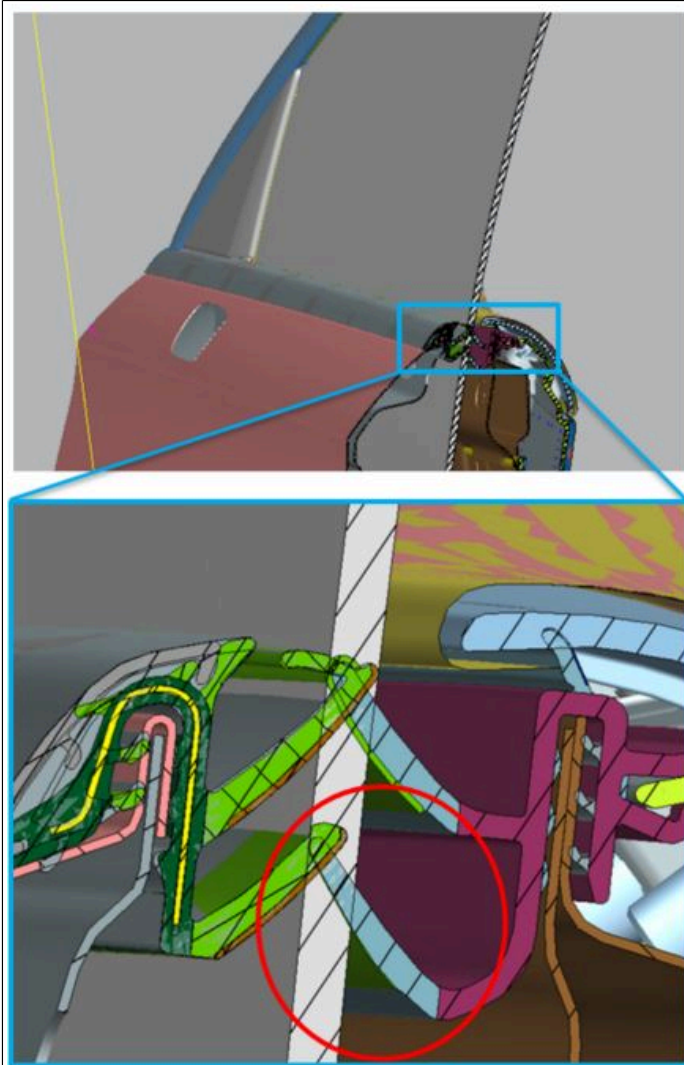
Attachments	
File	Description
Bild 1.JPG	Sealing Lip of Inner Seal Rail

Sealing lip of inner sealing rail (see picture 1 and picture 2, pos. 40 and 130) folds down while side windows are being lowered (opened).

When the side windows are raised (closed), the sealing lip is pulled back up again.

Replace inner sealing rail.

Then perform normalization of the window lifter system in the relevant door control unit.

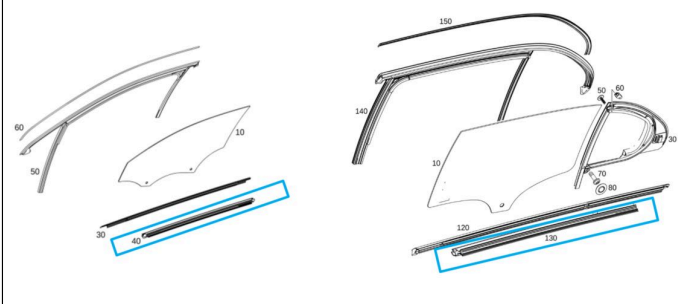
Bild 2.JPG

XPPI Callout of Inner Seal Rail
