Service Bulletin

Bulletin No.: 00-06-01-012M

Subject: Use of Surface Conditioning Disks When Cleaning Gasket Sealing Surfaces and/or Reused Parts

Models: 2023 and Prior GM Passenger Cars and Trucks including Silverado 4500HD, 5500HD and 6500HD (Excluding Chevrolet Medium Duty Low Cab Forward Equipped with Diesel Engine).
2017-2024 Chevrolet Silverado 2500/3500
2017-2024 GMC Sierra 2500/3500

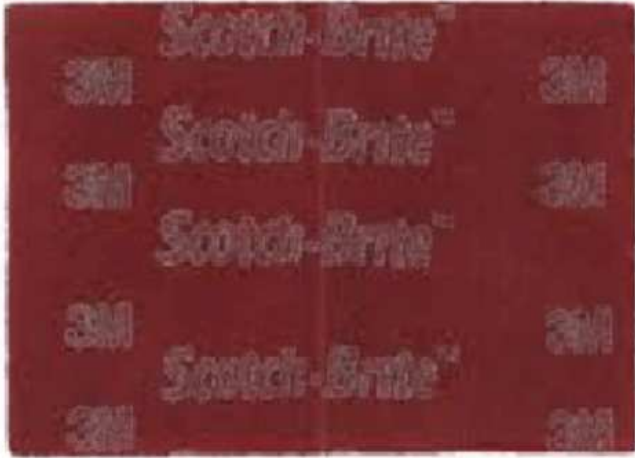
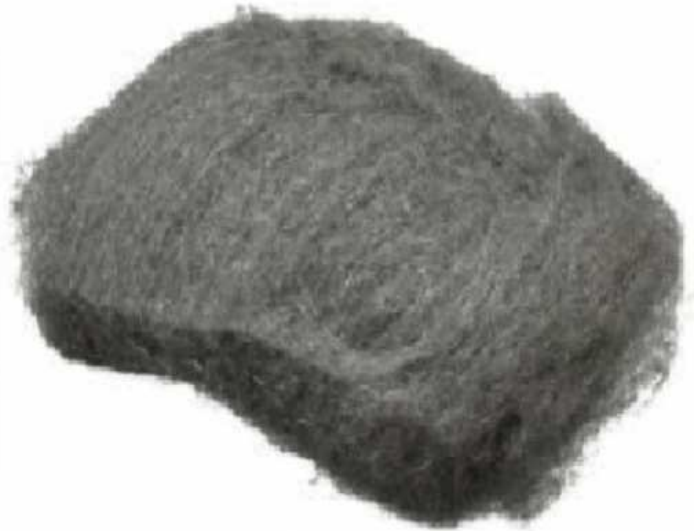
2726943

The use of an abrasive hand pads and/or steel wool can also create imperfections in the metal and therefore are not recommended for use when cleaning surfaces.

When cleaning gasket sealing surfaces and/or cleaning parts that are to be reused, surface conditioning disks, hand pads, or steel wool (typically constructed of woven fiber, steel or molded bristles) that contain abrasives, such as a high amount of Aluminum Oxide, should NOT be used.

The use of such surface conditioning items dislodges Aluminum Oxide (from the disk) and metal particles (from steel wool), which can lead to premature engine bearing failure.

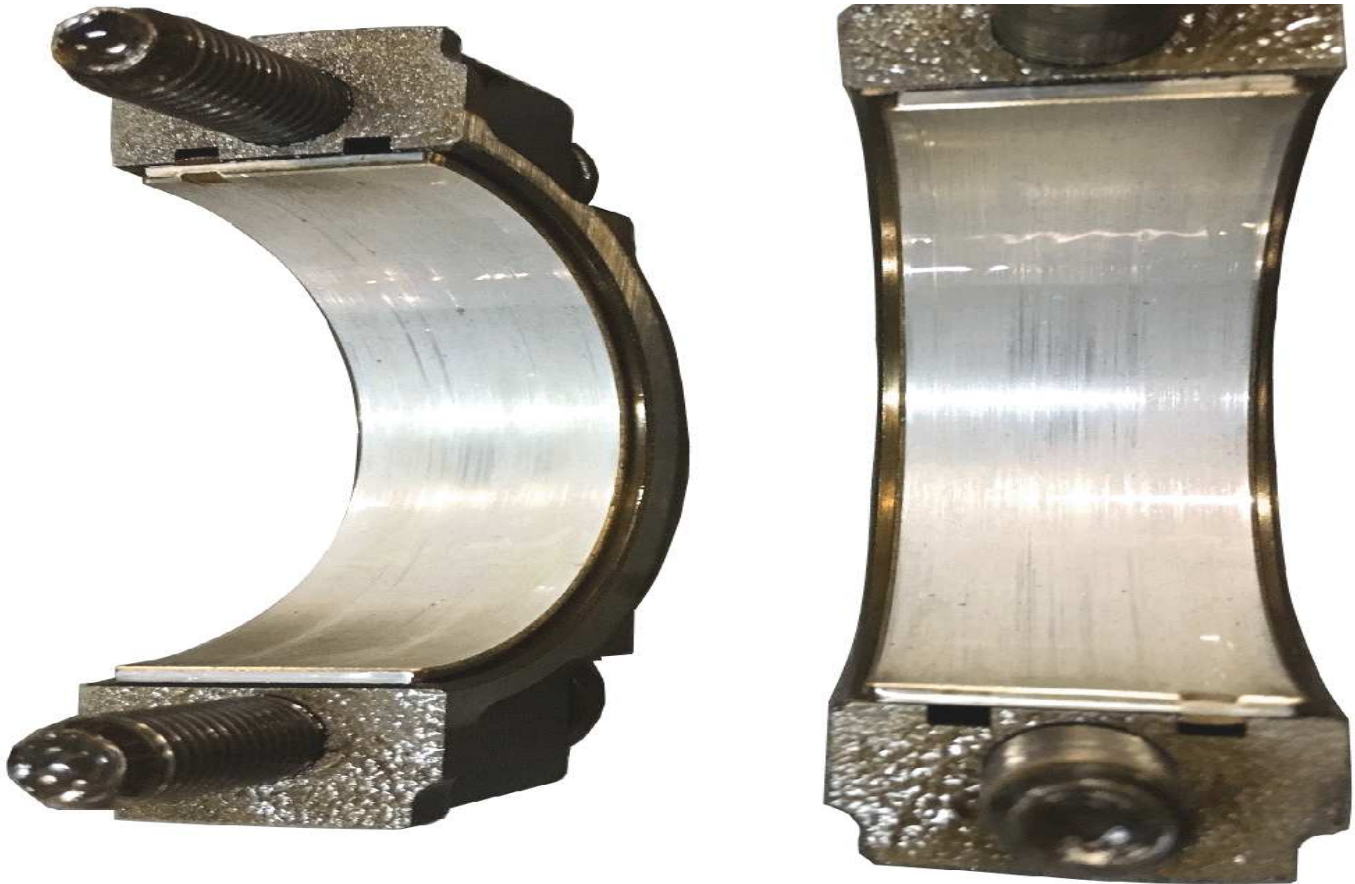
4788796

The presence of Aluminum Oxide in engine oil has been shown to cause premature engine bearing failure. In some cases, this failure occurs in as little as 2,200♦km (1,367♦mi) or less after the repair has been made.

The scratches on the bearings in the above picture were created when debris from an abrasive pad made its way into the bearing. This debris is a combination of the metal and particles from the abrasive pad that were removed when the engine was cleaned.

General Motors recommends the use of a razor blade or plastic gasket scraper to clean the gasket surface on components that are to be reused. When cleaning gasket surfaces, please note the following:

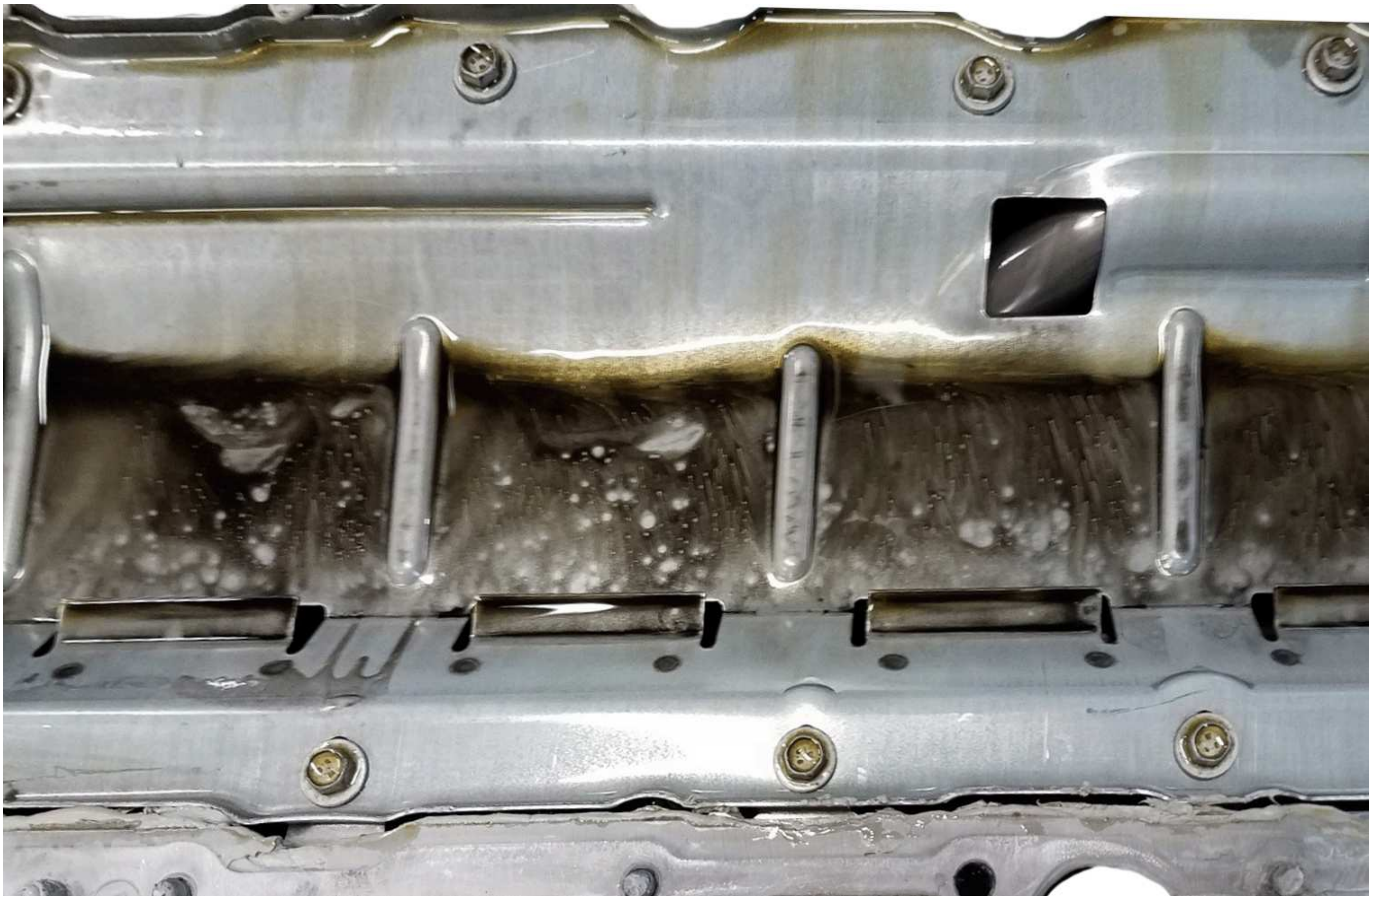
4789486

The crankshaft deflector in the picture above has debris that was left behind from the abrasive cleaning methods. Once the debris has gotten here, it can be distributed to any surface in the engine.

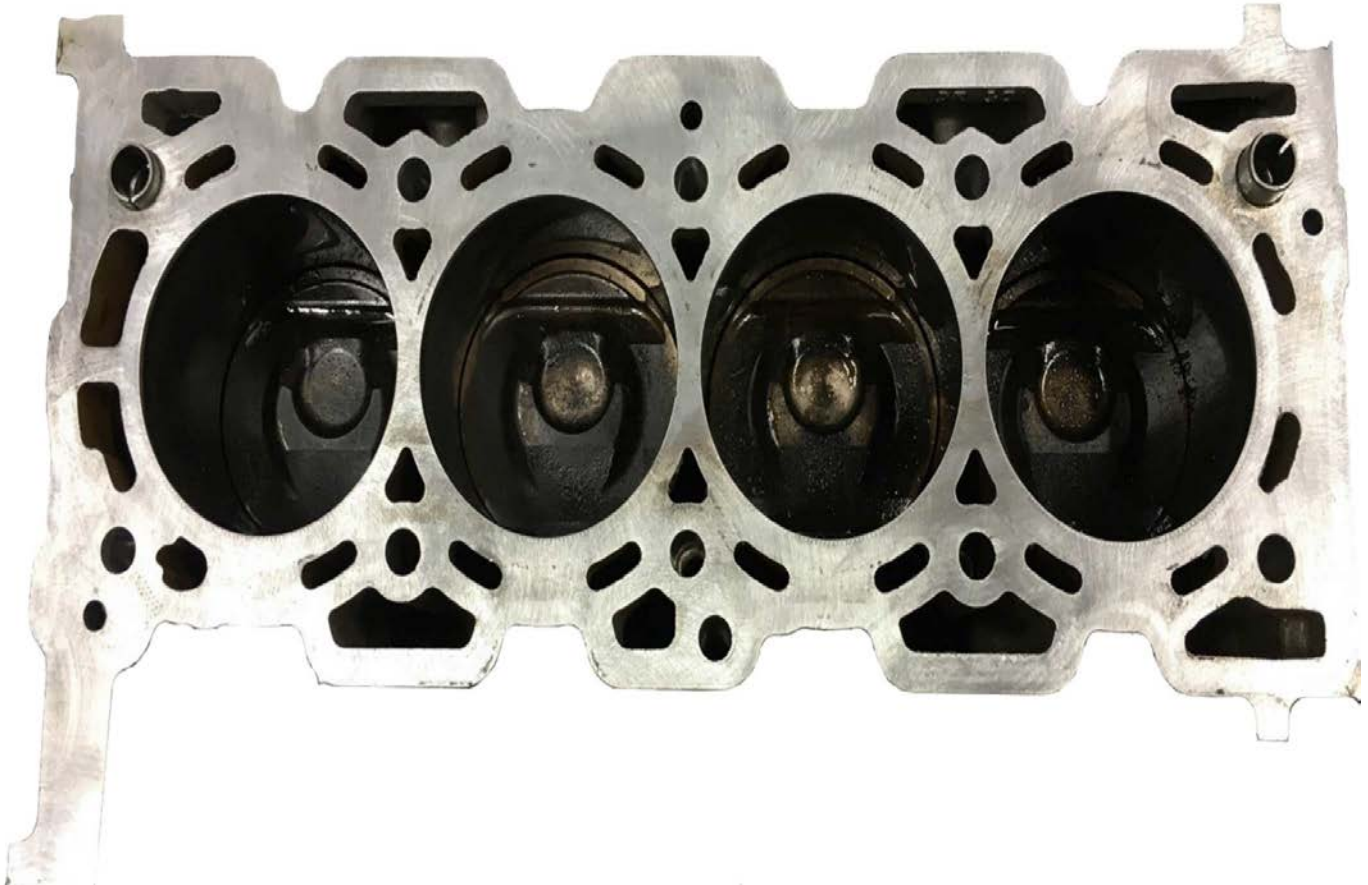
4788615

An overview of the deck face when it has been cleaned with an abrasive pad, left swirls on the surface and do not go in the same direction, which caused changes in the surface dimensions (flatness) of the block leaving it un-usable.

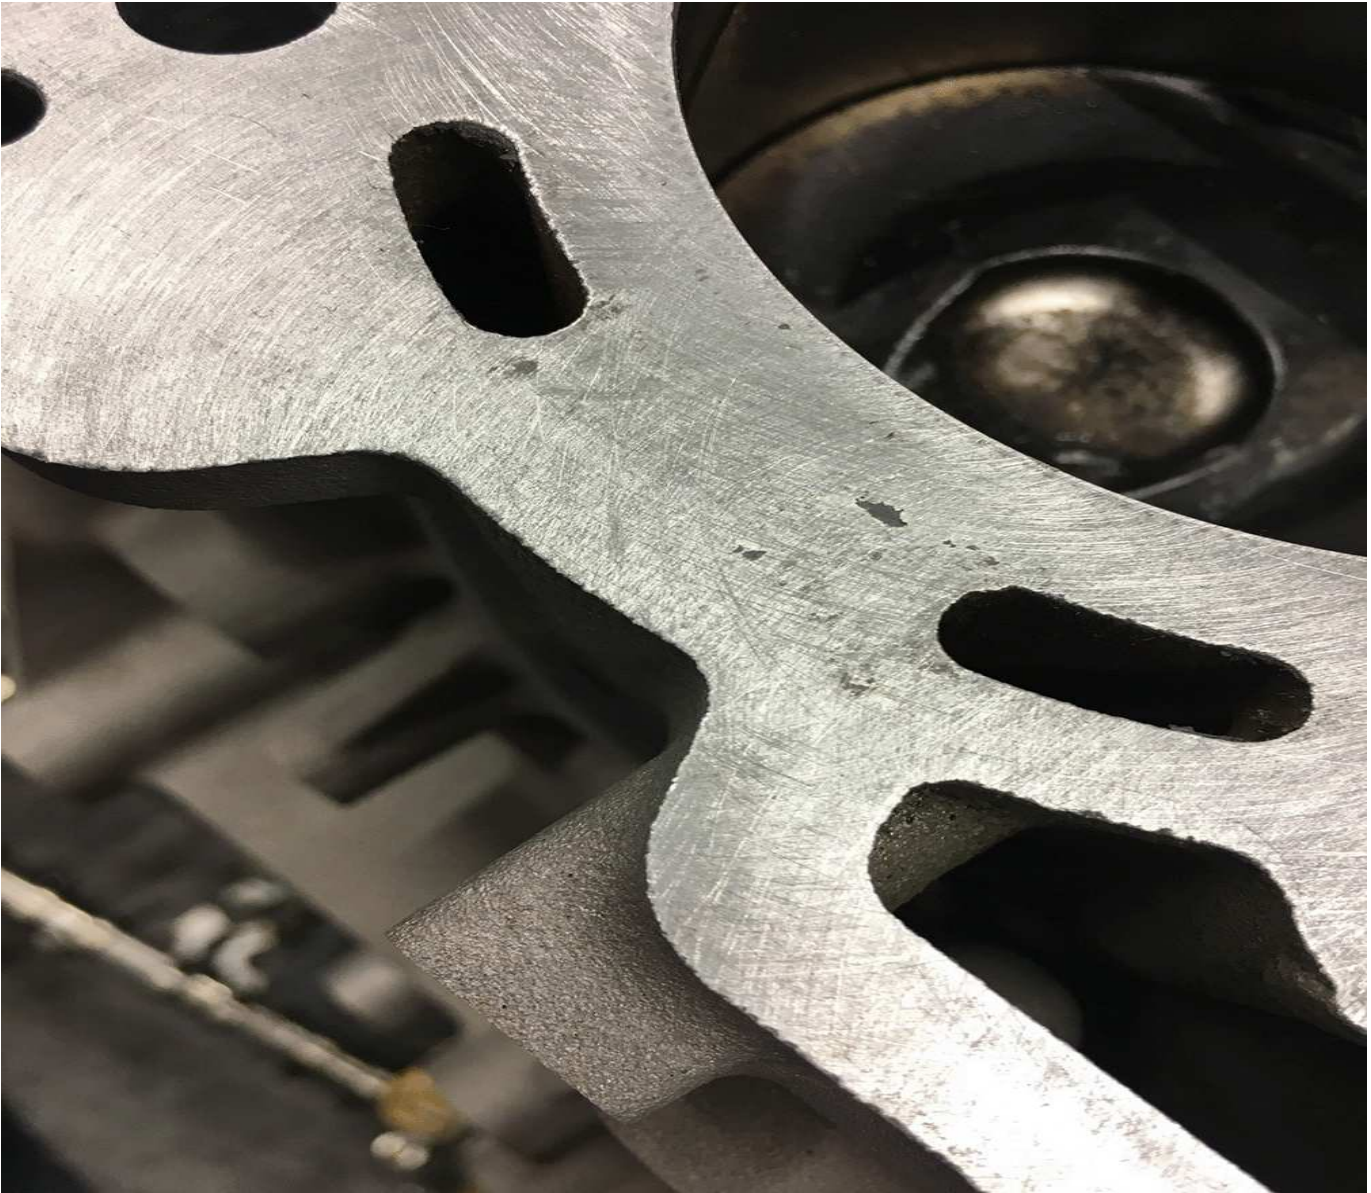
4789846

Scratches from the pad are deeper in some areas than others causing the gasket/seals not to properly seal against an uneven surface.

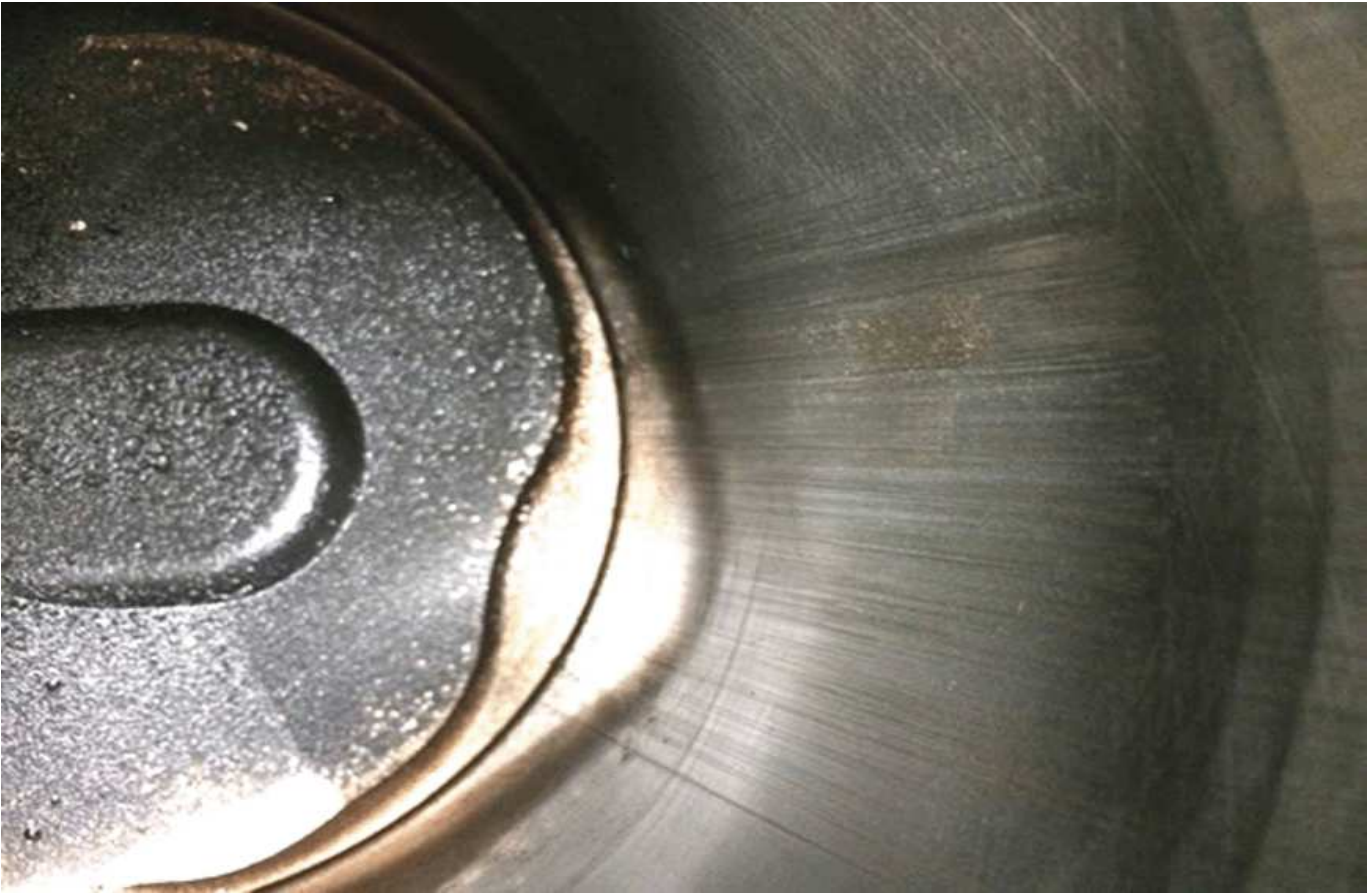
4788657

Note: Damage to the pistons and/or cylinder walls may result in an engine knocking, tapping and/or possible low compression.

The sides of this cylinder wall were scarred with scratches as a result of the debris created by the abrasive cleaning pads. This debris gets trapped between the piston head and the cylinder wall causing damage to the cylinder bore as the piston moves up and down.

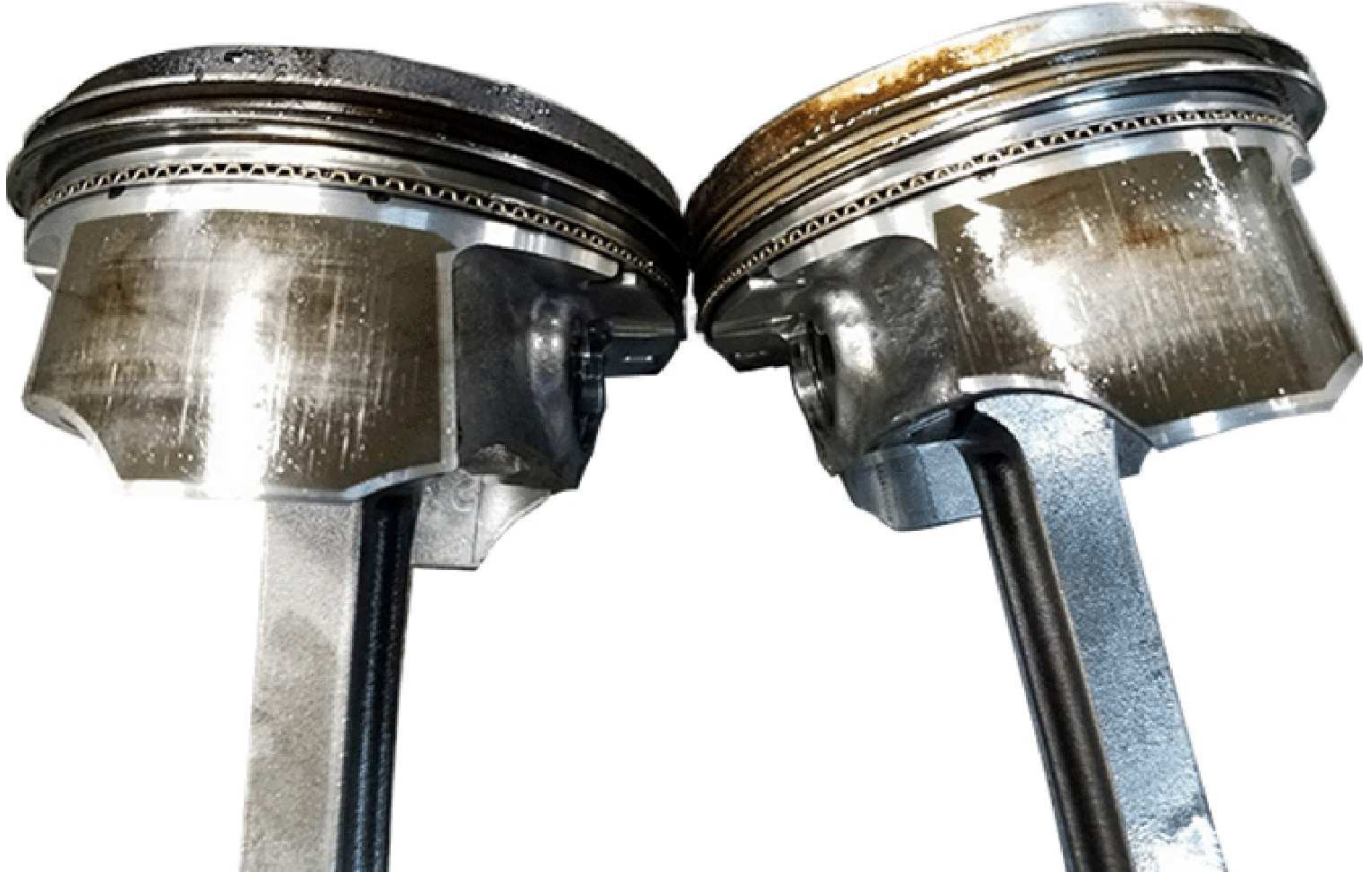
4800927

The piston skirt and piston ring damage caused by abrasive cleaning pads.

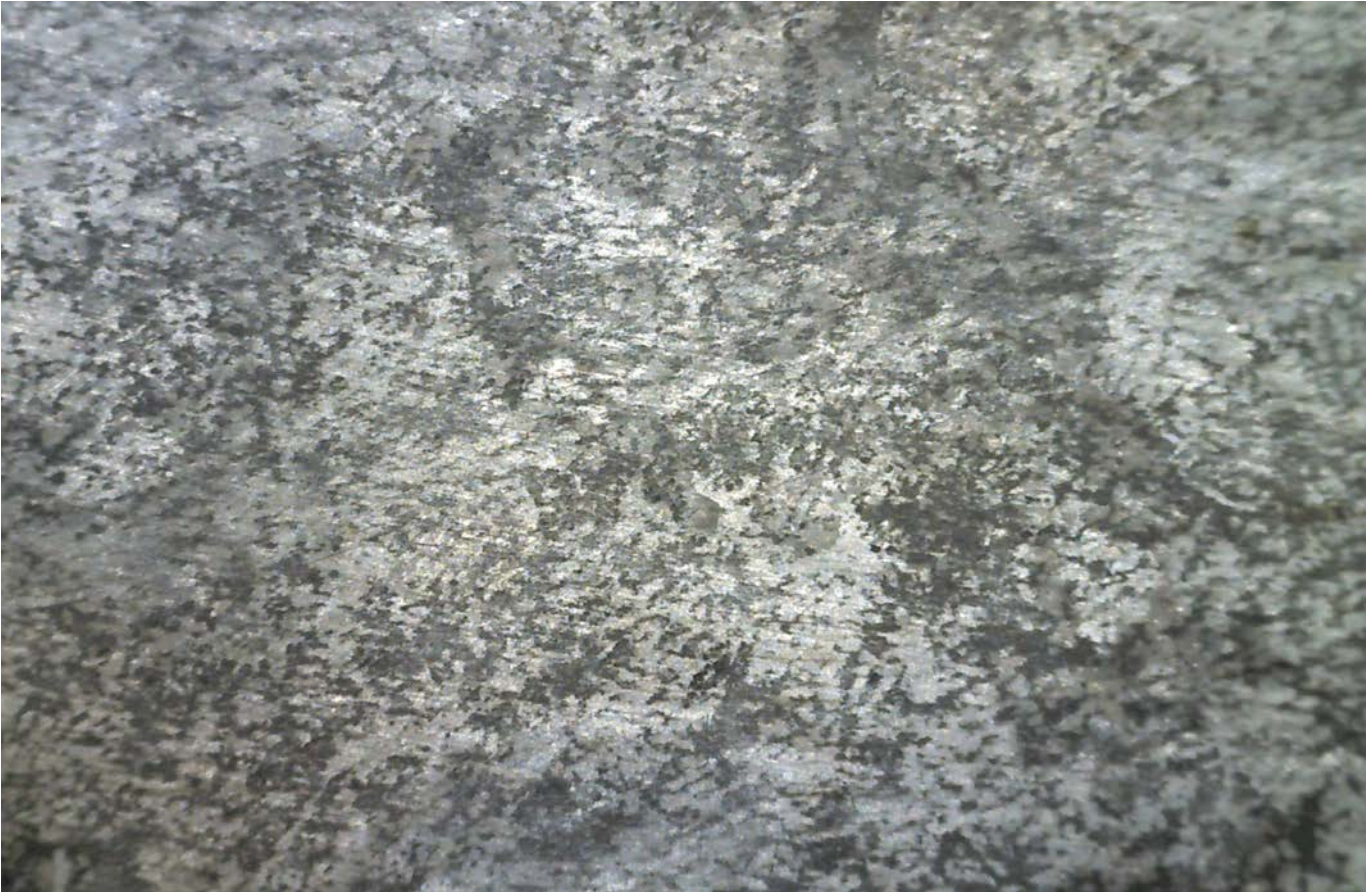
4791153

A close up of the sealing surface after cleaned with GM Low VOC Cleaner and plastic scraper.

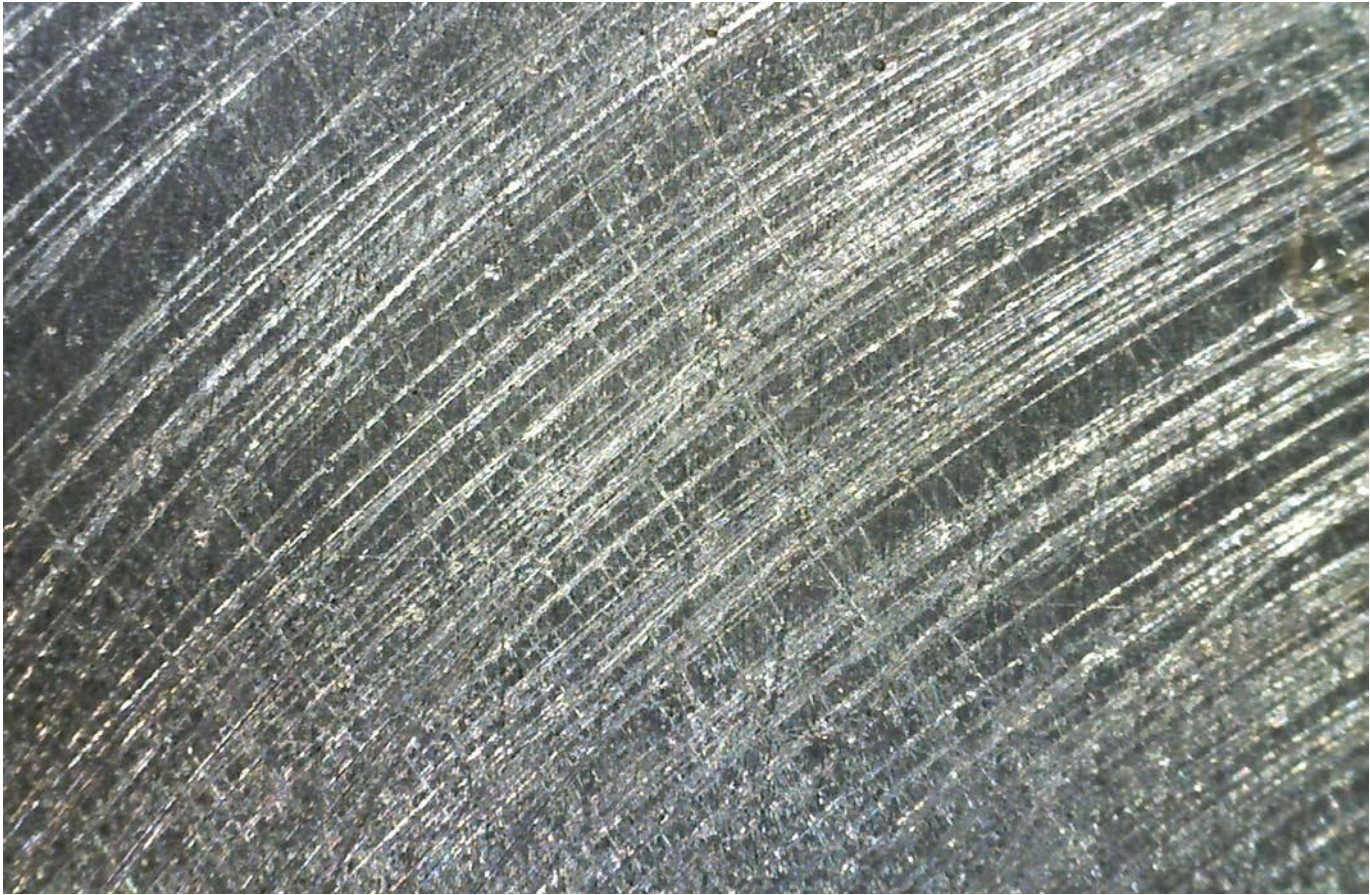
4791149

A close-up of the surface shows deep grooves caused by using an abrasive cleaning disc.

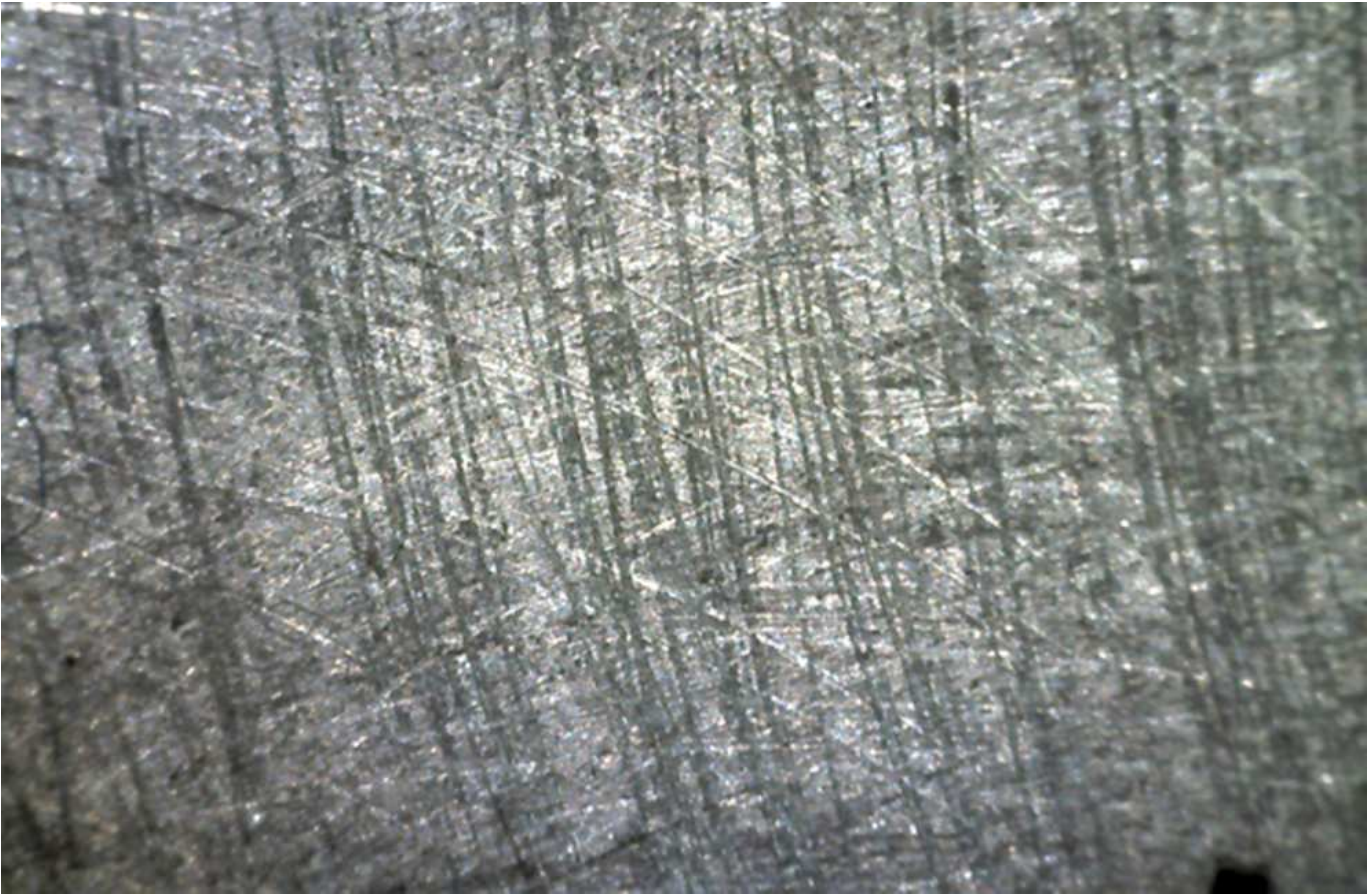
4791276

A close-up of the surface shows deep grooves caused by use of a wire wheel.
