Additional Coolant Pump Fault (POC4700) Causes MIL

Models	Model Year	Model Type	VIN Range	Vehicle-Specific Equipment
Cayenne	2015 - 2017	92A	n/a	PHEV

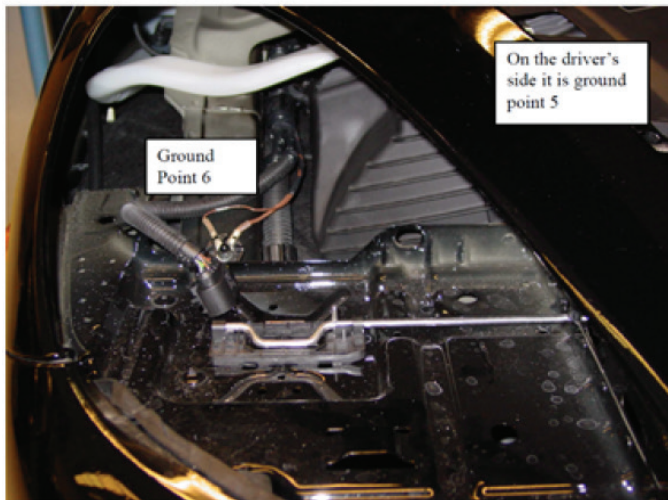
Figure 1 - Ground PIN 6B

- a) Corrosion on Ground Pin 6B (See figures 1 and 2.)
- b) Corrosion on the connector to the secondary low temperature coolant pump.
- c) A bad ground or otherwise unsound wiring.

Looking into right front wheel well through the headlamp area (Driver side similar)

The service recommendation is to check the ground, connector, and wiring for corrosion and circuit continuity. Repair the ground, connector, or wiring as needed. Sometimes, the ground bolt is painted and not adequately conductive. In this case, clean the ground bolt and eyelet using a wire brush and sandpaper. If the ground, connector, and wiring are acceptable, replace the electric water pump and the electric water pump relay.

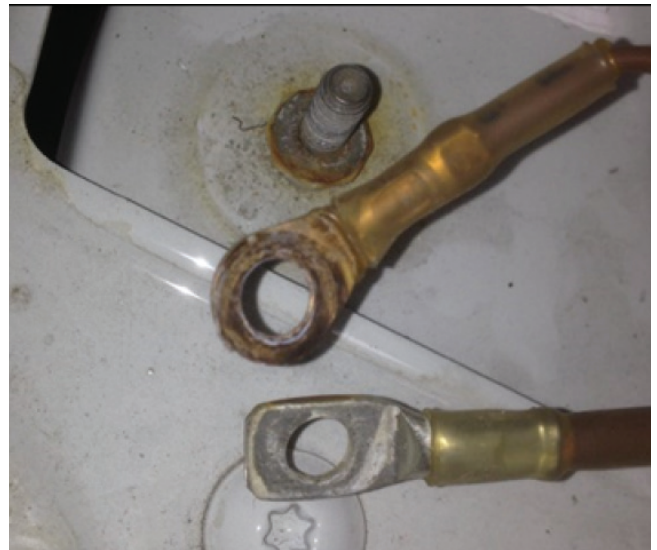
Figure 2 - Example of corrosion on ground point
